Bel Air Elementary School

Property Executive Summary

Bel Air Elementary School
Summary of Findings

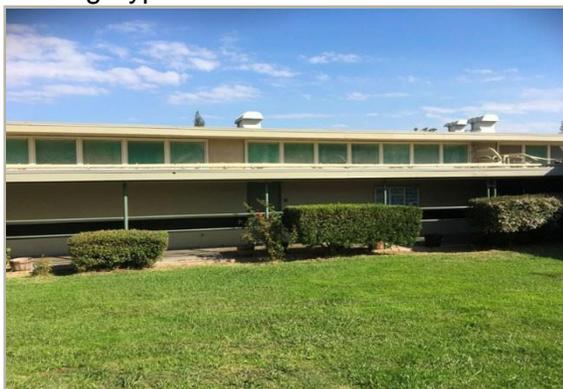
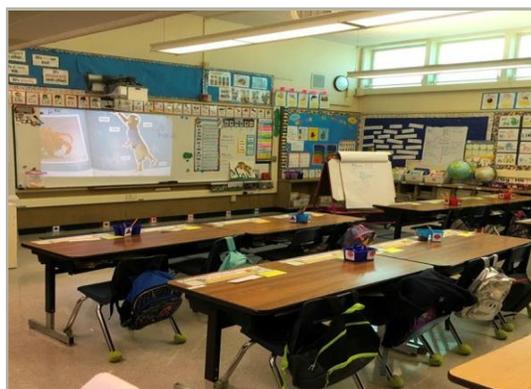
Building Type 1 Information

Fire Alarm	Alarm panel, smoke detectors, alarms, strobes, pull stations, back-up emergency lights, and exit signs	Fair
Equipment/Special	None	--
Key Issues & Findings	Buildings lack fire suppression, peeling paint on some original windows, peeling paint on some wood fascia around library, remodeled restroom sinks do not have wrapped drains per ADA, lots of exterior lights are on during the day

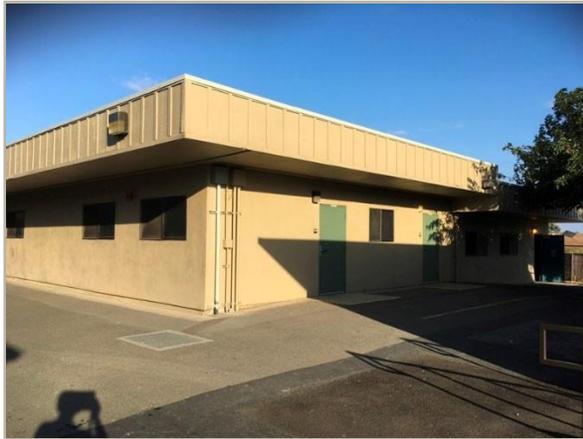
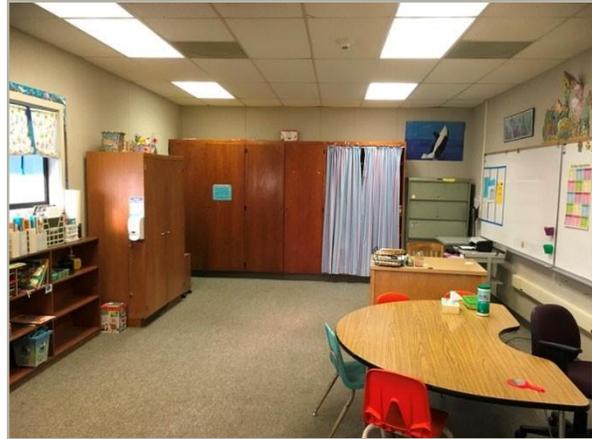
Building Type 2 Information

Equipment/Special	None	--
Key Issues & Findings	Building lacks fire suppression, wood fascia needs new coat of paint, rodent issues in Classroom 27 due to poor door sweeps

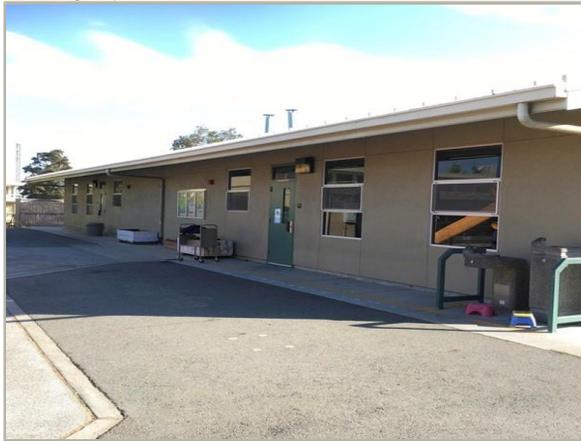
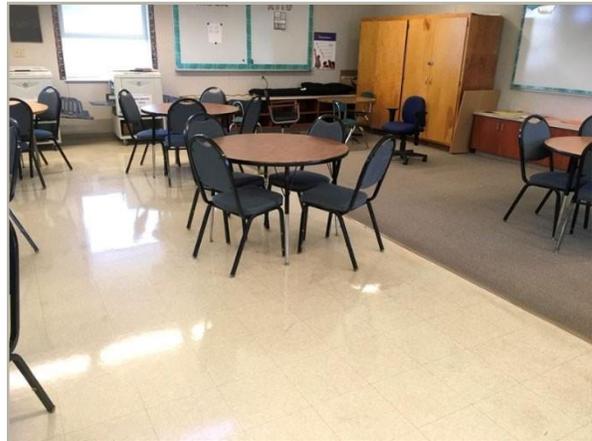
Bel Air Elementary School
 Building Type 3 Information

Fire Alarm	Alarm panel, smoke detectors, alarms, strobes, pull stations, back-up emergency lights, and exit signs	Fair
Equipment/Special	None	--
Key Issues & Findings	No fire suppression

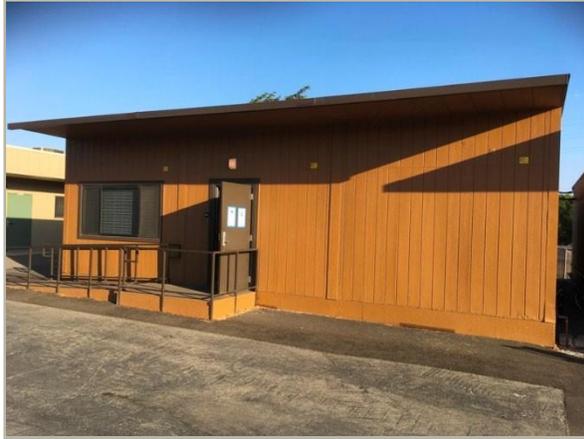
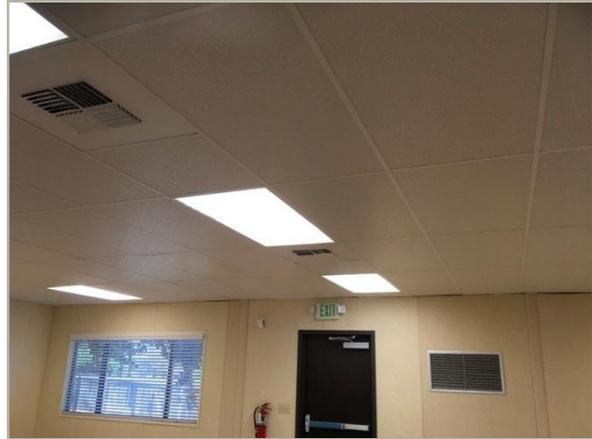
Building Type 4 Information

Fire Alarm	Alarm panel, smoke detectors, alarms, strobes, pull stations, back-up emergency lights, and exit signs	Fair
Equipment/Special	None	--
Key Issues & Findings	Building lacks fire suppression

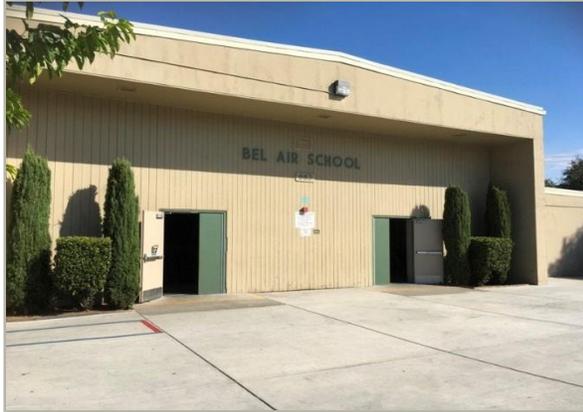
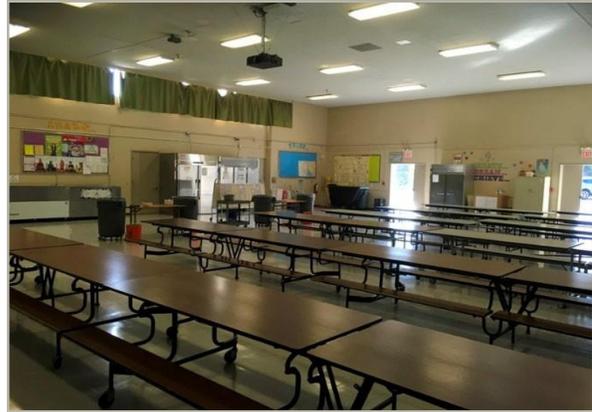
Building Type 5 Information

Fire Alarm	Alarm panel, smoke detectors, alarms, strobes, pull stations, back-up emergency lights, and exit signs	Fair
Equipment/Special	Commercial kitchen equipment, sound system	Fair
Key Issues & Findings	Building lacks fire suppression, kitchen hood lacks fire suppression, kitchen garbage disposal is not operable, electric code violations with hot water heating pump

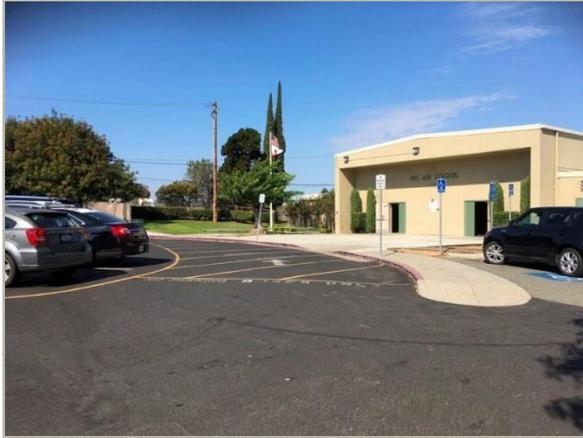
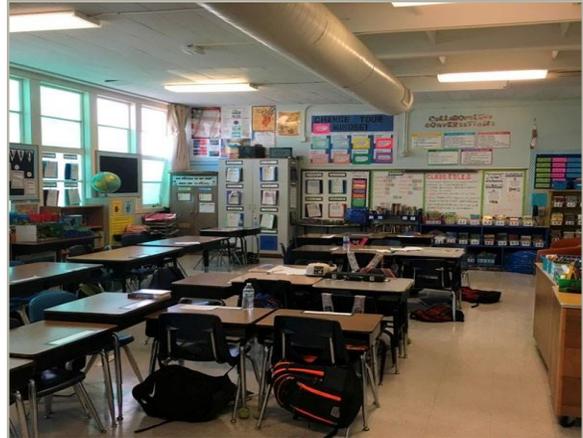
Site Summary Information

Key Issues & Findings	Unlocked main switchboard gate along with unlocked and open main switchboard enclosure, there is a noticeable amount of live tree growth within the east side perimeter fence
