Sunrise Special Education School

OVERVIEW

Property Executive Summary

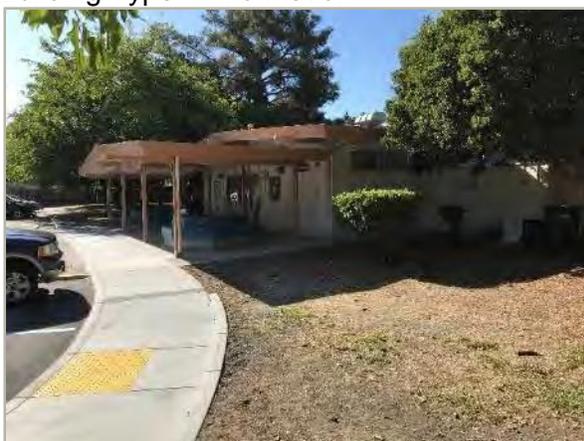
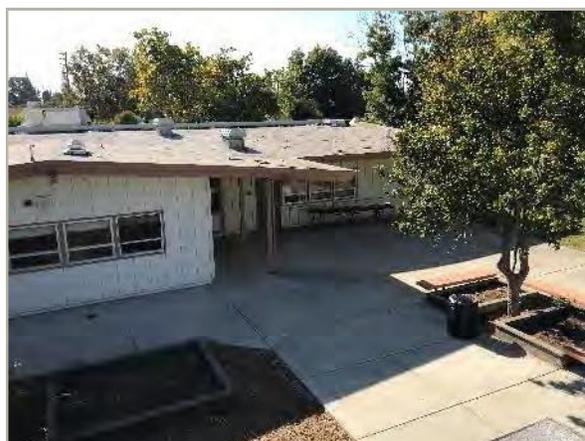
Sunrise Special Education School
 Building Type 1 Information

Equipment/Special	Commercial kitchen equipment	Fair
Key Issues & Findings	Blocked roof drains, dated fire sprinkler layout, restrooms under renovation
