Diablo View Middle School

### OVERVIEW

#### **Property Executive Summary**

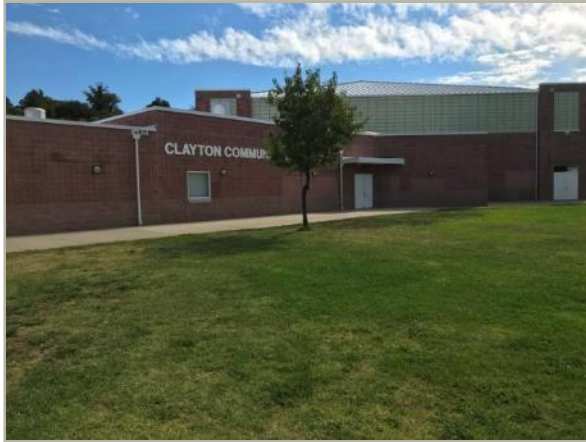
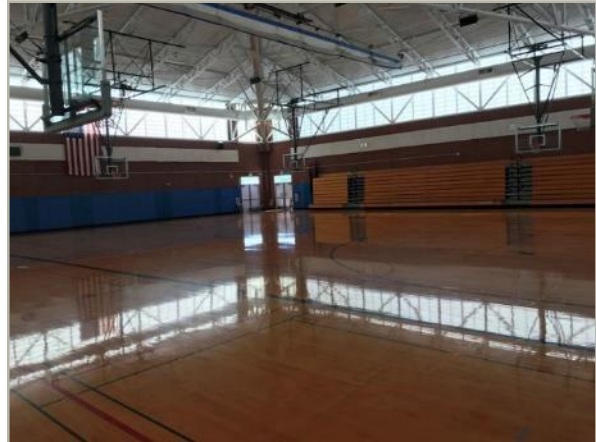
Building Gymnasium Information

<b>Fire Alarm</b>	Smoke detectors, alarms, strobes, pull stations, back-up emergency lights, and exit signs	Fair
<b>Equipment/Special</b>	None	--
<b>Key Issues &amp; Findings</b>	None noted

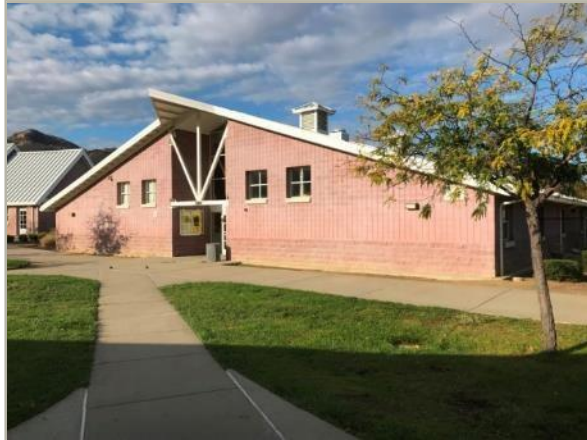
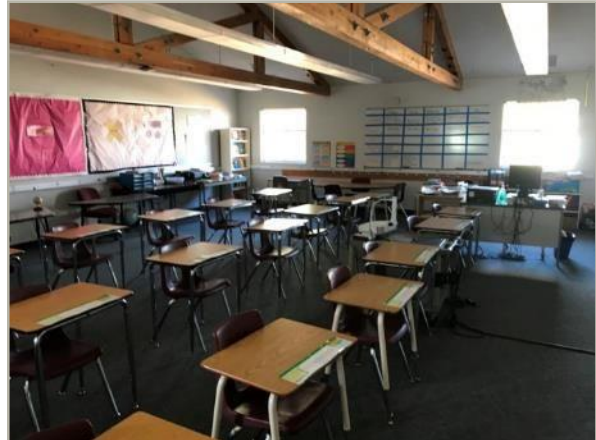
Building M-U, Admin/200, 300, 500, 700, 800 Building Information

<b>Electrical</b>	Source & Distribution: Main switchboard with copper wiring Interior Lighting: T-8, CFL Emergency: None	Fair
<b>Fire Alarm</b>	Alarm panel, smoke detectors, alarms, strobes, pull stations, back-up emergency lights, and exit signs	Fair
<b>Equipment/Special</b>	Commercial kitchen equipment	Fair
<b>Key Issues &amp; Findings</b>	Antiquated HVAC components and infrastructure, most buildings lack fire sprinklers

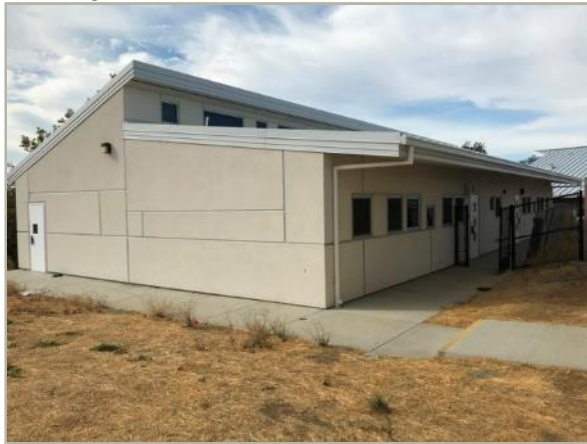
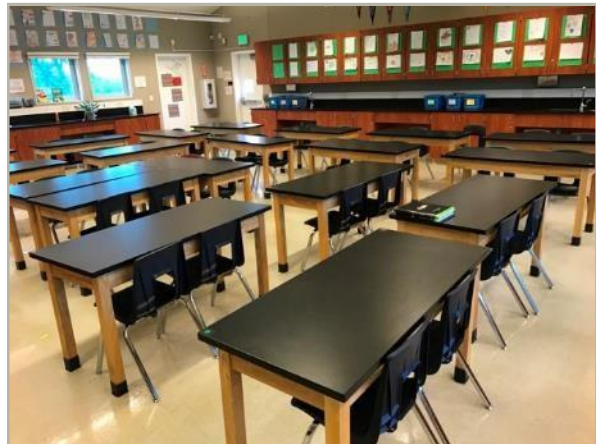
Diablo View Middle School  
 Building 600 Information

<b>Equipment/Special</b>	None	Fair
<b>Key Issues &amp; Findings</b>	Building lacks fire sprinklers

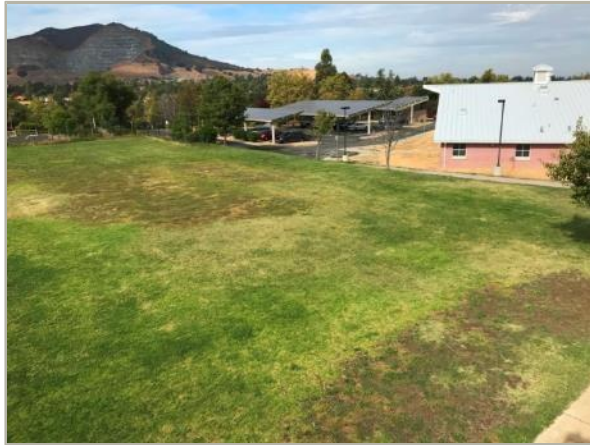
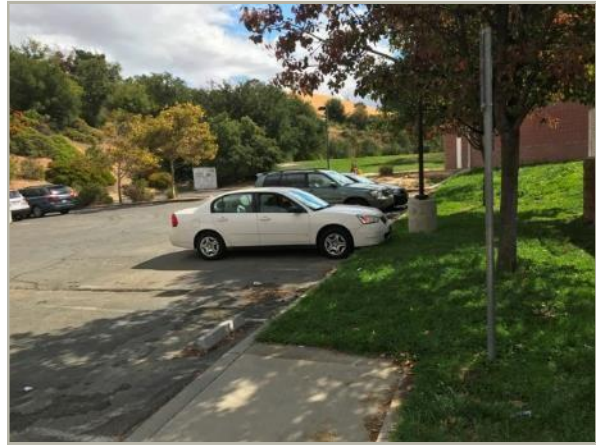
### Site Summary Information

<b>Site Lighting</b>	Pole-mounted: HPS, metal halide Building-mounted: LED, CFL	Fair
<b>Ancillary Structures</b>	Pre-fabricated storage sheds, a storage trailer, solar parking structures and gazebos	Fair
<b>Key Issues &amp; Findings</b>	None noted
