Foothill Middle School

OVERVIEW

Property Executive Summary

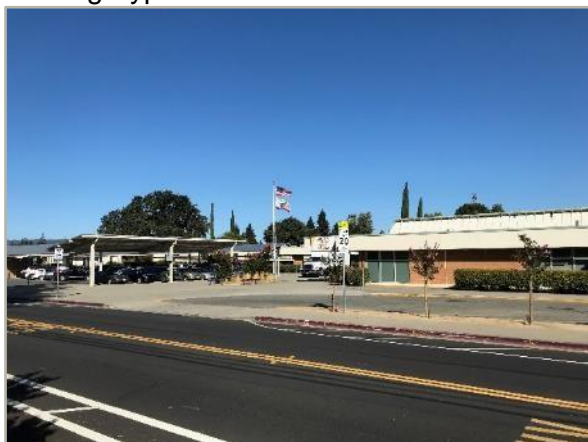
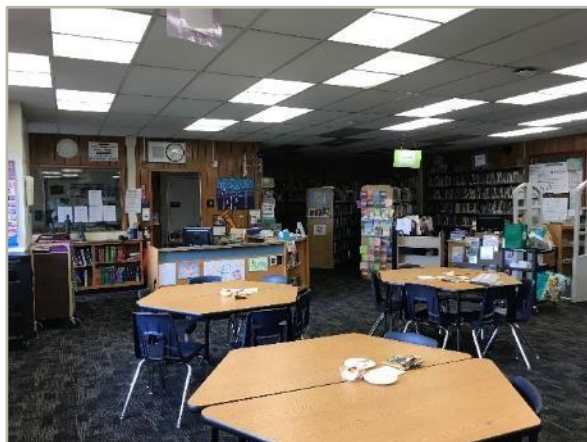
Building Type 1 Information		
Building Locations	New PE, A2-A8, D, C, B, T1-T4, M-U, E1-E2 and BG	
Constructed/ Renovated	1966 / 2016	
Total Area	64,150 SF	
Number of Stories	1	
<i>System</i>	<i>Description</i>	<i>Condition</i>
Structure	Concrete bearing walls on concrete slabs	Fair
Façade	Stucco with aluminum- and steel-framed windows	Fair
Roof	Primary: Gable construction with metal finish	Fair
Interiors	Walls: Painted gypsum board and unfinished concrete Floors: Carpet, VCT, ceramic tile Ceilings: Painted gypsum board, ACT	Fair
Elevators	None	Fair
Plumbing	Copper supply, cast iron waste and vent Gas and electric water heaters	Fair
HVAC	Individual package and split-system units and furnaces Supplemental components: ductless split-systems	Fair
Fire Suppression	Hydrants, fire extinguishers, hose cabinets	Fair
Electrical	Source & Distribution: Main switchboard and distribution panels Interior Lighting: T-8, T-12, incandescent Emergency: None	Fair

Fire Alarm	Alarm panel, smoke detectors, alarms, strobes, pull stations	Fair
Equipment/Special	Commercial kitchen equipment	Fair
Key Issues & Findings	Building lacks fire suppression.

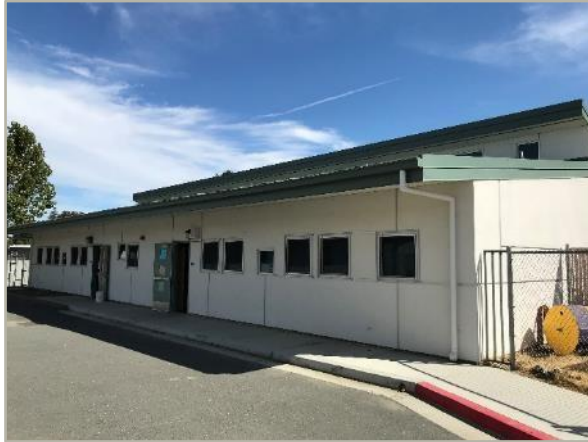
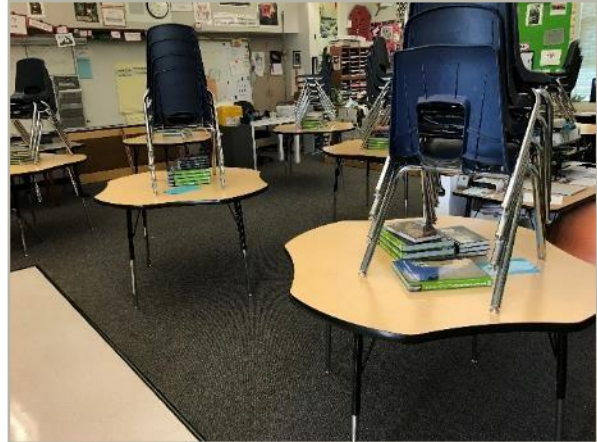
Foothill Middle School
 Building Type 2 Information

Building Type 2 Information		
Building Locations	Buildings M, S, T5-T7, A9-A10, and restroom buildings	
Constructed/ Renovated	1990 / 2016	
Building Size	20,590 SF	
Number of Stories	1	
<i>System</i>	<i>Description</i>	<i>Condition</i>
Structure	Conventional wood-framed structure on concrete slabs	Fair
Façade	Stucco with aluminum-framed windows	Fair
Roof	Primary: Gable construction with metal finish	Fair
Interiors	Walls: Painted gypsum board Floors: Carpet, VCT, ceramic tile Ceilings: Painted gypsum board, ACT	Fair
Elevators	None	--
Plumbing	Copper supply, cast iron waste and vent Electric water heaters	Fair
HVAC	Split systems	Fair
Fire Suppression	Hydrants, fire extinguishers, hose cabinets	Fair
Electrical	Source & Distribution: Main switchboard and distribution panels Interior Lighting: T-8, T-12, incandescent Emergency: None	Fair
Fire Alarm	Alarm panel, smoke detectors, alarms, strobes, pull stations	Fair

Equipment/Special	None	Good
Key Issues & Findings	Building M was constructed below grade, and the entry floods during rain. Engineer study and evaluation is recommended.

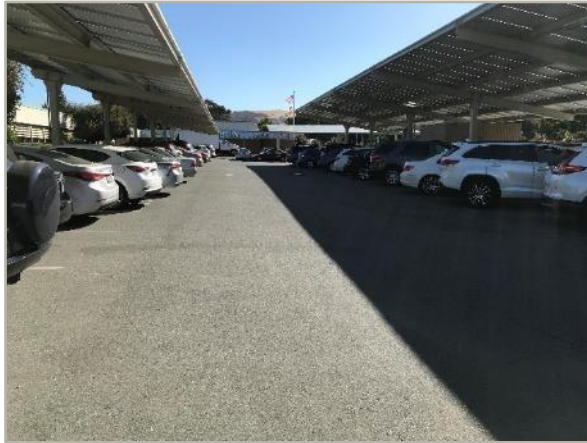
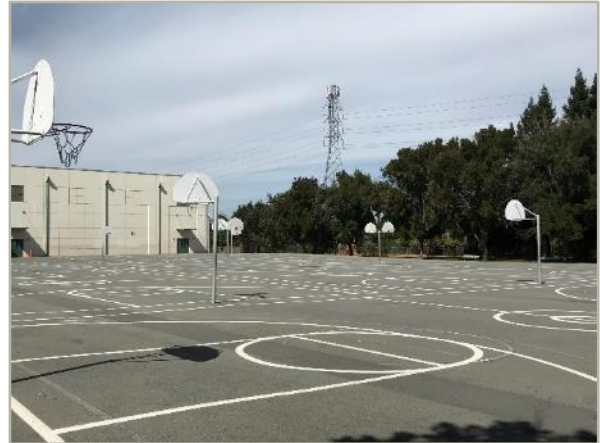
Foothill Middle School
 Site Summary Information

Site Information		
Lot Size	19.1 acres (estimated)	
Parking Spaces	94 total spaces all in open lots; 4 of which are accessible 1 accessible (included in total above), 3 van-accessible	
<i>System</i>	<i>Description</i>	<i>Condition</i>
Pavement/Flatwork	Asphalt lots with areas of concrete and concrete sidewalks, curbs, ramps, and stairs	Fair
Site Development	Property entrance signage, Chain Link fencing, Chain Link dumpster enclosures Sports courts, fencing, and site lights	Fair
Landscaping & Topography	Moderate landscaping features Irrigation present No retaining walls Low to moderate site slopes throughout	Fair
Draining Systems and Erosion Control	Surface flow, inlets, swales, underground piping	Fair
Utilities	Municipal water and sewer Local utility-provided electricity and natural gas	Fair
Site Lighting	Pole-mounted: metal halide Building-mounted: metal halide	Fair
Ancillary Structures	Steel-framed carports for solar system.	Good

Key Issues & Findings	None
