Pine Hollow Middle School

OVERVIEW

Pine Hollow Middle School
Summary of Findings

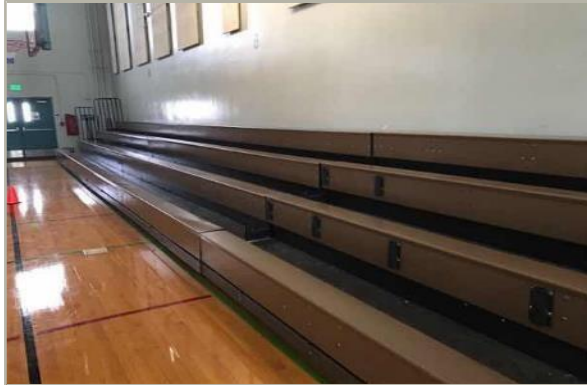
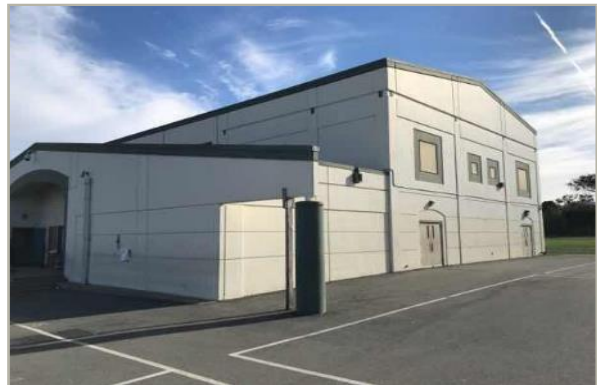
Building Type 1 Information		
Building Locations	Gymnasium	
Constructed/ Renovated	1963	
Building Size	7,750 SF	
Number of Stories	One	
<i>System</i>	<i>Description</i>	<i>Condition</i>
Structure	Conventional wood-framed structure on concrete slabs	Good
Façade	Stucco with aluminum-framed windows	Fair
Roof	Primary: Flat construction with modified bituminous finish Secondary: Gable construction with asphalt shingles	Fair
Interiors	Walls: Painted gypsum board & CMU Floors: VCT, wood strip Ceilings: Unfinished/exposed	Fair
Elevators	None	--
Plumbing	Copper supply, cast iron waste and vent No hot water	Fair
HVAC	Single air handler	Fair
Fire Suppression	Extinguishers	Fair
Electrical	Source & Distribution: Fed from main panel located on site building with copper wiring Interior Lighting: T-8, Emergency: None	Fair
Fire Alarm	Alarm panel, smoke detectors, alarms, strobes, pull stations, back-up emergency lights, and exit signs	Fair

Equipment/Special	None	--
Key Issues & Findings	None

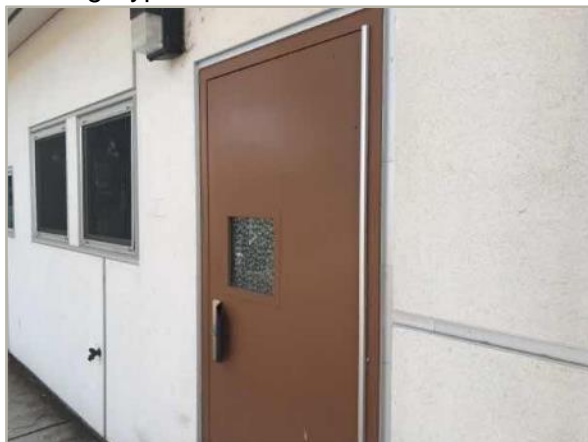
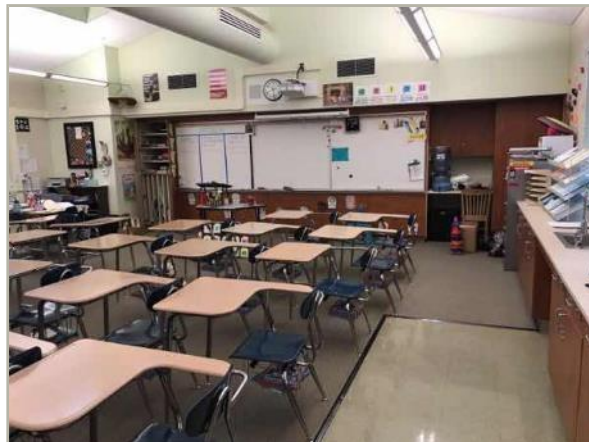
Pine Hollow Middle School
 Building Type 2 Information

Building Type 2 Information		
Building Locations	Portable Classrooms	
Constructed/ Renovated	2003, 2006, 2012	
Building Size	14,650 SF	
Number of Stories	1	
<i>System</i>	<i>Description</i>	<i>Condition</i>
Structure	Conventional wood-framed structure on concrete slabs	Good
Façade	Stucco with aluminum-framed windows	Fair
Roof	Primary: Gable construction with metal finish	Good
Interiors	Walls: Painted gypsum board Floors: Carpet, VCT, Ceilings: Painted gypsum board, ACT	Fair
Elevators	None	Fair
Plumbing	Copper supply, cast iron waste and vent No hot water	Fair
HVAC	Individual split-system	Fair
Fire Suppression	Fire extinguishers	Fair
Electrical	Source & Distribution: Main switchboard with copper wiring Interior Lighting: T-8 Emergency: None	Fair
Fire Alarm	Alarm panel, smoke detectors, alarms, strobes, pull stations, back-up emergency lights, and exit signs	Fair
Equipment/Special	None	--
Key Issues & Findings	None

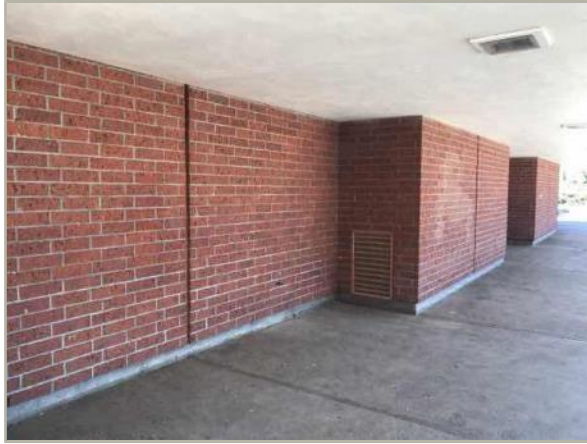
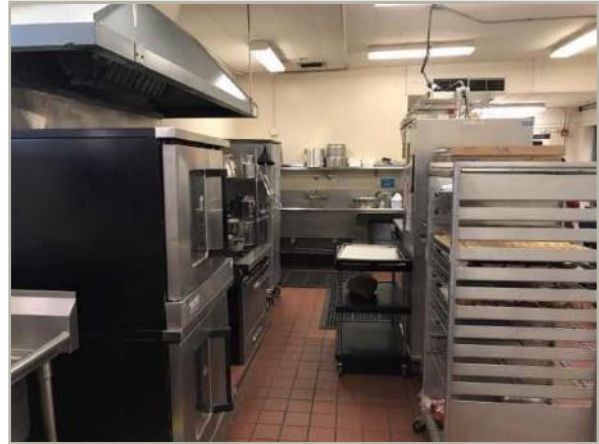
Pine Hollow Middle School
 Building Type 3 Information

Building Type 3 Information		
Building Locations	Multipurpose	
Constructed/ Renovated	1963	
Building Size	11,250 SF	
Number of Stories	1	
<i>System</i>	<i>Description</i>	<i>Condition</i>
Structure	Conventional wood-framed structure on concrete slabs	Fair
Façade	Brick with aluminum-framed windows	Fair
Roof	Primary: Flat construction with modified bituminous finish	Fair
Interiors	Walls: Painted gypsum board Floors: Quarry Tile in kitchen, VCT, Wood strip on stage, Carpet Ceilings: Painted gypsum board, ACT	Fair
Elevators	Wheelchair lifts	Good
Plumbing	Copper supply, cast iron waste and vent Gas-fired water heater	Fair
HVAC	Individual package units, split systems Supplemental components: fan coil units in music classroom	Fair
Fire Suppression	Fire extinguishers	Fair
Electrical	Source & Distribution: Main switchboard with copper wiring Interior Lighting: T-8 Emergency: None	Fair
Fire Alarm	Alarm panel, smoke detectors, alarms, strobes, pull stations, back-up emergency lights, and exit signs	Fair

Equipment/Special	Commercial kitchen equipment	Fair
Key Issues & Findings	None

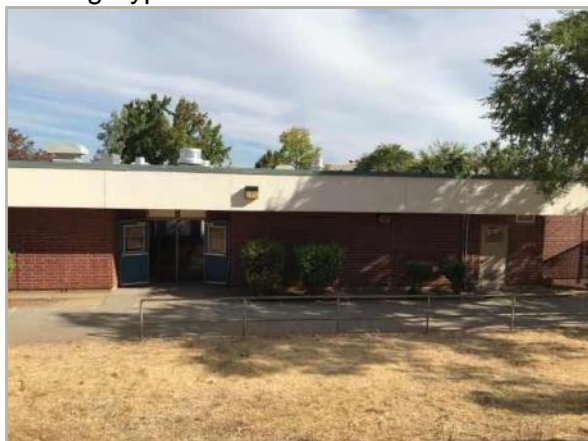
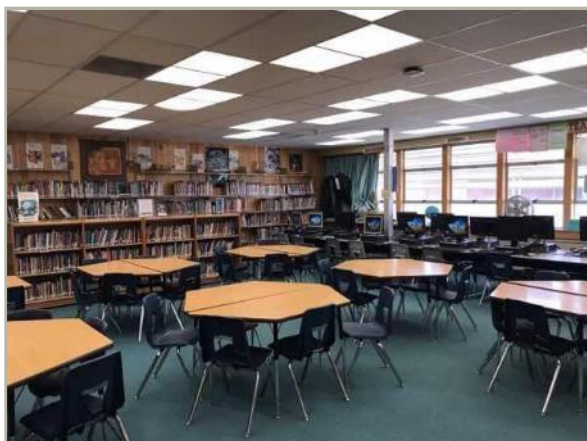
Pine Hollow Middle School
 Building Type 4 Information

Building Type 4 Information		
Building Locations	Administration and Classroom Buildings A, B, C, D, S	
Constructed/ Renovated	1963	
Building Size	55,900 SF	
Number of Stories	1	
<i>System</i>	<i>Description</i>	<i>Condition</i>
Structure	Conventional wood-framed structure on concrete slabs	Good
Façade	Brick with aluminum-framed windows	Fair
Roof	Primary: Flat construction with modified bituminous finish	Fair
Interiors	Walls: Painted gypsum board Floors: Carpet, VCT Ceilings: Painted gypsum board, ACT	Fair
Elevators	None	--
Plumbing	Copper supply, cast iron waste and vent No hot water	Fair
HVAC	Individual package units, split systems	Fair
Fire Suppression	Fire extinguishers	Fair
Electrical	Source & Distribution: Main switchboard with copper wiring Interior Lighting: T-8 Emergency: None	Fair
Fire Alarm	Alarm panel, smoke detectors, alarms, strobes, pull stations, back-up emergency lights, and exit signs	Fair

Equipment/Special	None	--
Key Issues & Findings	None

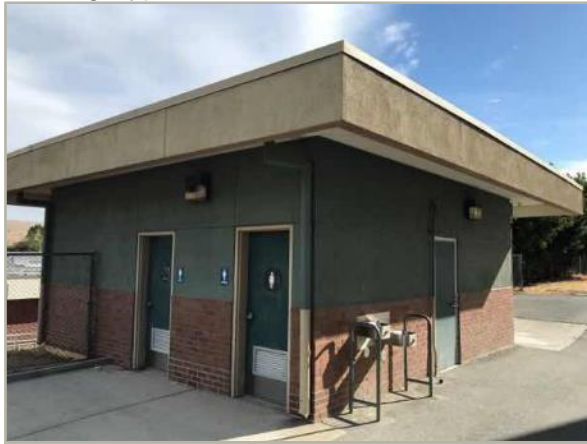
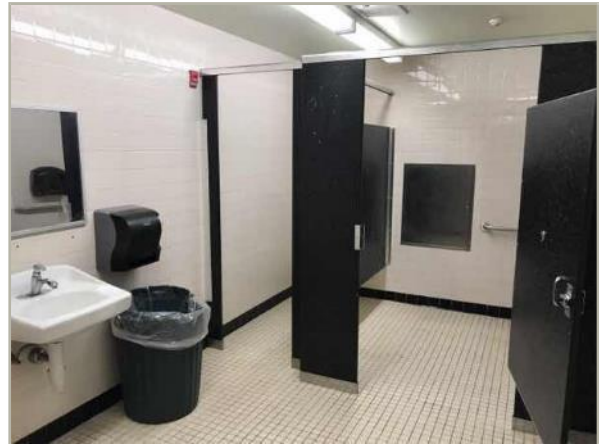
Building Type 5 Information		
Building Locations	Restroom	
Constructed/ Renovated	2000	
Building Size	1,100 SF	
Number of Stories	1	
<i>System</i>	<i>Description</i>	<i>Condition</i>
Structure	Conventional wood-framed structure on concrete slabs	Good
Façade	Stucco, no windows	Fair
Roof	Primary: Flat construction with modified bituminous finish	Fair
Interiors	Walls: Ceramic tile Floors: ceramic tile Ceilings: Painted gypsum board	Fair
Elevators	None	--
Plumbing	Copper supply, cast iron waste and vent No hot water	Fair
HVAC	None	--
Fire Suppression	None	--
Electrical	Source & Distribution: Fed from panel located on site with copper wiring Interior Lighting: T-8 Emergency: None	Fair
Fire Alarm	Alarm panel, smoke detectors, alarms, strobes, pull stations, back-up emergency lights, and exit signs	Fair
Equipment/Special	None	Fair
Key Issues & Findings	None

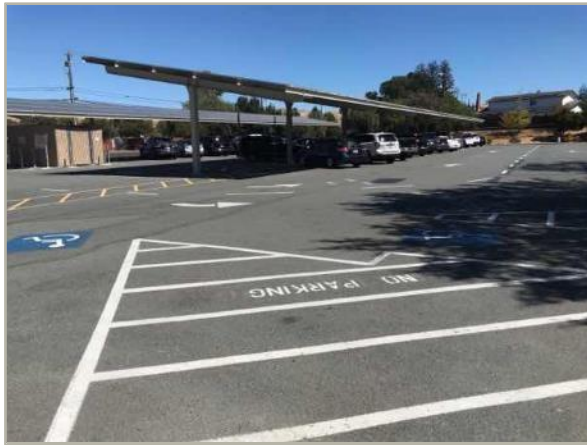
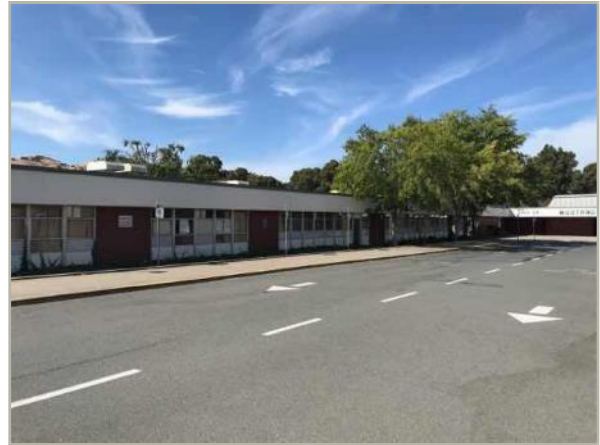
Site Summary Information

Site Information		
Lot Size	11.33 acres (estimated)	
Parking Spaces	56 total spaces all in open lots; 6 of which are accessible	
<i>System</i>	<i>Description</i>	<i>Condition</i>
Pavement/Flatwork	Asphalt lots with areas of concrete and concrete sidewalks, curbs, ramps, and stairs	Fair
Site Development	Property entrance signage, chain link fencing, CMU dumpster enclosures Playgrounds and sports courts Limited park benches, picnic tables, trash receptacles	Fair
Landscaping & Topography	Limited landscaping features Irrigation present No retaining walls Low to moderate site slopes throughout	Fair
Draining Systems and Erosion Control	Surface flow, inlets, underground piping, municipal system Ponding occurs in the landscaped areas	Fair
Utilities	Municipal water and sewer Local utility-provided electric and natural gas	Fair
Site Lighting	Pole-mounted: metal halide Building-mounted: metal halide Pedestrian walkway and accent landscaping lighting	Fair

Ancillary Structures	Solar carports	Good
Key Issues & Findings	None
