Valley View Middle School

Property Executive Summary

Summary of Findings

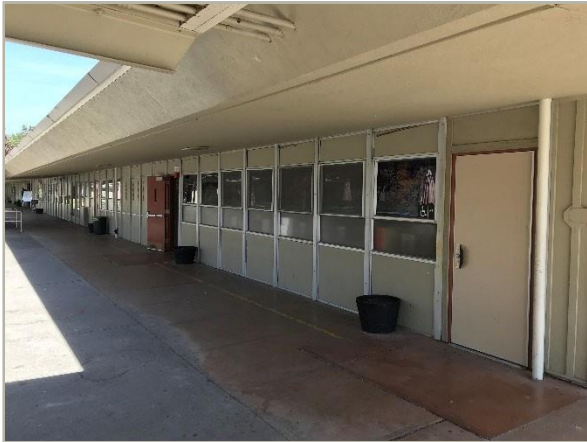
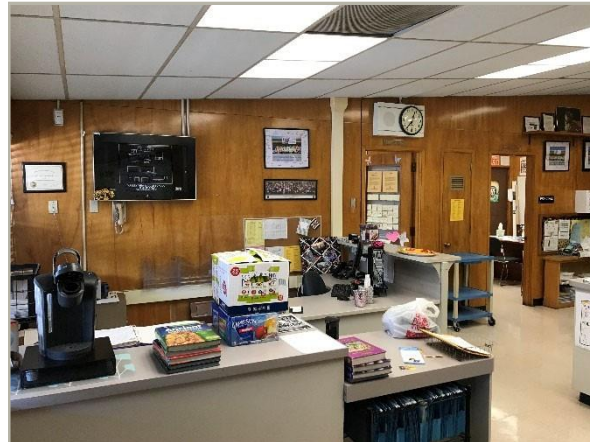
Valley View Middle School
 Building Type 1 Information

Fire Alarm	Alarm panel, smoke detectors, alarms, strobes, pull stations, back-up emergency lights, and exit signs	Fair
Equipment/Special	Commercial kitchen equipment	Fair
Key Issues & Findings	Building lacks fire suppression

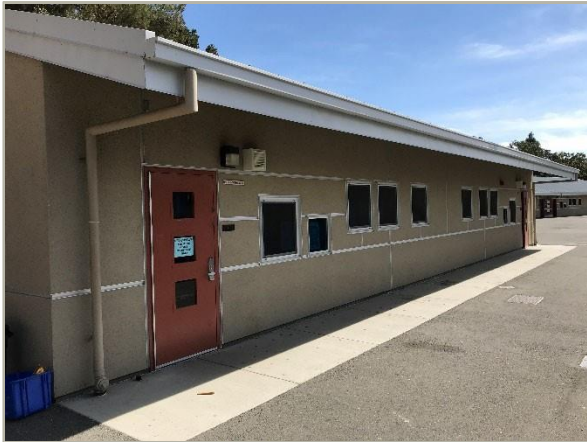
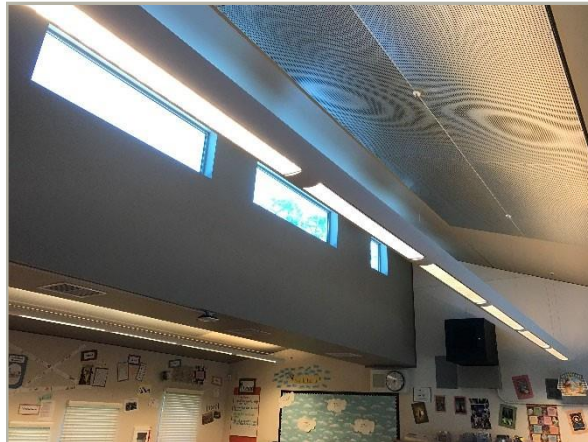
Valley View Middle School
 Building Type 2 Information

Equipment/Special	None	--
Key Issues & Findings	Building lacks fire suppression

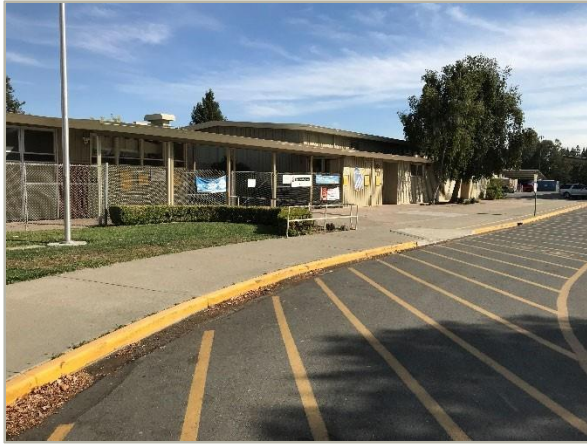
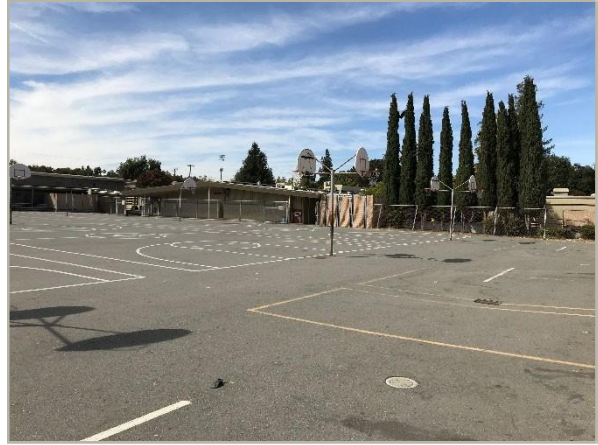
Site Summary Information

Ancillary Structures	Solar panel steel structure carports and pre-fabricated storage sheds	Fair
Key Issues & Findings	Inadequate site lighting
