FACILITY NEEDS ASSESSMENT

BLUE HILLS ELEMENTARY SCHOOL

FACILITY CONDITION ASSESSMENT

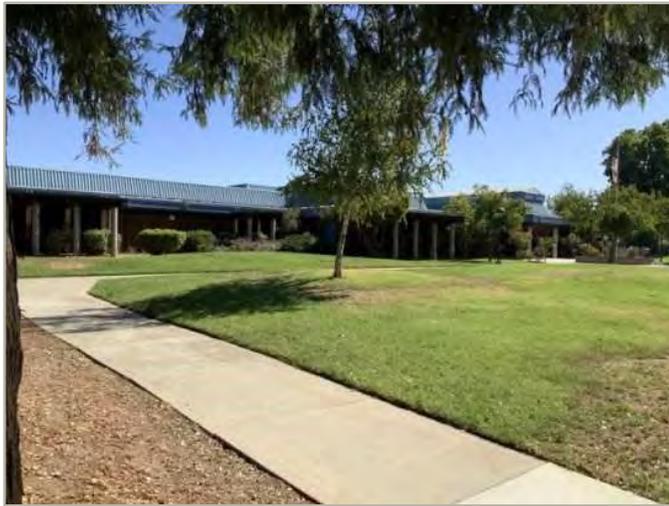
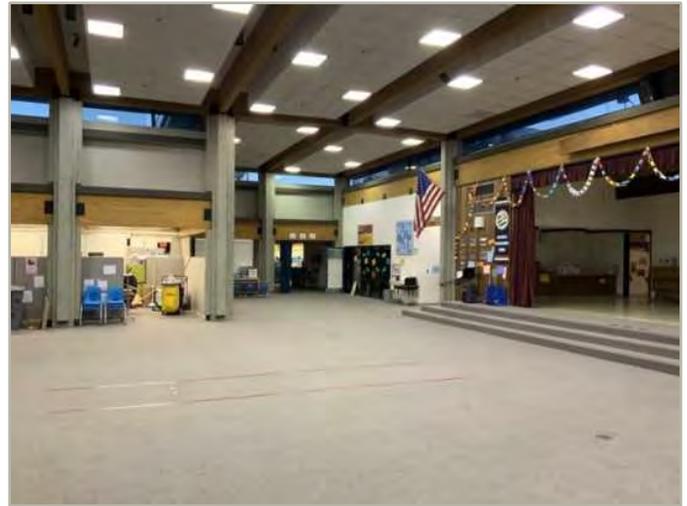
2. Main Building

Accessibility	Presently it does not appear an accessibility study is needed for this property.
Key Issues and Findings	Deteriorating roof HVAC apron walls that are separating at their supports
