# **COLLINS ELEMENTARY SCHOOL**

**2020** | FACILITIES MASTER PLAN

# FACILITY CONDITION ASSESSMENT

L.P. COLLINS ELEMENTARY SCHOOL

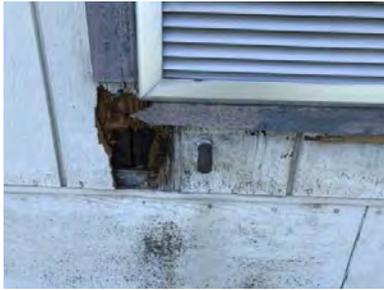
### Exterior Wall in Failed condition.

Textured Plywood (T1-11)  
Modular Classrooms Building exterior

Repair wall at HVAC condensate drains, re-route all - AssetCALC ID: 1432366

Uniformat Code: B2011  
Recommendation: **Replace in 2020**

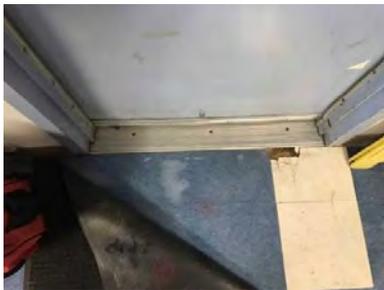
### Structural Flooring/Decking in Failed condition.

Wood  
Child Development Center Exit door

Floor damage at rear door, remove tile and repair - AssetCALC ID: 1432361

Uniformat Code: B1012  
Recommendation: **Repair in 2020**

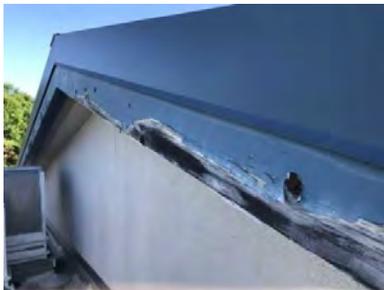
### Exterior Wall in Failed condition.

Textured Plywood (T1-11)  
Administration Building Roof

Replace wood fascia board along metal roof - AssetCALC ID: 1432270

Uniformat Code: B2011  
Recommendation: **Repair in 2020**

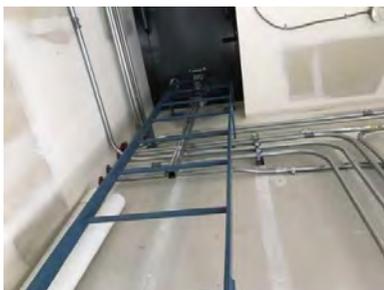
### Roof Hatch in Failed condition.

Metal  
Guided Learning Center Roof

Broken at time of site visit, needs repair not replacement - AssetCALC ID: 1432328

Uniformat Code: B3022  
Recommendation: **Replace in 2020**
