FACILITY NEEDS ASSESSMENTS

DE VARGAS ELEMENTARY SCHOOL

2020 | FACILITIES MASTER PLAN

FACILITY CONDITION ASSESSMENT

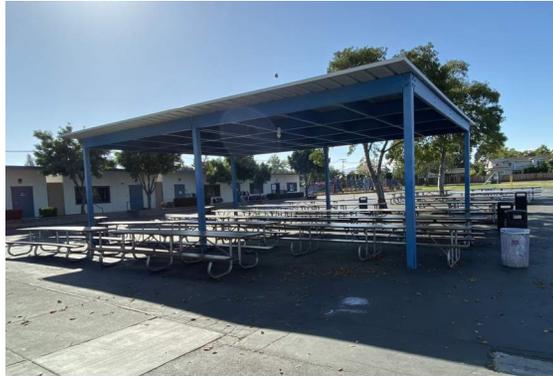
Shade Structure

Students are served out of a serving window at the exterior of the kitchen. The site would like more shade for student dining.

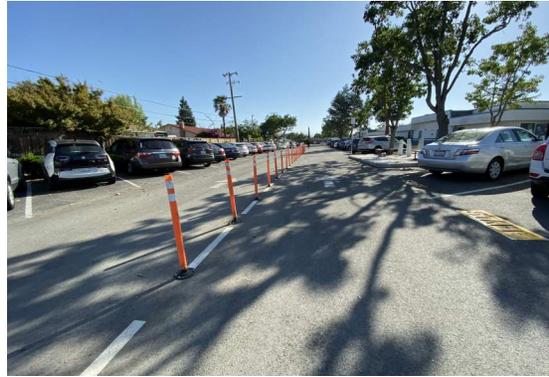
Drop-Off Lane

Parking and drop-off is very limited.

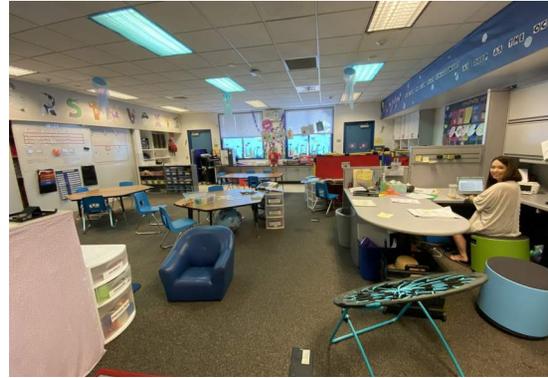
Special Education Classroom

The Special Education classrooms for the moderate/severe population are among the smallest classrooms on the campus. They are located next to restrooms but do not have restrooms interior to the classroom.

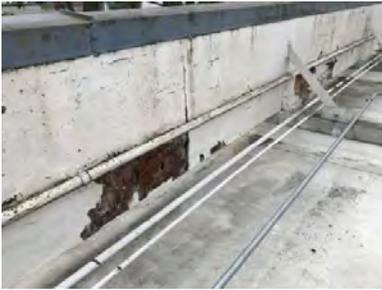
Rooftop Parapet in Poor condition.

Wood Clapboard Siding
Administration Roof

Wood parapet on roof is damaged at isolated areas throughout roof. - AssetCALC ID: 1492675

Key Issues and Findings Damaged wood parapet

Uniformat Code: B2011
Recommendation: **Repair in 2020**

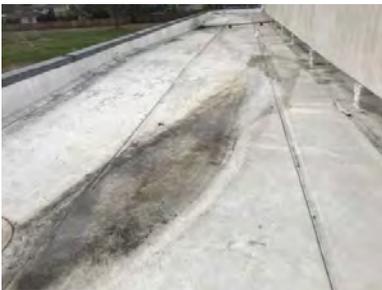
Roof in Poor condition.

any type per man-day
GLC-Library Roof

Single-Ply TPO membrane is separating from roof decking allowing air and moisture to penetrate the membrane. The air underneath the membrane is also causing ponding to occur. - AssetCALC ID: 1492696

Accessibility	Presently it does not appear an accessibility study is needed for this property.
Key Issues and Findings	Roof requires repairs

Uniformat Code: B3011
Recommendation: **Repair in 2020**

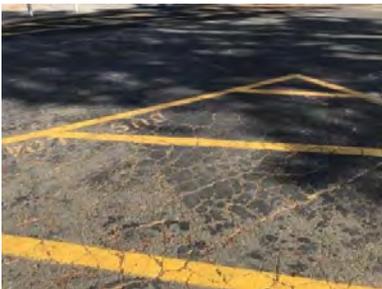
Parking Lots in Poor condition.

Asphalt Pavement
Site

Alligator cracking and raveling at isolated areas in parking lot. - AssetCALC ID: 1489472

Uniformat Code: G2022
Recommendation: **Cut & Patch in 2020**
