# EATON ELEMENTARY SCHOOL

2020 | FACILITIES MASTER PLAN

# FACILITY CONDITION ASSESSMENT

C. B. EATON ELEMENTARY SCHOOL  
20220 Suisun Drive  
Cupertino, California 95014

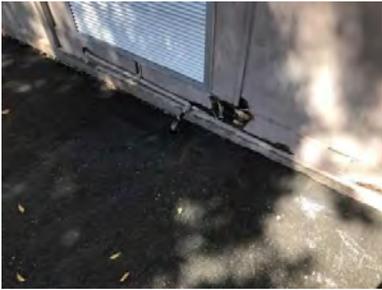
### Exterior Wall in Failed condition.

Textured Plywood (T1-11)  
Classrooms A-B-C-D-E Building Exterior

Uniformat Code: B2011  
Recommendation: **Replace in 2020**

Exterior wood replace and paint - AssetCALC ID: 1438052

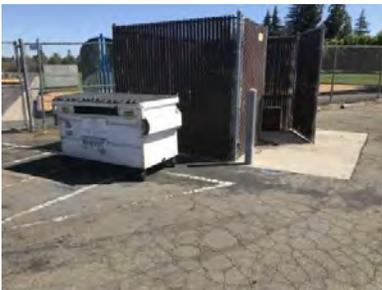
### Parking Lots in Poor condition.

Asphalt Pavement, Full Depth (includes sub-base)  
Site Dumpster Area

Uniformat Code: G2022  
Recommendation: **Repair in 2020**

Deteriorated paving around the dumpster. Severe alligatoring was observed, which will lead to more serious water damage if not repaired. - AssetCALC ID: 1478186

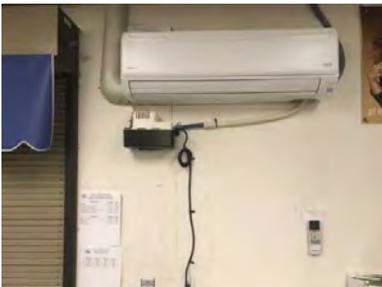
### Condensing Unit/Heat Pump in Failed condition.

Split System, 1 Ton  
Multi-Use Kitchen

Uniformat Code: D3032  
Recommendation: **Replace in 2020**

System never commissioned, assumed failed - AssetCALC ID: 1438046

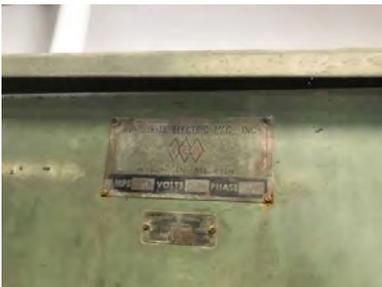
### Building/Main Switchgear in Poor condition.

800 AMP  
Classrooms A-B-C-D-E Classroom electrical closet

Uniformat Code: D5012  
Recommendation: **Replace in 2020**

Original main gear; outside gear has been installed at school main - AssetCALC ID: 1438050
