FACILITY NEEDS ASSESSMENTS

EISENHOWER ELEMENTARY SCHOOL

2020 | FACILITIES MASTER PLAN

FACILITY CONDITION ASSESSMENT

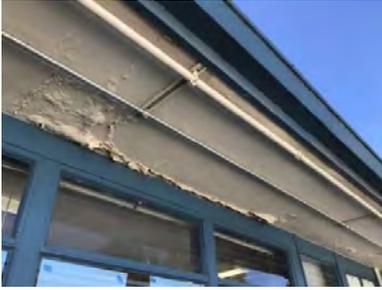
Exterior Wall in Poor condition.

Wood Clapboard Siding, 1-2 Stories
Classrooms and Kindergarten Classrooms

Blistering paint and possible wood deterioration indicating water damage at soffit. - AssetCALC ID: 1489099

Uniformat Code: B2011
Recommendation: **Repair in 2020**

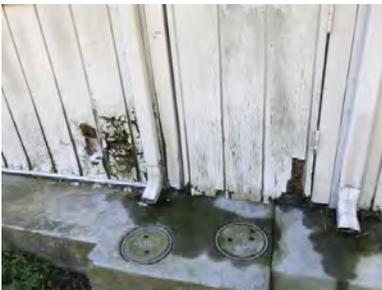
Exterior Wall in Poor condition.

Textured Plywood (T1-11)
Portables Portables

Holes and damage in skirting, siding, and fencing between portables. - AssetCALC ID: 1489100

Uniformat Code: B2011
Recommendation: **Repair in 2020**

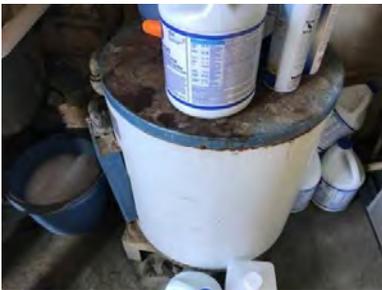
Water Heater in Poor condition.

Electric, Residential, 20 GAL
Classrooms and Kindergarten Electrical room

Rusted and excessively aged. - AssetCALC ID: 1490408

Uniformat Code: D2023
Recommendation: **Replace in 2020**

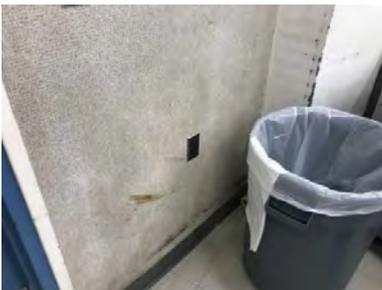
Interior Wall Finish in Poor condition.

Vinyl
940 940

Wall finish is marred and discolored. - AssetCALC ID: 1489072

Uniformat Code: C3012
Recommendation: **Replace in 2020**

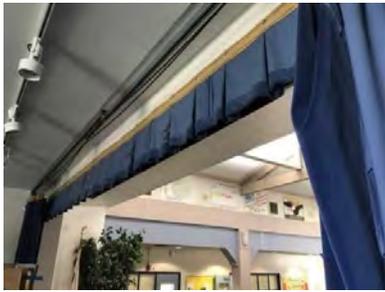
Stage Curtain in Poor condition.

Medium Weight Velour, Flameproof (per SF)
920 920

Curtains are torn - AssetCALC ID: 1489093

Uniformat Code: E1023
Recommendation: **Replace in 2020**

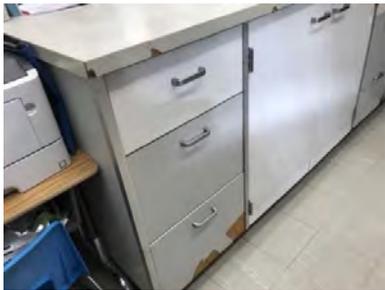
Kitchen Cabinetry in Poor condition.

Stock Hardwood
940 Kitchen

Laminate finish is chipped and mismatched. - AssetCALC ID: 1489059

Uniformat Code: E2012
Recommendation: **Replace in 2021**

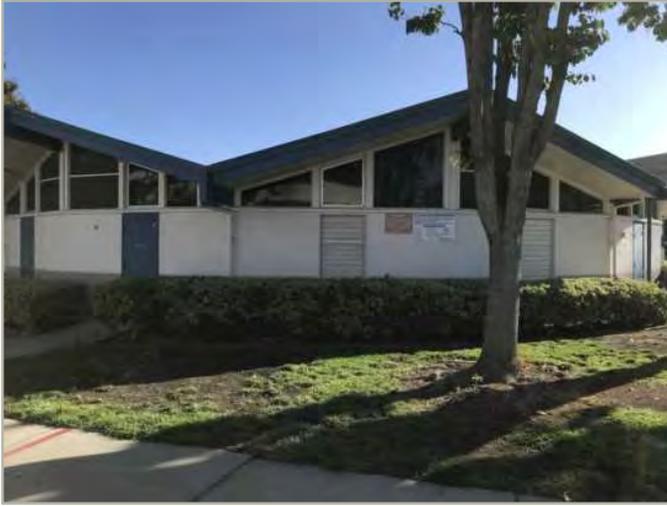
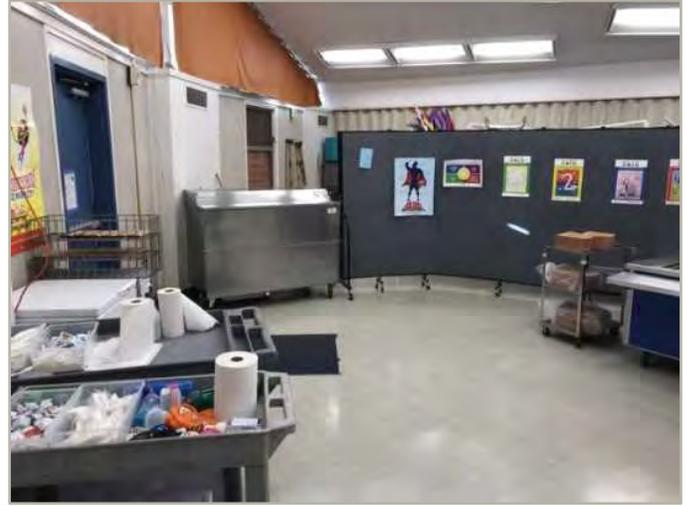
4. 940 Building

Equipment/Special	Commercial kitchen equipment	--
Accessibility d	Presently it does not appear an accessibility study is needed for this property.	
Key Issues and Findings	Roof has history of leaks
