FACILITY NEEDS ASSESSMENTS

FARIA ELEMENTARY SCHOOL

FACILITY CONDITION ASSESSMENT

FARIA ELEMENTARY SCHOOL
10155 Barbara Lane
Cupertino, California 95014

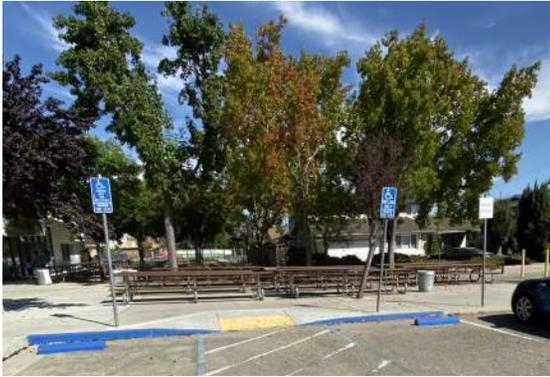
Student Dining

The kitchen is able to serve the student population who participate in hot lunch. The location of the kitchen is not ideal as it is in the front of school, near the parking lot. The student dining area is also located at the front of school and only has trees for shade. Ideally, the food service area and student dining would relocate to the hardcourts.

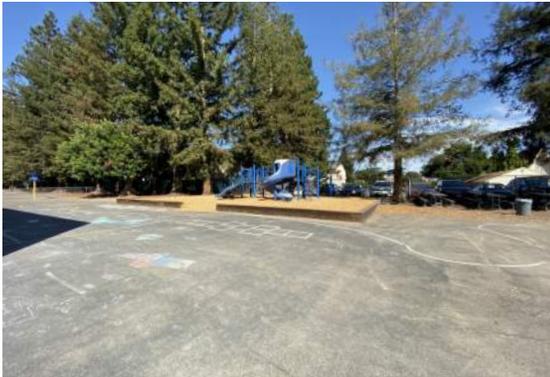
Hardcourts

Interior assembly and social spaces like the Library and GLC are sufficient. There is a large concern coming from the school community regarding a desire for shade at the hardcourts.
