FACILITY NEEDS ASSESSMENTS

LINCOLN ELEMENTARY SCHOOL

2020 | FACILITIES MASTER PLAN

FACILITY CONDITION ASSESSMENT

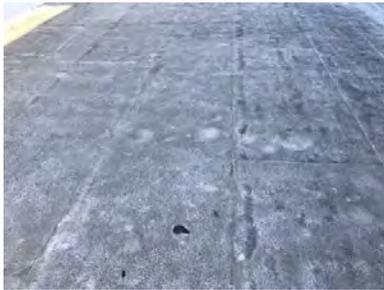
Roof in Poor condition.

Single-Ply TPO/PVC Membrane
Classrooms Buildings 1-17 Older roof 15-17

Open seams, blisters - AssetCALC ID: 1465702

Uniformat Code: B3011
Recommendation: **Replace in 2020**

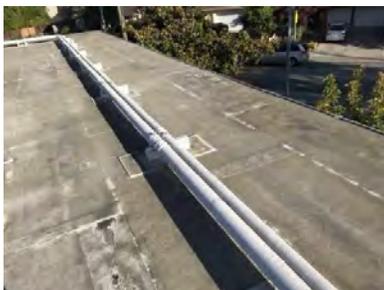
Roof in Poor condition.

Single-Ply EPDM Membrane
Administration Building 900/940 Roof 940

Visible open seams blisters - AssetCALC ID: 1455726

Uniformat Code: B3011
Recommendation: **Replace in 2020**

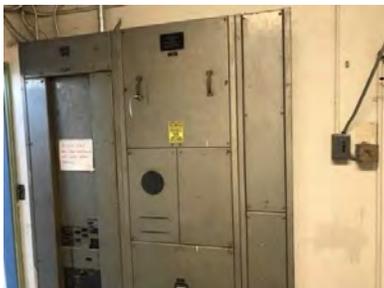
Building/Main Switchboard in Poor condition.

120/208 V, 800 Amp
Classrooms Buildings 1-17 Mechanical room

Possibly original; being used as lighting panel - AssetCALC ID: 1465706

Uniformat Code: D5012
Recommendation: **Replace in 2020**

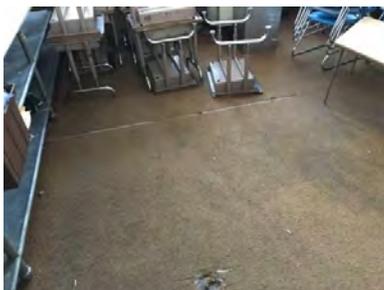
Interior Floor Finish in Poor condition.

Carpet Commercial Standard
Administration Building 900/940 940 only

Carpet in old cafeteria - AssetCALC ID: 1455734

Uniformat Code: C3025
Recommendation: **Replace in 2020**

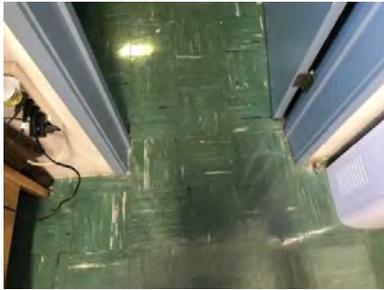
Interior Floor Finish in Poor condition.

Vinyl Tile (VCT) with Asbestos Abatement Administration Building 900/940 940 only maintenance office

Possibly original 9x9 tile - AssetCALC ID: 1455735

Uniformat Code: C3024
 Recommendation: **Replace in 2020**

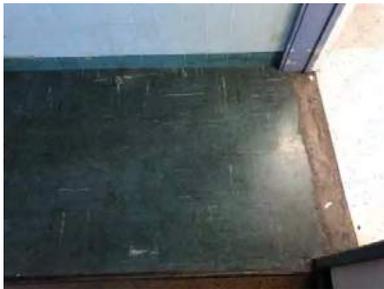
Interior Floor Finish in Poor condition.

Vinyl Tile (VCT) with Asbestos Abatement Administration Building 900/940 940 only Kitchen

Possibly original, old cafeteria - AssetCALC ID: 1455733

Uniformat Code: C3024
 Recommendation: **Replace in 2020**

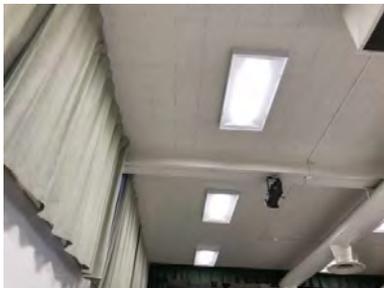
Interior Ceiling Finish in Poor condition.

Hard Tile Ceiling with ACT Administration Building 900/940 940 only

Older glue on ceiling tile - AssetCALC ID: 1455709

Uniformat Code: C3032
 Recommendation: **Replace in 2020**
