FACILITY NEEDS ASSESSMENTS

MEYERHOLZ ELEMENTARY SCHOOL

2020 | FACILITIES MASTER PLAN

FACILITY CONDITION ASSESSMENT

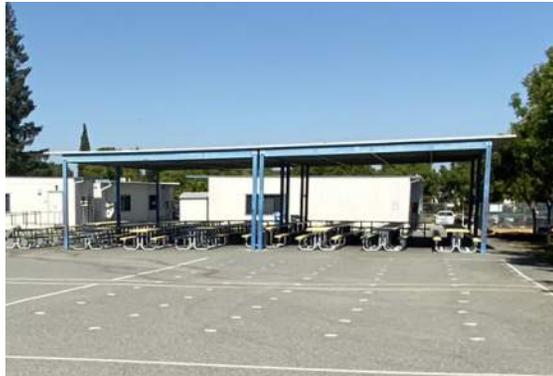
The site has four (4) staggered lunches. The food service window (at the kitchen within the GLC) is far from the lunch shelter. The principal is unhappy with lunch shelter at the Kindergarten play yard and would like a better structure that covers all lunch tables.

Shade Structure

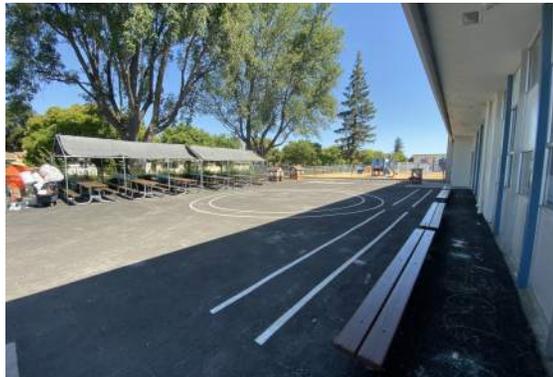
Kindergarten Play Yard

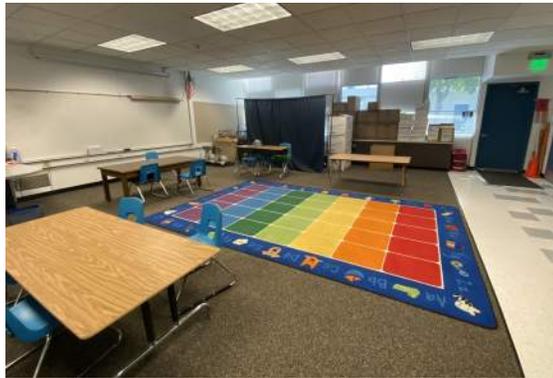
This site supports CAP students. Counselors are spread throughout campus, some operating out of portable classrooms.

Student Services / Counseling

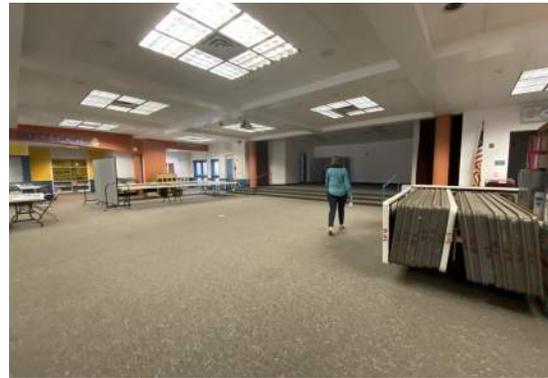
Assemblies are held within the GLC. Due to its capacity, the site runs two (2) assemblies but would like the capacity for a single, whole-school assembly. The Library occupies a portion of the GLC.

Guided Learning Center / Assembly Space
