# MONTCLAIRE ELEMENTARY SCHOOL

2020 | FACILITIES MASTER PLAN

# FACILITY CONDITION ASSESSMENT

**MONTCLAIRE ELEMENTARY SCHOOL**  
1160 St. Joseph Avenue  
Los Altos, California 94022

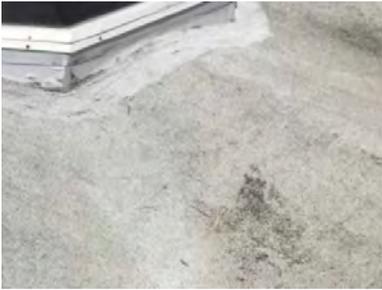
### Roof in Poor condition.

Modified Bituminous  
Star Building Roof

Replacement Recommended per Roofing Inventory - AssetCALC ID: 1497526

Uniformat Code: B3011  
Recommendation: **Replace in 2020**

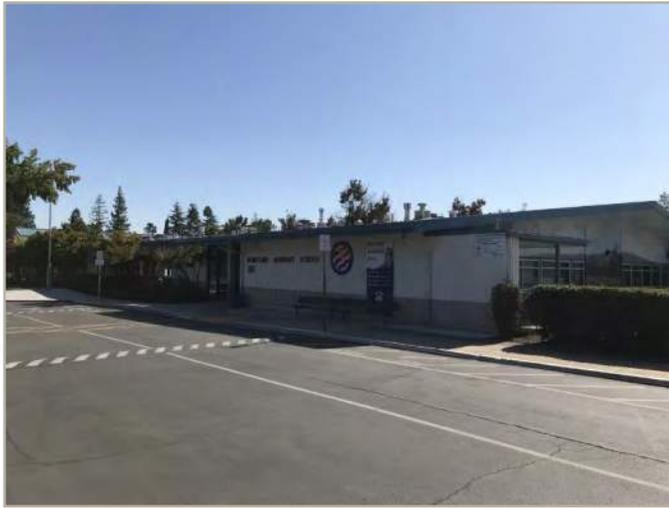
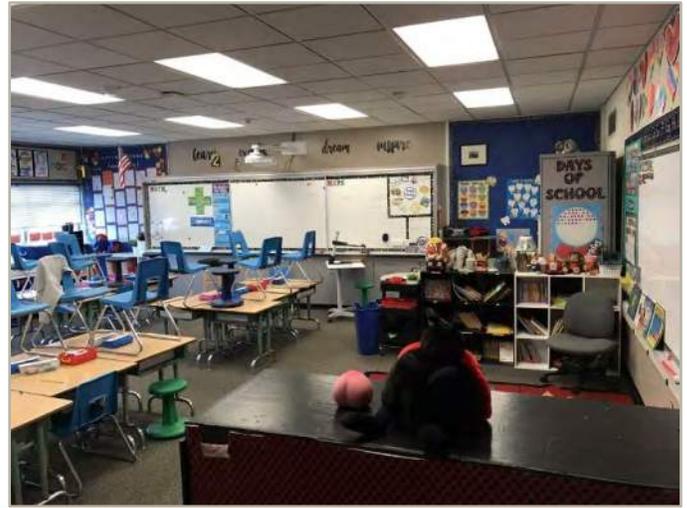
## 2 Classroom Buildings

| <b>Key Issues and Findings</b> | Aged HVAC components and infrastructure, building lacks fire suppression, hard ceiling tiles frayed/falling near hallway attic hatch |

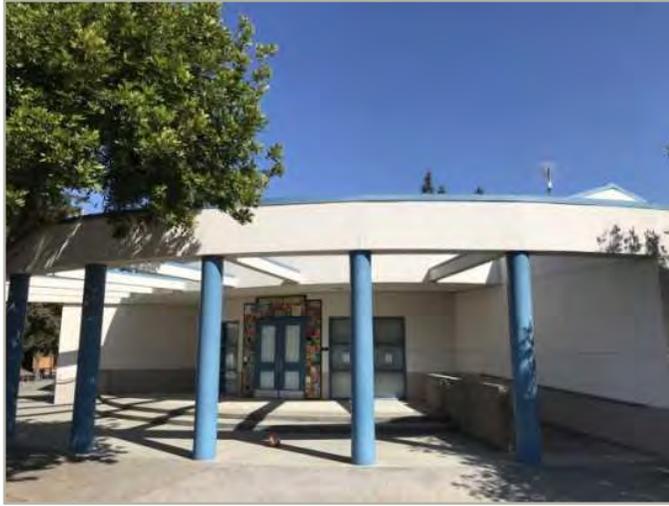
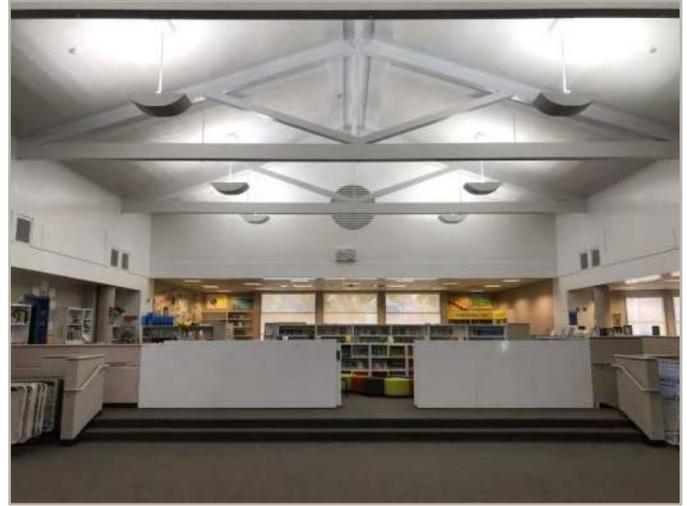
### 3 Guided Learning Center

| <b>Key Issues and Findings</b> | Aged HVAC components and infrastructure, building lacks fire suppression | |

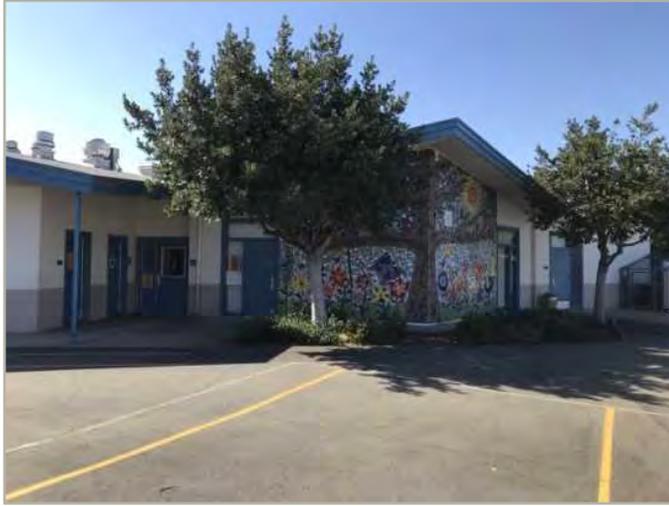
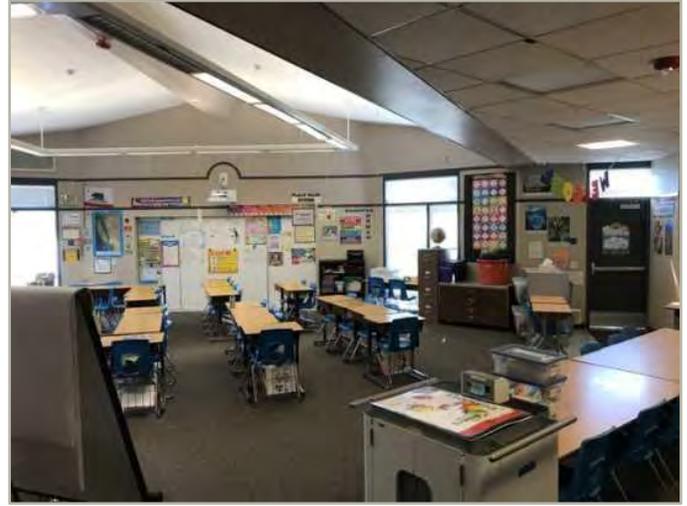
## 4 Star Building

| <b>Key Issues and Findings</b> | Roof reportedly requires replacement, antiquated HVAC components and infrastructure, building lacks fire suppression |

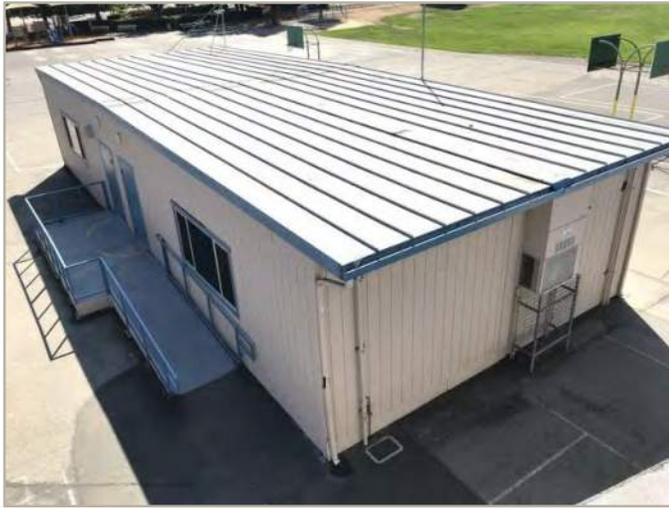
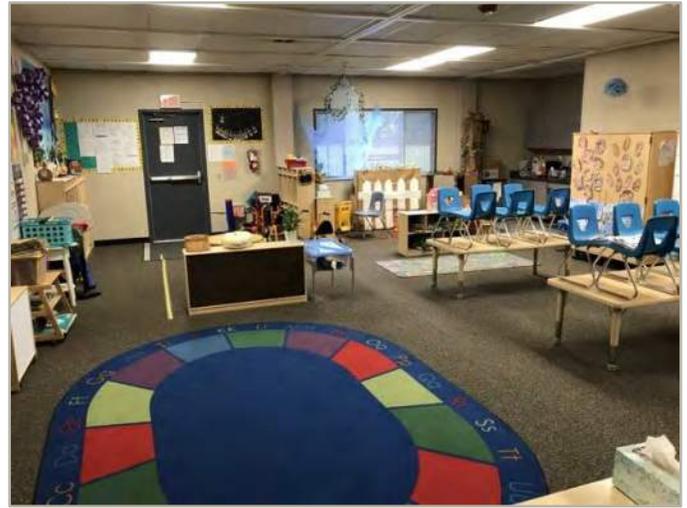
## 5 Portables

| <b>Key Issues and Findings</b> | Aged HVAC components | |
