FACILITY NEEDS ASSESSMENTS

MUIR ELEMENTARY SCHOOL

2020 | FACILITIES MASTER PLAN

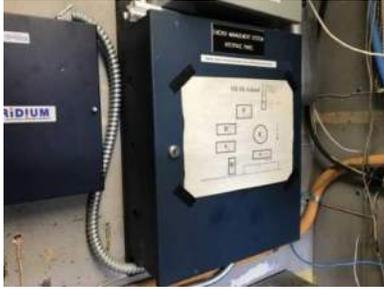
BAS/HVAC Controls in Poor condition.

Basic System
Administration Electrical room

BAS system is outdated and failing. - AssetCALC ID: 1490609

Uniformat Code: D3068
Recommendation: **Upgrade in 2021**

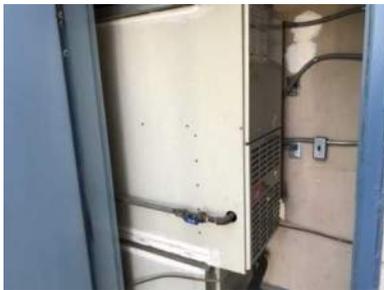
The furnaces located throughout the Main Classroom buildings are antiquated. The property maintenance staff has reported that the ductwork for the furnaces runs underneath buildings and is frequently flooded whenever a major rainstorm occurs. Upon replacement of the furnaces, consideration should be given to installing new ductwork inside the buildings. One condensing unit for the Administration Building is patched and requires frequent repairs to prevent refrigerant leaks. The BAS system for the school is aged and failing, causing system errors which require HVAC technicians to reset. The property maintenance staff indicated that they are satisfied with the electrical and plumbing services.

Furnace in Poor condition.

119 MBH
Main Classrooms Utility closet

Furnaces are antiquated, condensate lines flood into closet, frequent repairs are required. - AssetCALC ID: 1488874

Uniformat Code: D3051
Recommendation: **Replace in 2021**

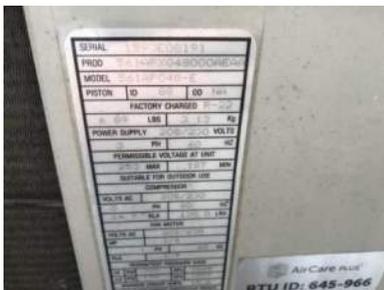
Condensing Unit/Heat Pump in Poor condition.

3 TON
Administration Building exterior

Leaks refrigerant, taped with Teflon to stop leak. - AssetCALC ID: 1488922

Uniformat Code: D3032
Recommendation: **Replace in 2021**

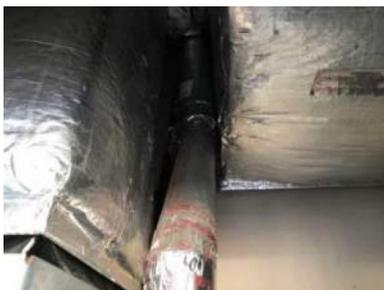
HVAC System Ductwork in Poor condition.

Medium Density
Main Classrooms Throughout building

Furnace ductwork runs underground and floods during rainstorms. - AssetCALC ID: 1488927

Uniformat Code: D3041
Recommendation: **Replace in 2021**
