REGNART ELEMENTARY SCHOOL

2020 | FACILITIES MASTER PLAN

FACILITY CONDITION ASSESSMENT

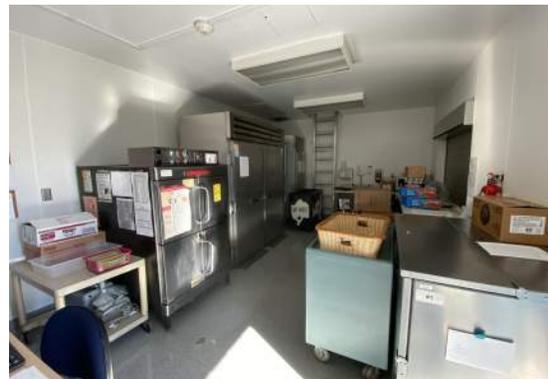
Students receive their meals from the exterior window at the kitchen. The kitchen itself is not properly ventilated, according to the principal, and regularly experiences swings in temperature. Shade at the Kindergarten eating area does not provide enough shade for all tables.

Food Service: Kitchen

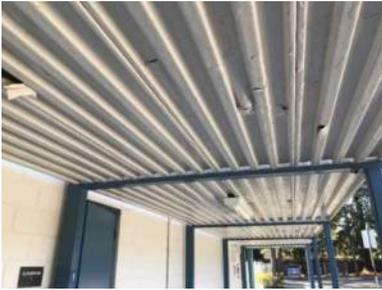
Exterior Wall in Poor condition.

any Painted Surface, 1-2 Stories
Site Exterior canopy

Paint is peeling - AssetCALC ID: 1486137

Uniformat Code: B2011
Recommendation: **Prep and Paint in 2020**

Cost Estimate: \$15,900
