SEDGWICK ELEMENTARY SCHOOL

2020 | FACILITIES MASTER PLAN

FACILITY CONDITION ASSESSMENT

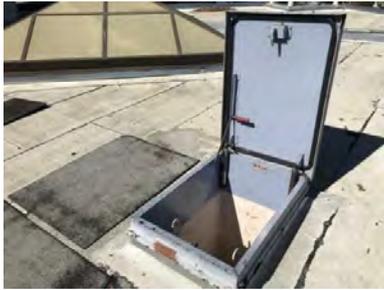
Roof Hatch in Failed condition.

Metal
Administration 900 Roof

Cylinder broken - AssetCALC ID: 1493237

Electrical	Source and Distribution: Building panels with copper wiring. Fed from exterior service entrance section at transformer. Interior Lighting: T-12, LED, CFL	Good
Fire Alarm	Fire Alarm panel, smoke detectors, alarms, strobes, pull stations, back-up emergency lights, and exit signs	Good
Equipment/Special	None	--
Accessibility	Presently it does not appear an accessibility study is needed for this property.	
Key Issues and Findings	The roof hatch has broken elements and requires repair.

Uniformat Code: B3022
Recommendation: **Replace in 2020**

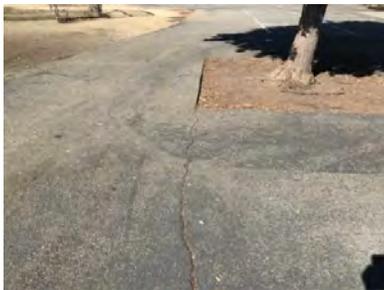
Play Surfaces and Sports Courts in Poor condition.

Asphalt
General Site Site Play Surfaces

Cracked play surfaces - AssetCALC ID: 1493202

Accessibility	Presently it does not appear an accessibility study is needed for the exterior site areas.	
Key Issues and Findings	The play area asphalt surfaces are worn and cracked.

Uniformat Code: G2047
Recommendation: **Mill and Overlay in 2020**
