# STEVENS CREEK ELEMENTARY SCHOOL

2020 | FACILITIES MASTER PLAN

# FACILITY CONDITION ASSESSMENT

STEVENS CREEK ELEMENTARY SCHOOL

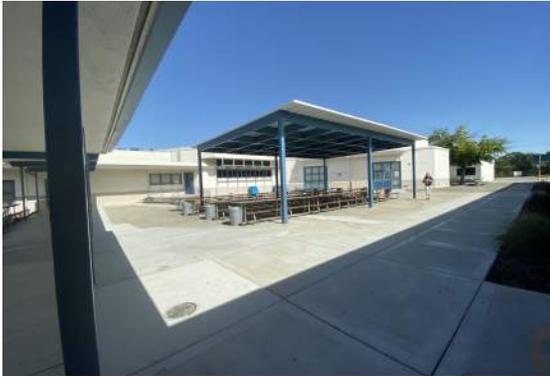
Shade Structure

Parents commonly request additional shade at the hardcourts. Currently the only shade structure sits in a courtyard, detached from the hardcourts. Also, the parking lot does not accommodate all site staff.

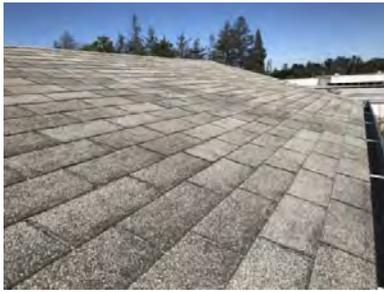
**Roof in Poor condition.**

Asphalt Shingle 30-Year  
Classrooms CR 11-18

Missing shingles - AssetCALC ID: 1502441

Uniformat Code: B3011  
Recommendation: **Replace in 2020**

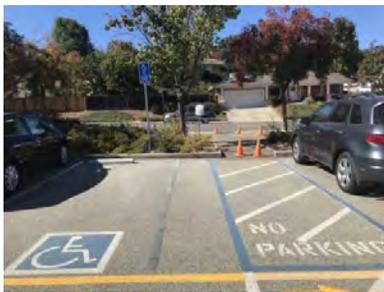
**Parking Lots in Poor condition.**

Asphalt Pavement  
General Site Site

Past EUL - AssetCALC ID: 1502458

Uniformat Code: G2022  
Recommendation: **Seal & Stripe in 2020**

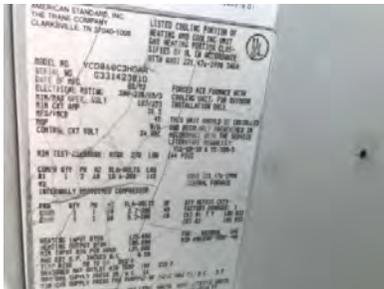
**Packaged Unit (RTU) in Poor condition.**

6 - 7.5 TON  
Classrooms CR Roof

1992 install, past EUL - AssetCALC ID: 1502442

Uniformat Code: D3052  
Recommendation: **Replace in 2020**

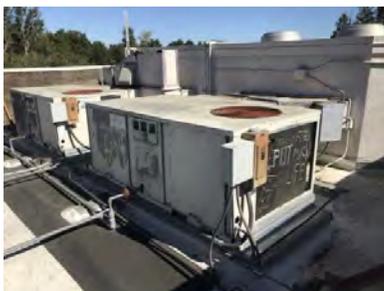
**Packaged Unit (RTU) in Poor condition.**

6 to 7.5 Ton  
Guided Learning Center GLC 920 Roof

Past EUL - AssetCALC ID: 1502464

Uniformat Code: D3052  
Recommendation: **Replace in 2020**

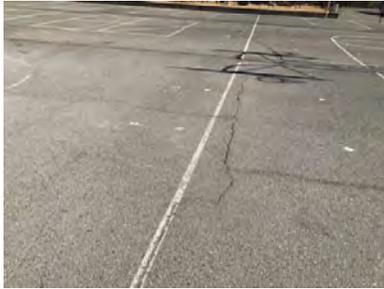
**Play Surfaces & Sports Courts in Poor condition.**

Asphalt  
General Site Site

Past EUL - AssetCALC ID: 1497222

Uniformat Code: G2047  
Recommendation: **Mill & Overlay in 2020**

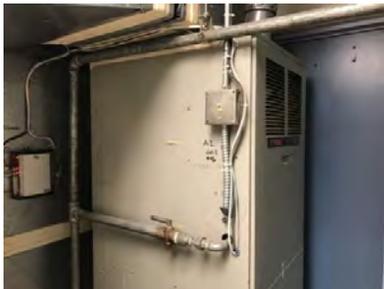
**BAS/HVAC Controls in Poor condition.**

Basic System or Legacy Upgrades  
Guided Learning Center GLC 920 HVAC

Uniformat Code: D3068  
Recommendation: **Upgrade/Install in 2020**

Replace with HVAC units - AssetCALC ID: 1513427
