FACILITY NEEDS ASSESSMENTS

WEST VALLEY ELEMENTARY SCHOOL

2020 | FACILITIES MASTER PLAN

FACILITY CONDITION ASSESSMENT

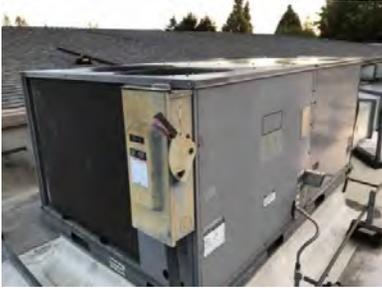
8 TON
Building 920 - Guided Learning Center Roof

Packaged Unit (RTU) in Poor condition.

Loud thumping sound, does not appear to activate. - AssetCALC ID: 1488979

Uniformat Code: D3052
Recommendation: **Replace in 2020**

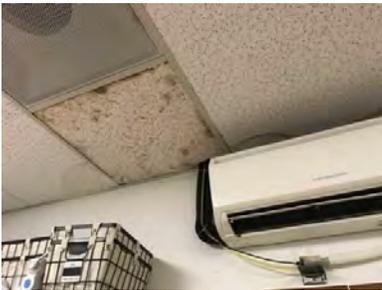
Water Damage
Building 920 - Guided Learning Center
Workroom

Moisture stains were observed on suspended ceiling tiles surrounding coolant lines to the ductless split system cooling unit at the 920 Guided Learning Center (GLC) Building. A leak could be occurring at the pipe penetration to the roof or from the coolant system. An HVAC technician should be retained to analyze the existing condition, provide recommendations and make repairs. Replacement of the ceiling tiles and a review of the above ceiling area for damage are recommended. The estimated cost of this review and repair is included in the cost tables.

Recommended Follow-up Study: Water Damage

Moisture stains on suspended ceiling tile surrounding coolant lines to ductless split. - AssetCALC ID: 1490521

Uniformat Code: P000X
Recommendation: **Evaluate/Report in 2020**
