Gregory Gardens Elementary School (includes Shearer Preschool)

Property Executive Summary

This report represents summary-level findings for the Property Condition Assessment. The deficiencies identified in this assessment can be combined with potential new construction requirements to develop an overall Long Term Capital Needs Plan that can be the basis for a facility wide capital improvement funding strategy. Key findings from the Assessment include:

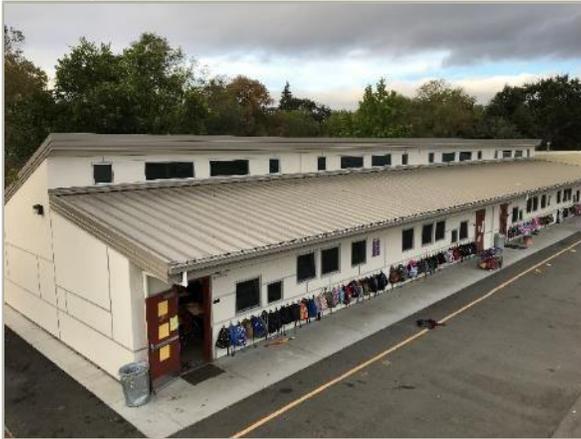
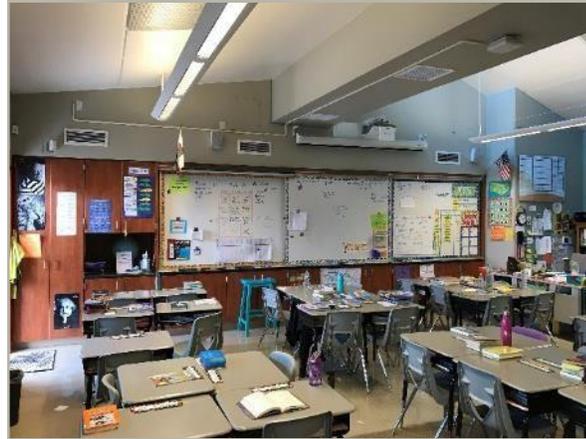
Building Type 1 Information

Fire Alarm	Alarm panel, smoke detectors, alarms, strobes, pull stations, back-up emergency lights, and exit signs	Fair
Equipment/Special	Commercial kitchen equipment	Fair
Key Issues & Findings	Possible roof leak, building lacks fire suppression

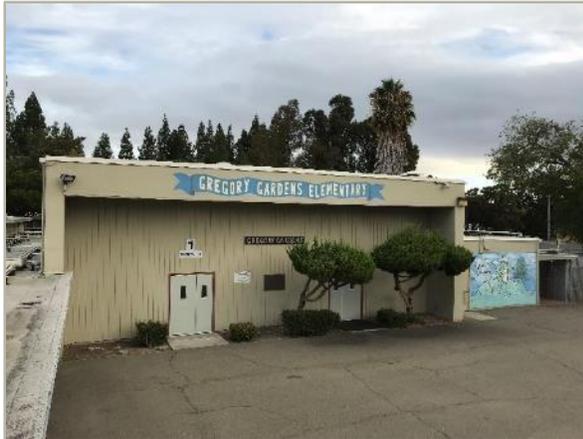
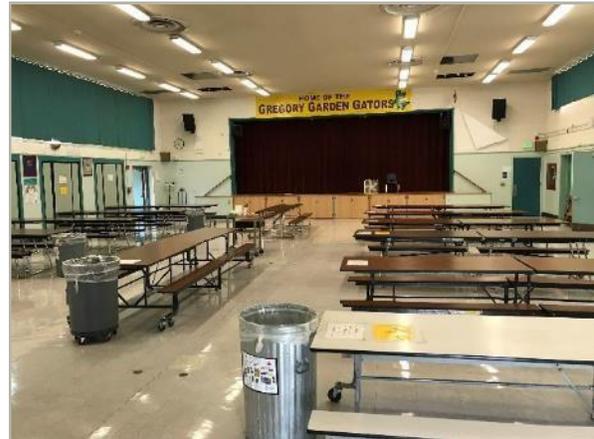
Site Summary Information

Ancillary Structures	Steel carport solar system, pre-fabricated storage sheds	Fair
Key Issues & Findings	Inadequate site lighting
