Pleasant Hills Elementary School

OVERVIEW

Property Executive Summary

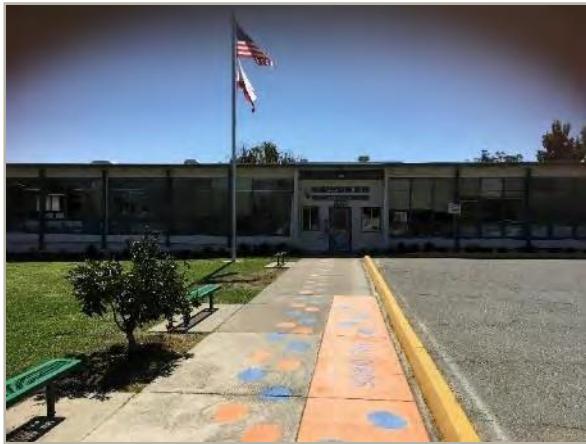
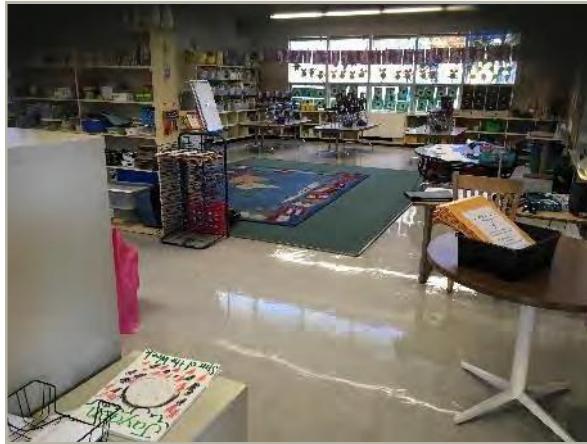
Building Type 1 Information

Building Locations	Offices, Classroom Building	
Constructed/Renovated	1951	
Total area	6,900 SF	
Number of Stories	1	
System	<i>Description</i>	<i>Condition</i>
Structure	Masonry bearing walls and wood-framed roofs	Good
Façade	Painted CMU with steel-framed windows	Fair
Roof	Primary: Flat construction with modified bituminous finish	Fair
Interiors	Walls: Painted gypsum board & CMU Floors: Carpet, VCT Ceilings: Painted gypsum board, ACT	Fair
Elevators	None	--
Plumbing	Copper supply, cast iron waste and vent No hot water	Fair
HVAC	Individual package units and split-systems Supplemental components: ductless split-systems	Good
Fire Suppression	Fire extinguishers	Good
Electrical	Source & Distribution: Main switchboard panel with copper wiring fed from exterior cabinet with copper wiring Interior Lighting: T-8	Good
Fire Alarm	Alarm panel, smoke detectors, alarms, strobes, pull stations, back-up emergency lights, and exit signs	Good

Equipment/Special	None	--
Key Issues & Findings	Building lacks fire suppression, roof shows signs of advanced age

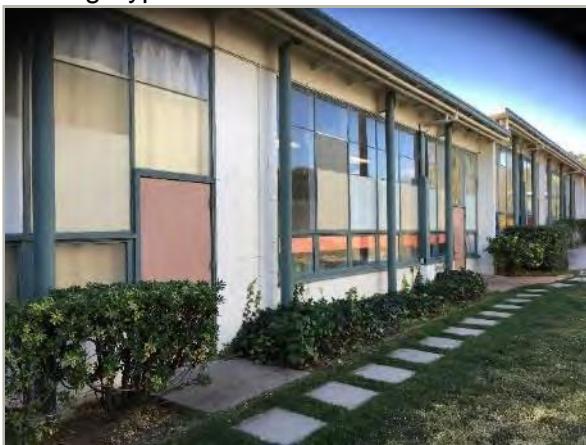
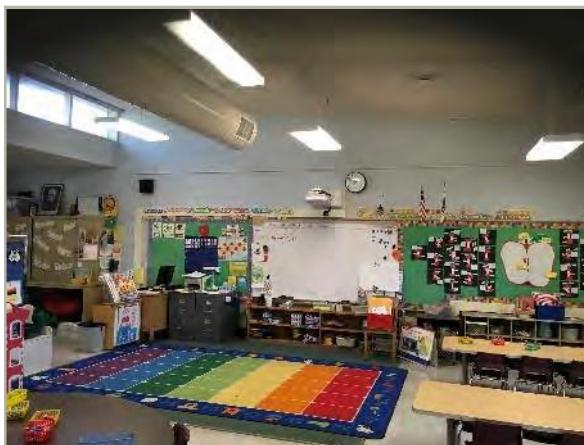
Building Type 2 Information

Building Locations	Library, Classroom Building 2-8, Restrooms	
Constructed/Renovated	1951	
Total Area	24,500 SF	
Number of Stories	1	
System	<i>Description</i>	<i>Condition</i>
Structure	Masonry bearing walls and wood-framed roofs	Good
Façade	Painted CMU with steel-framed windows	Fair
Roof	Primary: Flat construction with modified bituminous finish	Fair
Interiors	Walls: CMU with sporadic tack board Floors: VCT, ceramic tile in restrooms Ceilings: Painted gypsum board, ACT	Fair
Elevators	None	--
Plumbing	Copper supply, cast iron waste and vent No hot water	Fair
HVAC	Individual package units, split-systems	Good
Fire Suppression	Fire extinguishers	Good
Electrical	Source & Distribution: Sub panels with copper wiring fed from external switchboard building with copper wiring Interior Lighting: T-8	Good
Fire Alarm	Alarm panel, smoke detectors, alarms, strobes, pull stations, back-up emergency lights, and exit signs	Good

Equipment/Special	None	--
Key Issues & Findings	Building lacks fire suppression, misaligned gutter downspouts contribute to water pooling, some exterior lighting fixture covers are failing due to oversized bulbs, many exterior lights are on during the day, roof shows signs of advanced age, teacher work room still has original 9"x9" flooring tile

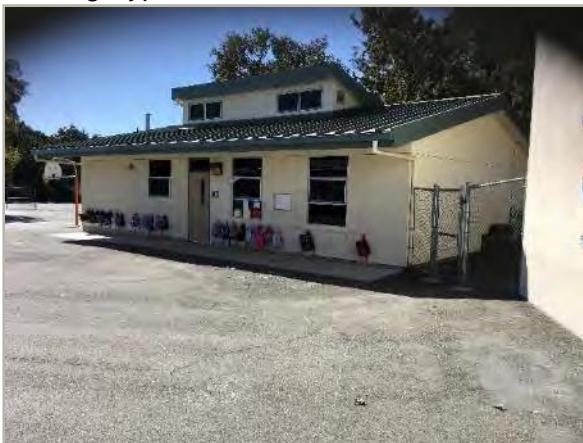
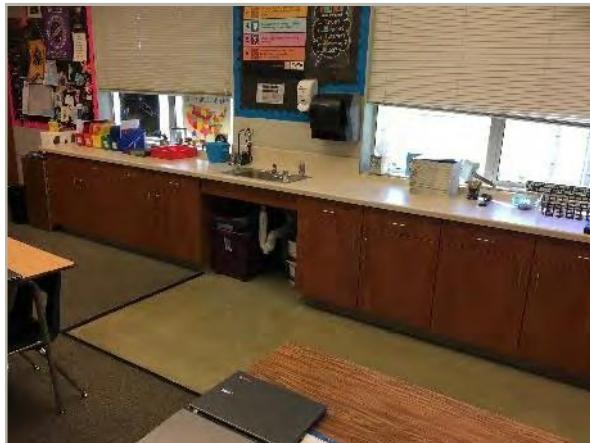
Building Type 3 Information

Building Locations	Classroom Buildings 9-11, 13	
Constructed/Renovated	2002	
Total Area	9,500 SF	
Number of Stories	1	
System	<i>Description</i>	<i>Condition</i>
Structure	Conventional wood-framed structure on concrete slab	Good
Façade	Stucco with aluminum-framed windows	Good
Roof	Primary: Gable construction with metal finish	Good
Interiors	Walls: Painted gypsum board Floors: Carpet, VCT Ceilings: Painted gypsum board, ACT, unfinished/exposed	Good
Elevators	None	--
Plumbing	Copper supply, PVC waste and vent No hot water	Good
HVAC	Split-systems	Good
Fire Suppression	Fire extinguishers	Good
Electrical	Source & Distribution: Sub panels with copper wiring fed from exterior switchboard cabinet with copper wiring Interior Lighting: T-8	Good
Fire Alarm	Alarm panel, smoke detectors, alarms, strobes, pull stations, back-up emergency lights, and exit signs	Good
Equipment/Special	None	--
Key Issues & Findings	Building lacks fire suppression

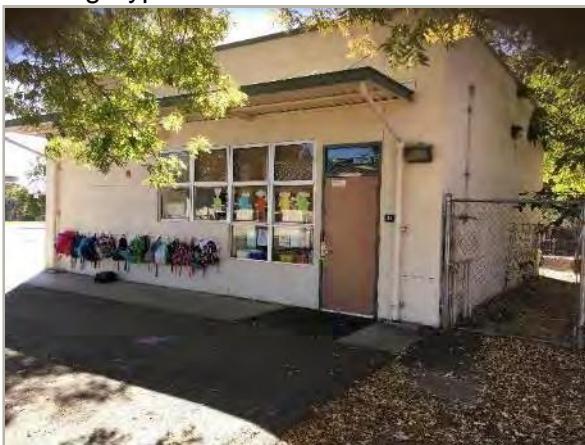
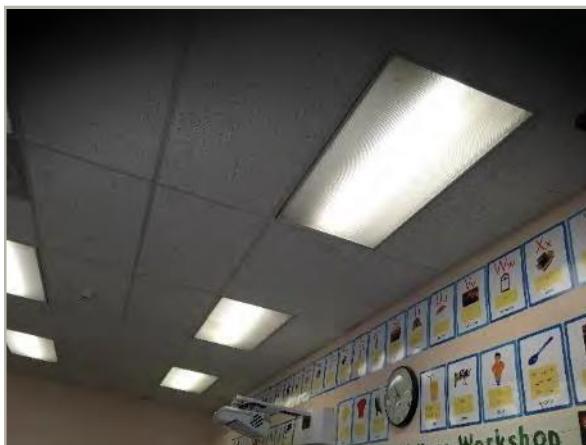
Building Type 4 Information

Building Locations	Classroom Building 12	
Constructed/Renovated	1990s	
Building Size	1,500 SF	
Number of Stories	1	
System	<i>Description</i>	<i>Condition</i>
Structure	Conventional wood-framed structure on concrete slab	Fair
Facade	Stucco with aluminum-framed windows	Good
Roof	Primary: Flat construction with modified bituminous finish	Fair
Interiors	Walls: Painted gypsum board Floors: VCT Ceilings: Suspended ACT	Good
Elevators	None	--
Plumbing	Copper supply, PVC waste and vent No hot water	Good
HVAC	Split-systems	Good
Fire Suppression	Fire extinguishers	Good
Electrical	Source & Distribution: Sub panels with copper wiring fed from exterior switchboard cabinet with copper wiring Interior Lighting: T-8	Good
Fire Alarm	Alarm panel, smoke detectors, alarms, strobes, pull stations, back-up emergency lights, and exit signs	Good
Equipment/Special	None	--
Key Issues & Findings	Building lacks fire suppression

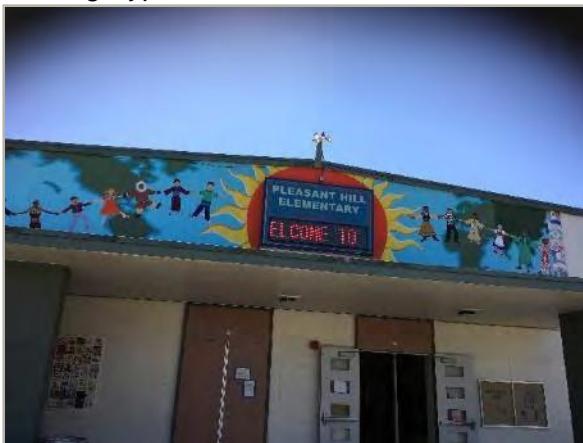
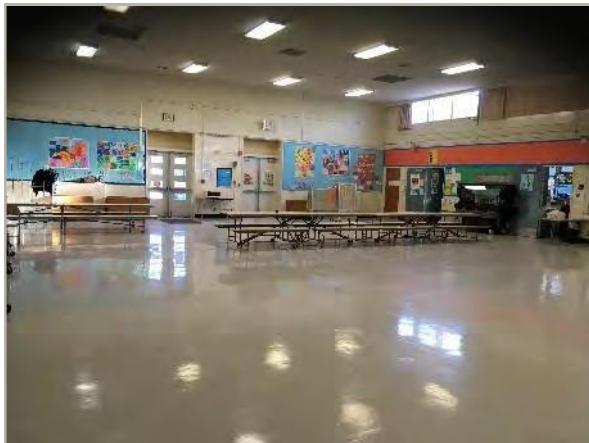
Building Type 5 Information		
Building Locations	Multipurpose, Kitchen, Cafeteria	
Constructed/Renovated	1951	
Building Size	5,900 SF	
Number of Stories	1	
System	<i>Description</i>	<i>Condition</i>
Structure	Masonry bearing walls and wood-framed roofs	Good
Façade	Painted CMU with steel-framed windows	Fair
Roof	Primary: Flat construction with modified bituminous finish	Fair
Interiors	Walls: VCT, painted gypsum board and painted CMU Floors: VCT, wooden stage flooring, vinyl Ceilings: ACT	Fair
Elevators	None	--
Plumbing	Copper supply, cast iron waste and vent Gas-fired water heater	Fair
HVAC	Central boiler with hydronic baseboard radiators and cabinets	Fair
Fire Suppression	Fire extinguishers	Good
Electrical	Source & Distribution: External sub-panel with copper wiring /// Fed from external switchboard with copper wiring Interior Lighting: T-8, incandescent	Good
Fire Alarm	Alarm panel, smoke detectors, alarms, strobes, pull stations, back-up emergency lights, and exit signs	Good

Equipment/Special	Commercial kitchen equipment	Fair
Key Issues & Findings	Building and kitchen hood lacks fire suppression, roof shows signs of advanced age

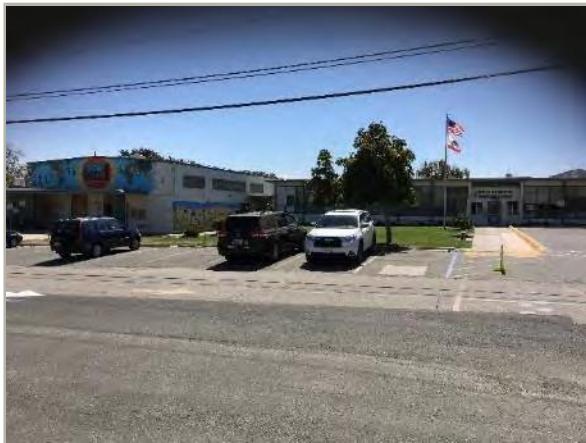
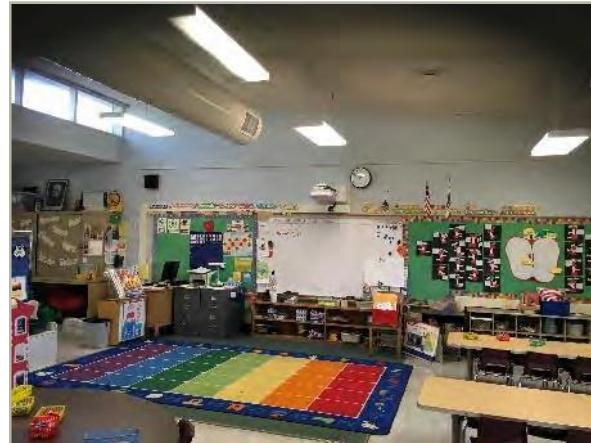
Site Summary Information

Site Information		
Lot Size	10.0 acres (estimated)	
Parking Spaces	67 total spaces all in open lots 4 accessible (included in total above), 1 van-accessible	
System	<i>Description</i>	<i>Condition</i>
Pavement/Flatwork	Asphalt lots with areas of concrete and concrete sidewalks, curbs, ramps, paver walk-ways	Fair
Site Development	Building-mounted entrance signage, chain link fencing, no dumpster enclosures Playgrounds with soft landings and asphalt sports courts Moderately furnished benches, picnic tables, trash receptacles	Fair
Landscaping & Topography	Moderate landscaping features Irrigation present Moderate site slopes north to south	Fair
Draining Systems and Erosion Control	Surface flow, pits Soil erosion occurs near Classrooms 8-9 Ponding occurs in the same landscaped areas The concrete drainage swales have isolated areas of cracked and spalling swales One concrete sump has a history of back-ups	Poor

Utilities	Municipal water and sewer Local utility-provided electric and natural gas	Fair
Site Lighting	Building-mounted: LED, HPS, metal halide	Fair
Ancillary Structures	Steel PV array structures, wood-framed bike shelter, pre-fabricated storage sheds, metal-framed picnic shelter	Fair
Key Issues & Findings	Inadequate lot drainage in specific areas
