Rio Vista Elementary School

Property Executive Summary

Summary of Findings

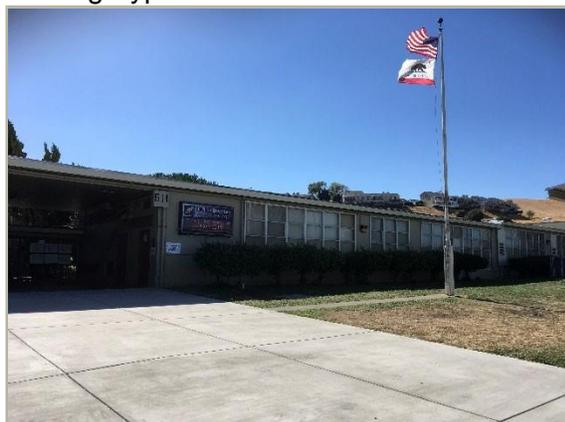
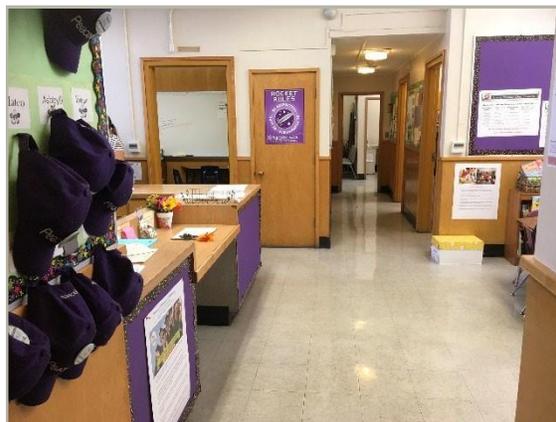
Building Type 1 Information

Fire Alarm	Alarm panel, smoke detectors, alarms, strobes, pull stations, back-up emergency lights, and exit signs	Fair
Equipment/Special	None	--
Key Issues & Findings	Potential asbestos flooring tile in classrooms B2, B3, and B8. Buildings lack fire suppression.

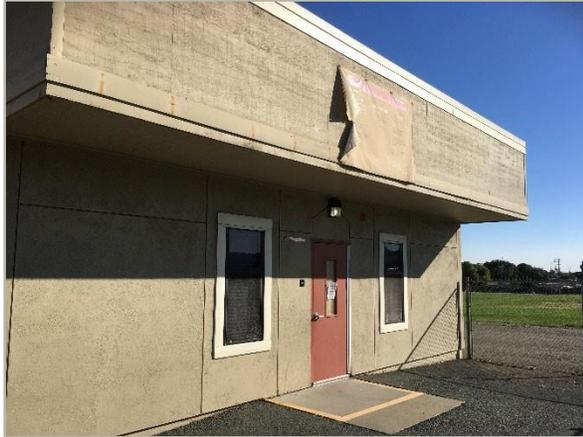
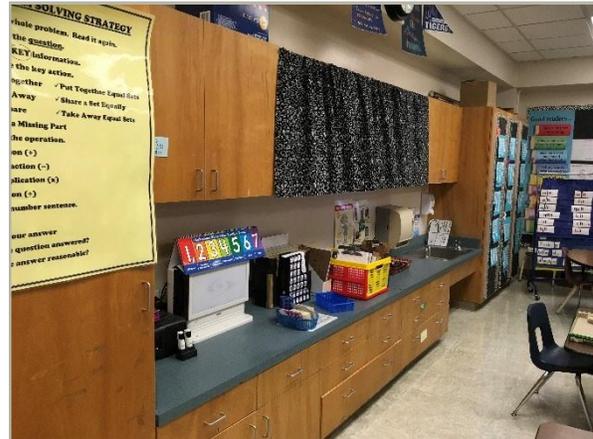
Building Type 2 Information

Equipment/Special	None	--
Key Issues & Findings	Building lacks fire suppression. Wood fascia has some warping with hardware backing out. Potential foundation settling issue should be investigated further.

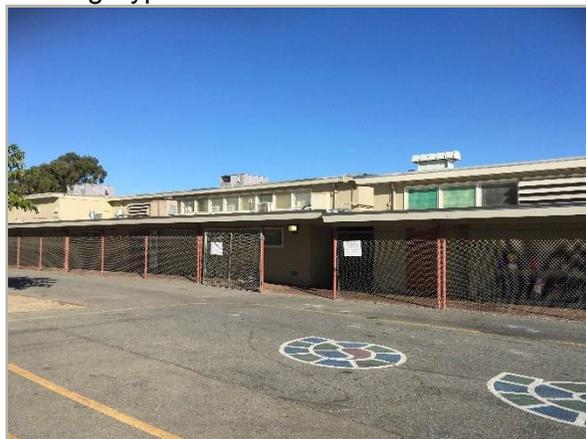
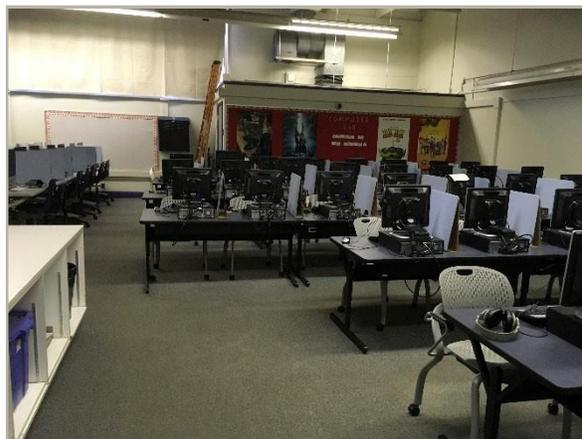
Building Type 4 Information

Fire Alarm	Alarm panel, smoke detectors, alarms, strobes, pull stations, back-up emergency lights, and exit signs	Fair
Equipment/Special	None	--
Key Issues & Findings	Building lacks fire suppression

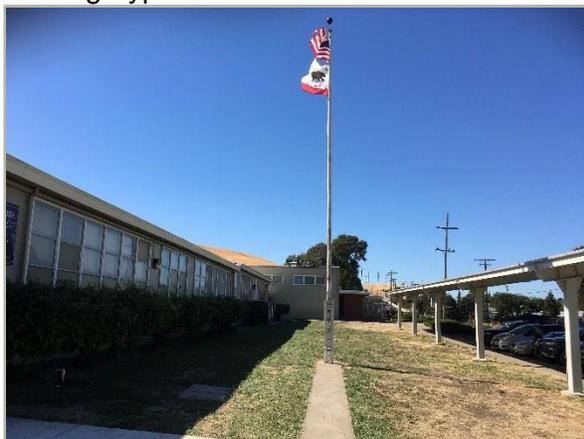
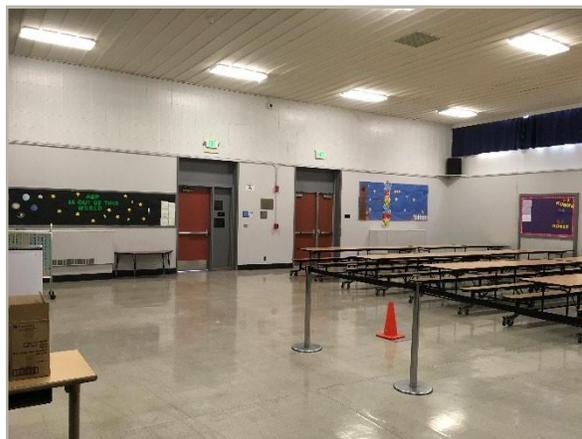
Building Type 5 Information

Fire Alarm	Alarm panel, smoke detectors, alarms, strobes, pull stations, back-up emergency lights, and exit signs	Fair
Equipment/Special	Commercial kitchen equipment	Fair
Key Issues & Findings	Building lacks fire suppression

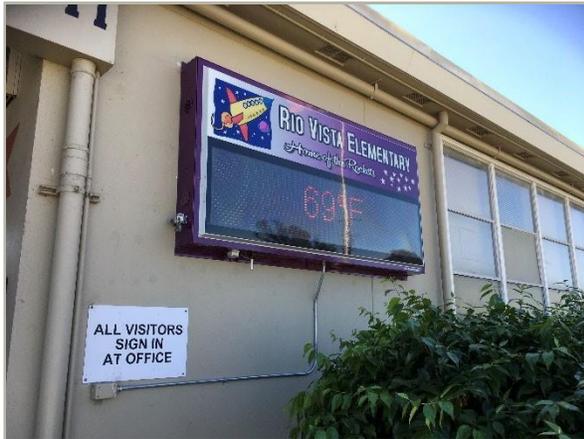
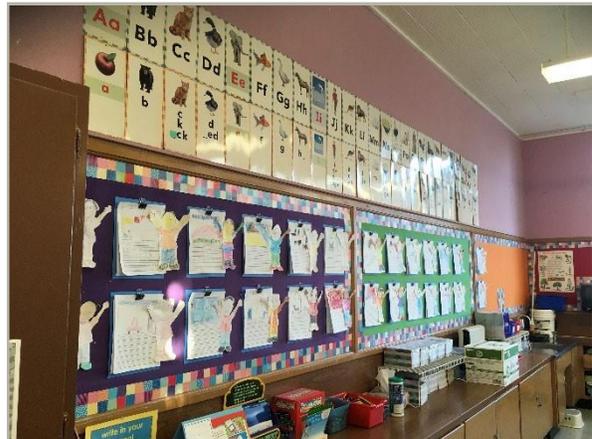
Site Summary Information

Key Issues & Findings	Some gutter drains near buildings are filled with mud and debris. Rodents are digging holes under fence on south side.
