El Dorado Middle School

Property Executive Summary

Summary of Findings

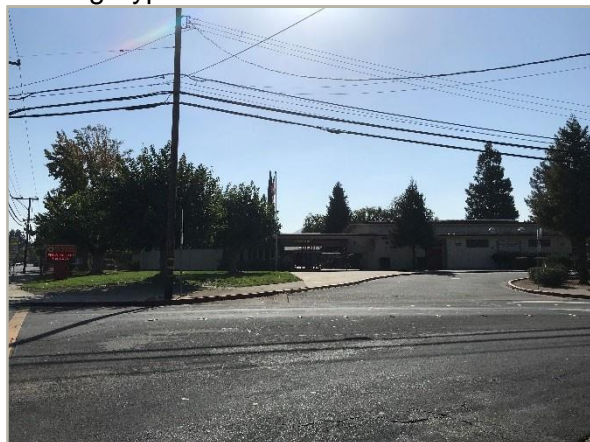
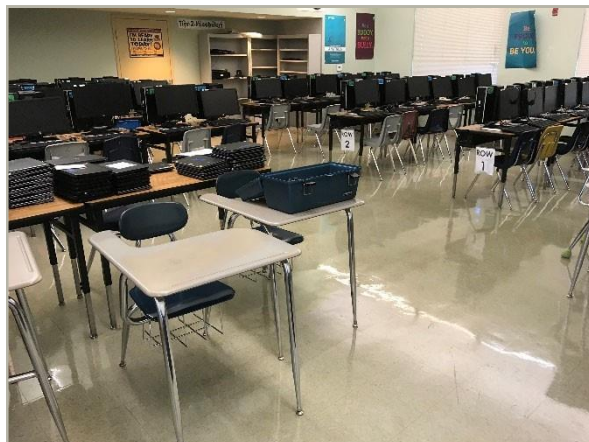
Building Type 1 Information		
Building Locations	M-U, Music, A, B, C, D and S	
Constructed/ Renovated	1960/ 2014	
Total Area	55,000 SF	
Number of Stories	1	
<i>System</i>	<i>Description</i>	<i>Condition</i>
Structure	Concrete bearing walls on concrete slab	Fair
Façade	Painted wood with steel- and wood-framed windows	Fair
Roof	Primary: Flat construction with modified bituminous finish	Fair
Interiors	Walls: Painted gypsum board and unfinished concrete Floors: Carpet, VCT, ceramic tile Ceilings: Painted gypsum board, ACT	Fair
Elevators	None	--
Plumbing	Copper supply, cast iron waste and vent Gas and electric water heaters	Fair
HVAC	Individual package and split-system units and furnaces Supplemental components: ductless split-systems	Fair
Fire Suppression	Hydrants, fire extinguishers, hose cabinets	Fair
Electrical	Source & Distribution: Main switchboard and distribution panels Interior Lighting: T-8, T-12, incandescent Emergency: None	Fair

Fire Alarm	Alarm panel, smoke detectors, alarms, strobes, pull stations,	Fair
Equipment/Special	Commercial kitchen equipment	Fair

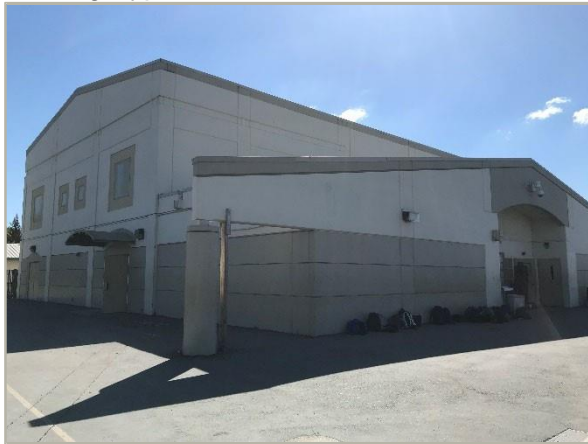
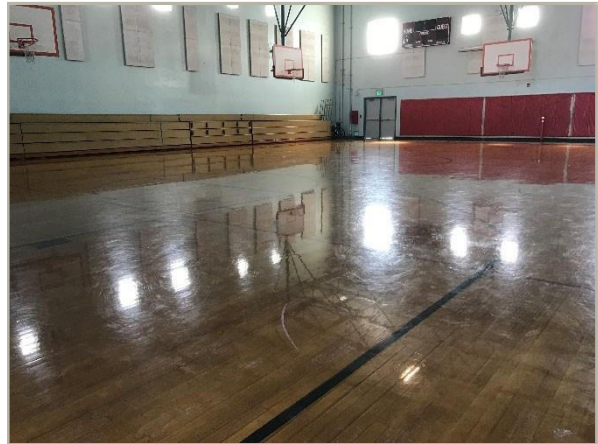
El Dorado Middle School
 Building Type 2 Information

Building Type 2 Information		
Building Locations	Buildings E, F, G, H, RR and PE.	
Constructed/ Renovated	2012	
Total Area	21,100 SF	
Number of Stories	1	
<i>System</i>	<i>Description</i>	<i>Condition</i>
Structure	Conventional wood-framed structure on concrete slab	Good
Façade	Stucco with aluminum-framed windows	Good
Roof	Primary: Gable construction with metal finish	Good
Interiors	Walls: Painted gypsum board Floors: Carpet, VCT, ceramic tile Ceilings: Painted gypsum board, ACT	Fair
Elevators	None	--
Plumbing	Copper supply, cast iron waste and vent Gas water heaters	Fair
HVAC	Split systems	Fair
Fire Suppression	Hydrants, fire extinguishers, hose cabinets	Fair
Electrical	Source & Distribution: Main switchboard and distribution panels Interior Lighting: T-8, T-12, incandescent Emergency: None	Fair
Fire Alarm	Smoke detectors, alarms, strobes, pull stations	Fair
Equipment/Special	None	--
Key Issues & Findings	Building lacks fire suppression.

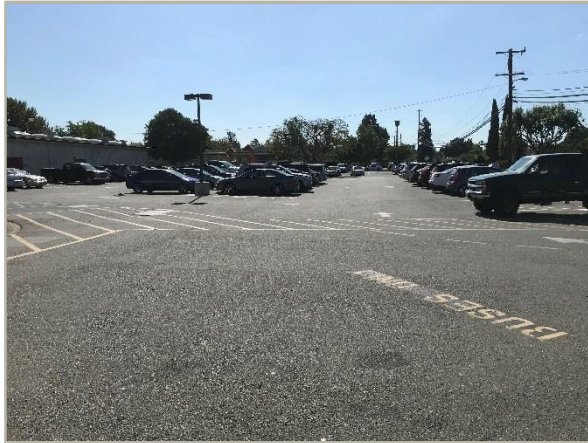
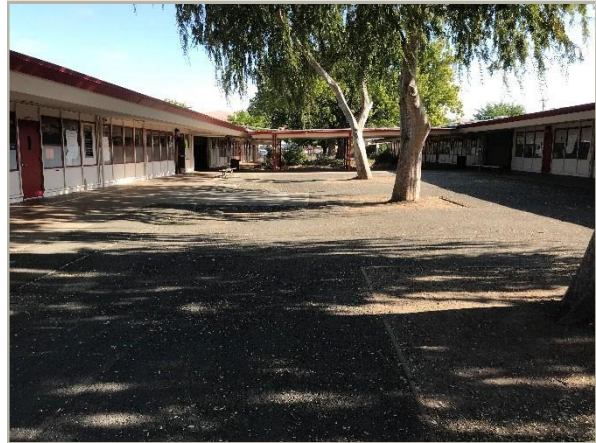
El Dorado Middle School
 Site Summary Information

Site Information		
Lot Size	15.00 acres (estimated)	
Parking Spaces	59 total spaces all in open lots; 4 of which are accessible 2 accessible (included in total above), 2 van-accessible	
<i>System</i>	<i>Description</i>	<i>Condition</i>
Pavement/Flatwork	Asphalt lots with areas of concrete and concrete sidewalks, curbs, ramps, and stairs	Fair
Site Development	Property entrance signage, chain link fencing, chain link dumpster enclosures Sports courts, fencing, and site lights	Fair
Landscaping & Topography	Moderate landscaping features Irrigation present No retaining walls Low to moderate site slopes throughout	Fair
Draining Systems and Erosion Control	Surface flow, inlets, swales, underground piping	Fair
Utilities	Municipal water and sewer Local utility-provided electricity and natural gas	Fair
Site Lighting	Pole-mounted: metal halide Building-mounted: metal halide	Fair
Ancillary Structures	Steel-framed carports for solar system.	Good

Key Issues & Findings	None
