Oak Grove Middle School
EXISTING SITE INFORMATION

Oak Grove Middle School

OVERVIEW

Property Executive Summary

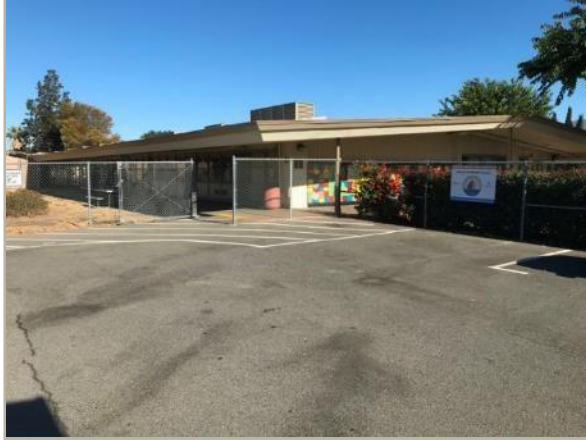
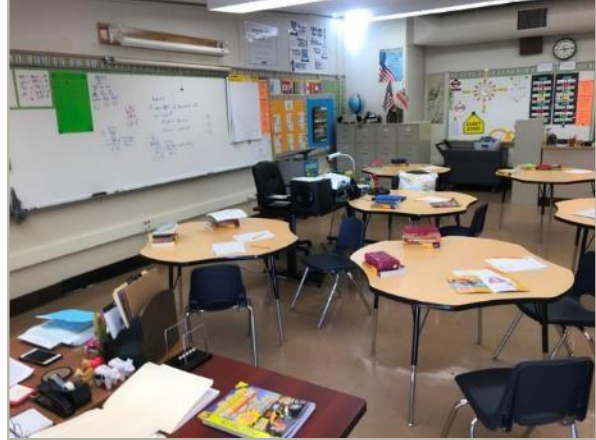
Building M-1, M-2, A-1-4, D 1-5, A 5-8, C 4-7, E 3-5 Information		
Building Locations	Classroom, Auditorium, Restroom, Kitchen	
Constructed/ Renovated	1958	
Total Area	50,000 SF	
Number of Stories	One	
<i>System</i>	<i>Description</i>	<i>Condition</i>
Structure	Conventional wood-framed structure on concrete slab with wood-framed roofs	Good
Façade	Wood siding with steel-framed windows	Fair
Roof	Primary: Flat construction with modified bituminous finish	Fair
Interiors	Walls: Painted gypsum board & ceramic tile Floors: Carpet, VCT, ceramic tile Ceilings: Painted gypsum board, ACT	Fair
Elevators	Wheelchair lifts	Fair
Plumbing	Copper supply, cast-iron waste and vent Gas & electric water heaters	Fair
HVAC	Central system with boilers feeding fan coil units Individual package, heat pump, split-system units Supplemental components: ductless split-systems	Fair
Fire Suppression	Wet-pipe sprinkler system; hydrants, fire extinguishers, kitchen hood system	Fair

Electrical	Source & Distribution: Main switchboard with copper wiring Interior Lighting: T-8, CFL Emergency: None	Fair
Fire Alarm	Alarm panel, smoke detectors, alarms, strobes, pull stations, back-up emergency lights, and exit signs	Fair
Equipment/Special	Commercial kitchen equipment	Fair
Key Issues & Findings	None noted

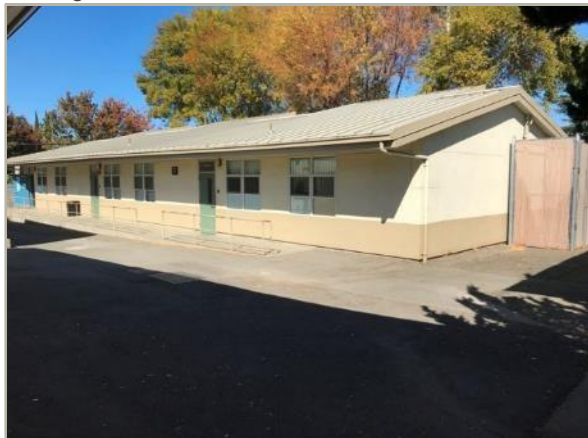
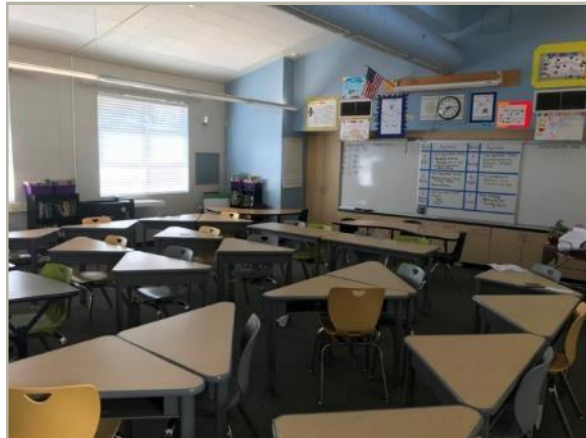
Building PE, G 1-3, E 1-2, F 1-3, F 4-5, F 6-7 Information

Building PE, G 1-2, E 1-2, F 1-3, F 4-5, F 6-7 Information		
Building Locations	Gymnasium, Classroom Building	
Constructed/ Renovated	2000s	
Total Area	22,550 SF	
Number of Stories	One	
<i>System</i>	<i>Description</i>	<i>Condition</i>
Structure	Conventional wood-framed structure on concrete slab with wood-framed roofs	Fair
Façade	Stucco with aluminum-framed windows	Fair
Roof	Primary: Gable construction with metal finish Secondary: Flat construction with metal finish	Fair
Interiors	Walls: Painted gypsum board, vinyl Floors: Carpet, VCT Ceilings: Painted gypsum board, ACT	Fair
Elevators	None	--
Plumbing	Copper supply, cast-iron waste and vent Gas or electric water heaters	Fair
HVAC	Individual package heat pump, split-system units Supplemental components: ductless split-systems	Fair
Fire Suppression	Hydrants, fire extinguishers, hose cabinets,	Fair
Electrical	Source & Distribution: Main switchboard with copper wiring Interior Lighting: T-8, CFL Emergency: None	Fair

Fire Alarm	Alarm panel, smoke detectors, alarms, strobes, pull stations, back-up emergency lights, and exit signs	Fair
Equipment/Special	None	
Key Issues & Findings	None noted

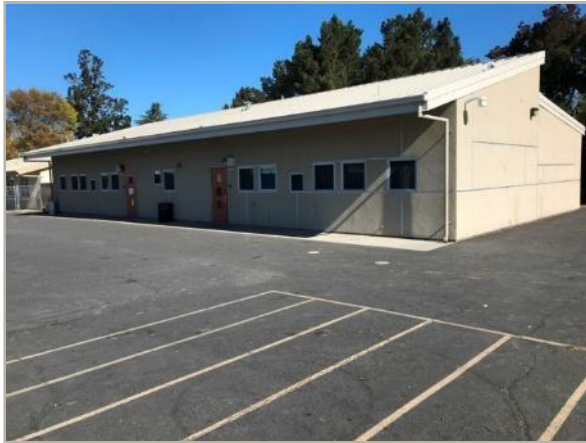
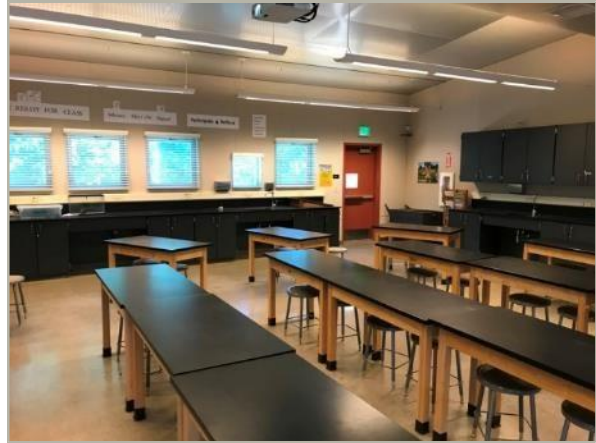
Building Type 3 Information

Building F 8-9 Information		
Building Locations	Classroom Building	
Constructed/ Renovated	2012	
Building Size	3,100 SF	
Number of Stories	1	
<i>System</i>	<i>Description</i>	<i>Condition</i>
Structure	Conventional wood-framed structure on concrete slab with wood-framed roofs	Fair
Façade	Stucco with aluminum-framed windows	Fair
Roof	Primary: Gable construction with metal finish	Fair
Interiors	Walls: Painted gypsum board & vinyl Floors: VCT Ceilings: Painted gypsum board, ACT	Fair
Elevators	None	--
Plumbing	Copper supply, cast-iron waste and vent No hot water	Fair
HVAC	Individual heat pump units Supplemental components: ductless split-systems	Fair
Fire Suppression	Wet-pipe sprinkler system; hydrants, fire extinguishers, hose cabinets	Fair
Electrical	Source & Distribution: Main panel with copper wiring Interior Lighting: T-8, LED, CFL Emergency: None	Fair
Fire Alarm	Alarm panel, smoke detectors, alarms, strobes, pull stations, back-up emergency lights, and exit signs	Fair

Equipment/Special	None	--
Key Issues & Findings	None noted

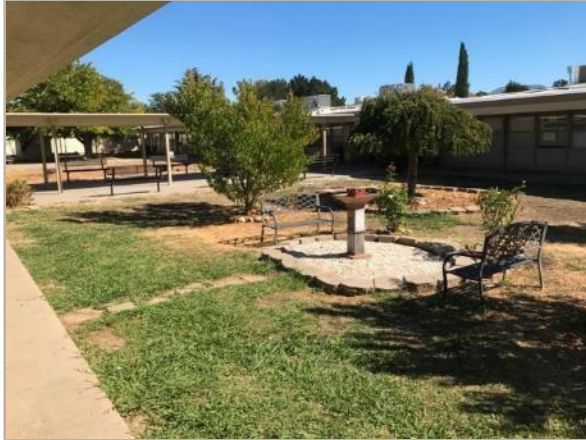
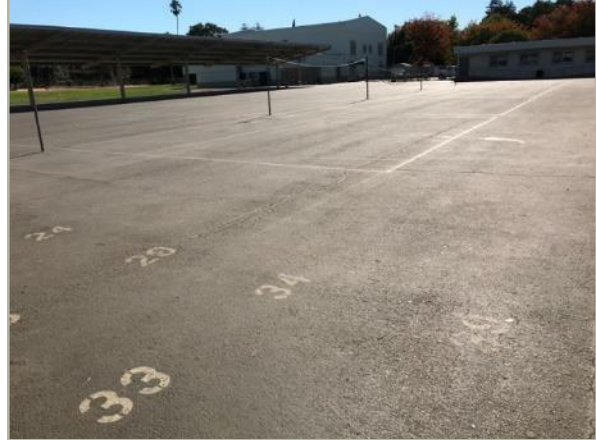
Site Summary Information

Site Information		
Lot Size	10.27 acres (estimated)	
Parking Spaces	Sixty-eight total spaces all in open lots; Four of which are accessible Four accessible (included in total above), two van-accessible	
<i>System</i>	<i>Description</i>	<i>Condition</i>
Pavement/Flatwork	Asphalt lots with areas of concrete and concrete sidewalks, curbs, ramps, and stairs	Fair
Site Development	Building-mounted & property entrance signage, chain link fencing, Playgrounds and sports courts with fencing Limited park benches, picnic tables, trash receptacles	Fair
Landscaping & Topography	Moderate landscaping features Irrigation present No retaining walls Low to moderate site slopes throughout	Fair
Draining Systems and Erosion Control	Surface flow, inlets, underground piping, municipal system	Fair
Utilities	Municipal water and sewer	Fair
Site Lighting	Pole-mounted: metal halide Building-mounted: LED	Fair
Ancillary Structures	Pre-fabricated storage sheds, solar parking and shade structures	Fair

Key Issues & Findings	None noted
