Pleasant Hill Middle School (includes Pleasant Hill Education Center)

Property Executive Summary

Summary of Findings

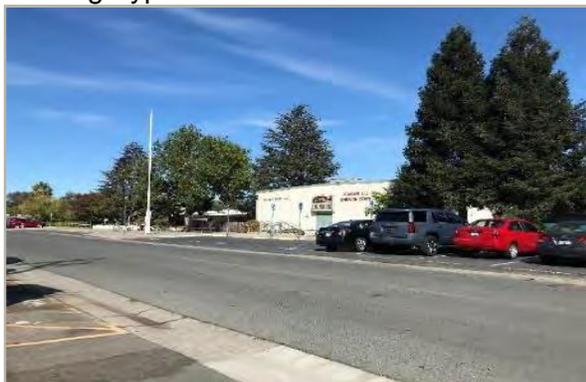
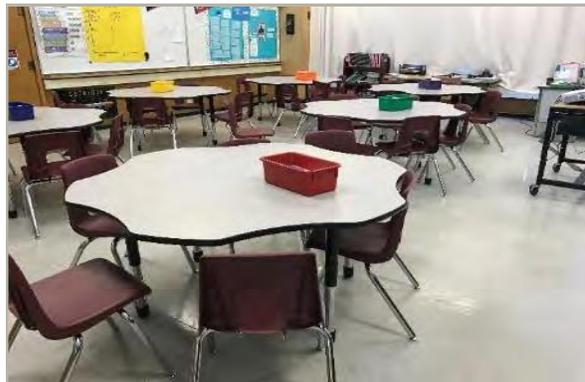
Building Type 1 Information

Electrical	Source & Distribution: Main switchboard and distribution panels Interior Lighting: T-8, T-12, incandescent Emergency: None	Fair
Fire Alarm	Alarm panel, smoke detectors, alarms, strobes, pull stations,	Fair
Equipment/Special	Commercial kitchen equipment	Fair
Key Issues & Findings	Building lacks fire suppression.

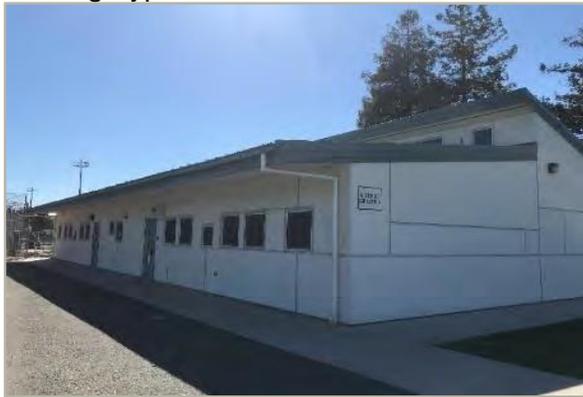
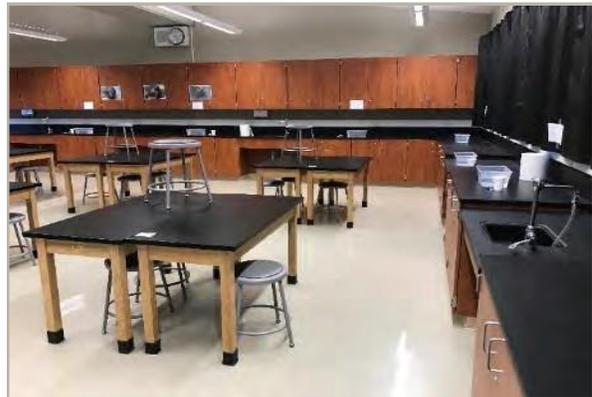
Building Type 2 Information		
Building Locations	Buildings 409-411 and S1-S2	
Constructed/ Renovated	2012	
Total Area	7,300 SF	
Number of Stories	1	
<i>System</i>	<i>Description</i>	<i>Condition</i>
Structure	Conventional wood-framed structure on concreteslab	Good
Façade	Stucco with aluminum windows	Good
Roof	Primary: Gable construction with metal finish	Good
Interiors	Walls: Painted gypsum board Floors: Carpet, VCT, ceramic tile Ceilings: Painted gypsum board, ACT	Fair
Elevators	None	--
Plumbing	Copper supply, cast iron waste and vent Electrical water heaters	Fair
HVAC	Split systems	Fair
Fire Suppression	Hydrants, fire extinguishers, hose cabinets	Fair
Electrical	Source & Distribution: Main switchboard and distribution panels Interior Lighting: T-8, T-12, incandescent Emergency: None	Fair
Fire Alarm	Smoke detectors, alarms, strobes, pull stations	Fair
Equipment/Special	None	--
Key Issues & Findings	Building lacks fire suppression.
