River View Middle School

Property Executive Summary

River View Middle School
Summary of Findings

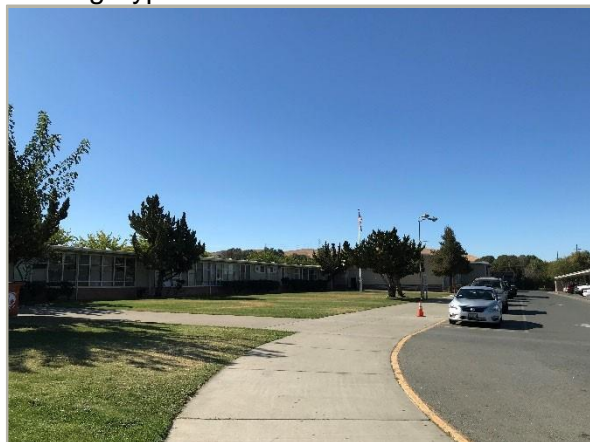
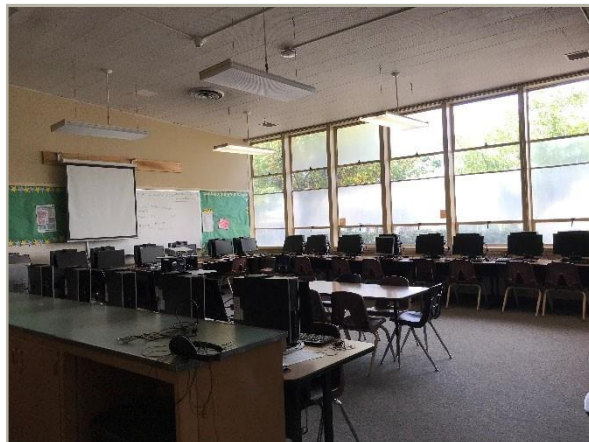
Building Type 1 Information

Electrical	Source & Distribution: Main switchboard and distribution panels Interior Lighting: T-8, T-12, incandescent Emergency: None	Fair
Fire Alarm	Alarm panel, smoke detectors, alarms, strobes, pull stations,	Fair
Equipment/Special	Commercial kitchen equipment	Fair
Key Issues & Findings	Buildings lacks fire suppression.

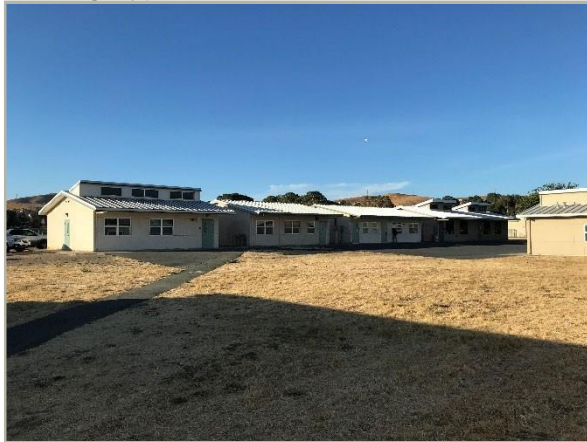
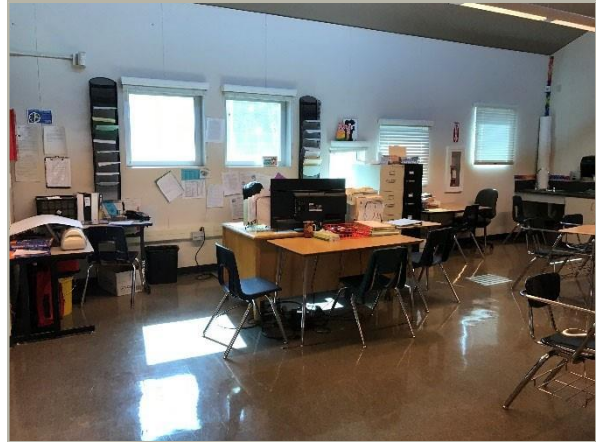
Building Type 2 Information

Fire Alarm	Alarm panel, smoke detectors, alarms, strobes, pull stations	Fair
Equipment/Special	None	--
Key Issues & Findings	None

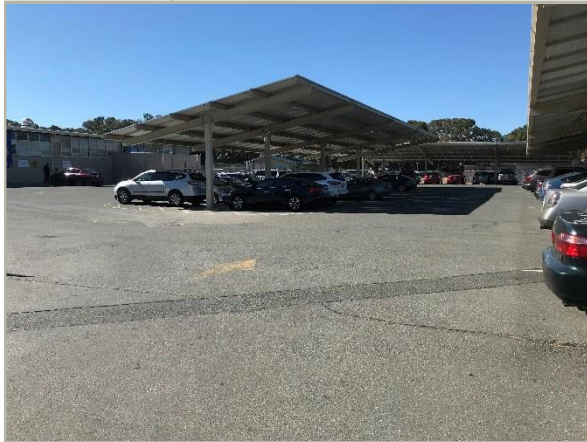
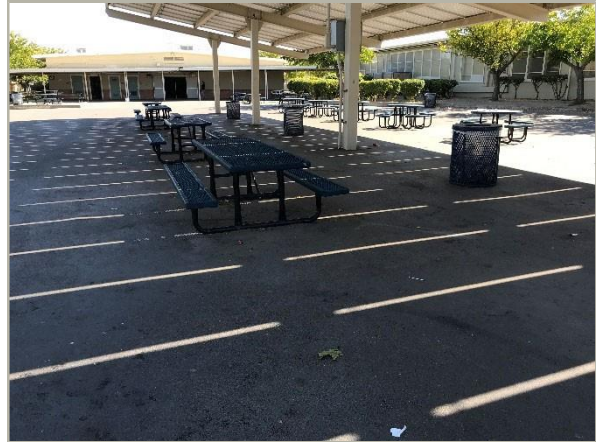
Site Summary Information

Key Issues & Findings	The irrigation system is not being used due to flooding some areas during operation.
