Sequoia Middle School
 EXISTING SITE INFORMATION

Sequoia Middle School

Sequoia Middle School OVERVIEW

Property Executive Summary

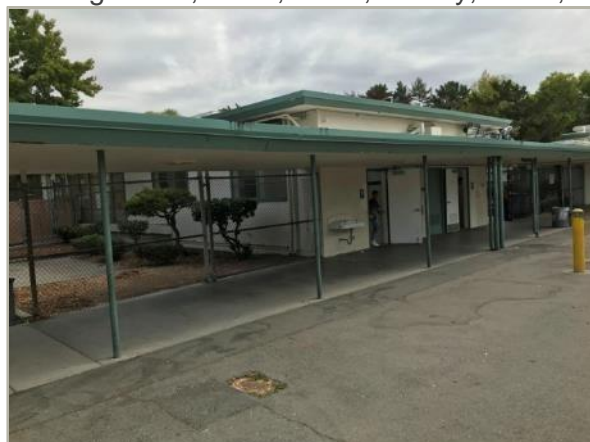
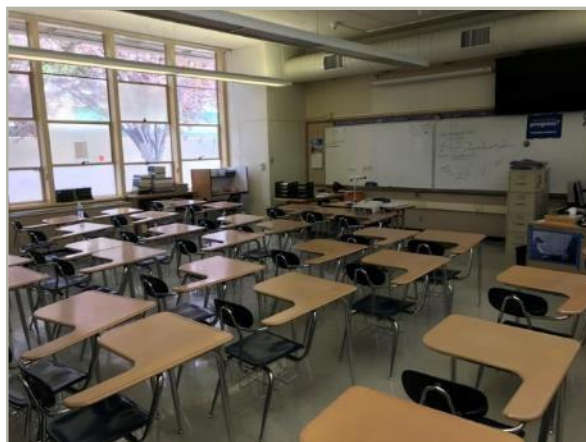
Building Office, A 1-5, B 1-5, Library, C 1-4, C 5-8, D 1-3 Information

Fire Alarm	Alarm panel, smoke detectors, alarms, strobes, pull stations, back-up emergency lights, and exit signs	--
Equipment/Special	None	--
Key Issues & Findings	Inefficient single pane windows

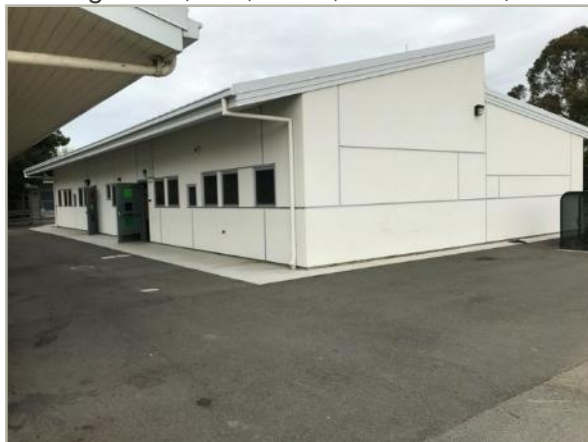
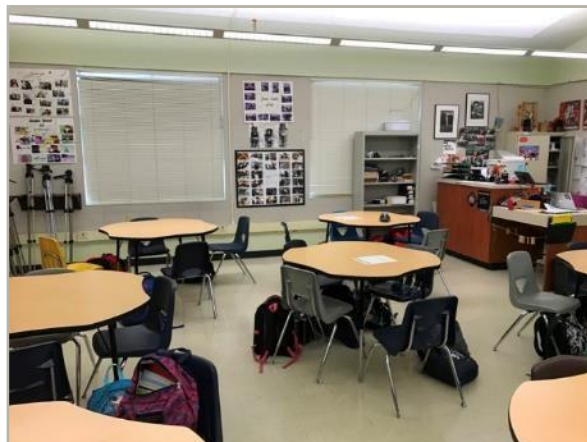
Building D 4-7, E-4, E 5-8, E Restroom, S 2-3, S 5-8 Information

Fire Alarm	Alarm panel, smoke detectors, alarms, strobes, pull stations, and exit signs	Fair
Equipment/Special	None	--
Key Issues & Findings	Probable roof leak in Classroom E-6

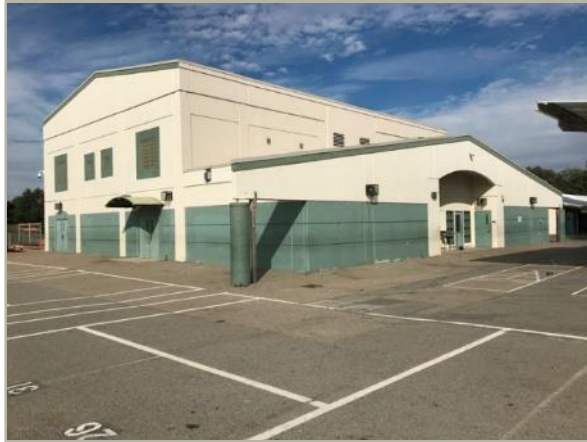
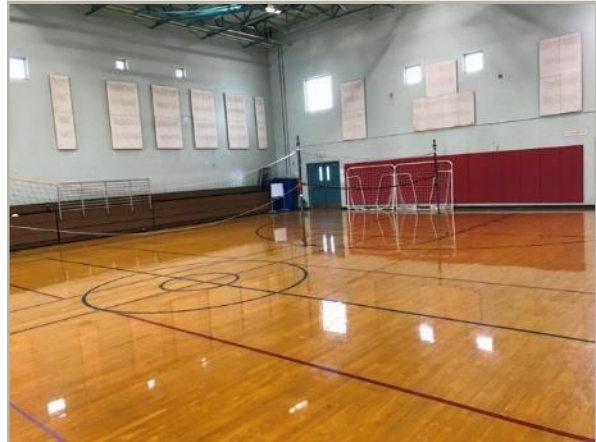
Building PE Information

Equipment/Special	None	--
Key Issues & Findings	Complaints about excessive heat, no AC present
