Concord High School (includes Summit High School)

Property Executive Summary

Summary of Findings

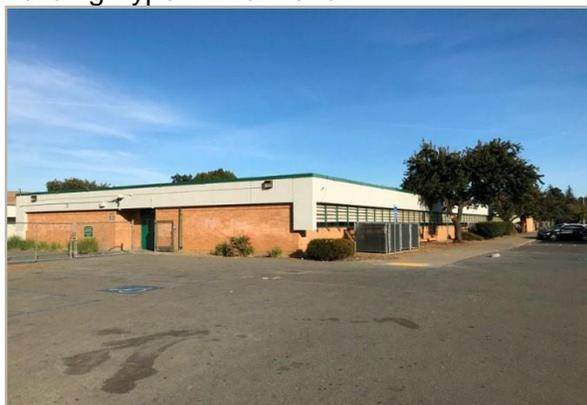
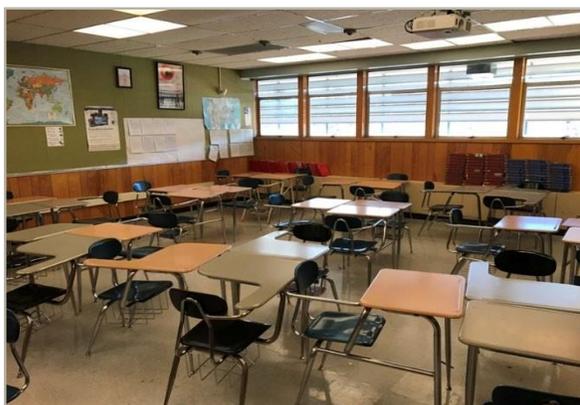
Building Type 1 Information

Fire Suppression	Hydrants, fire extinguishers, kitchen hood system	Fair
Electrical	Source & Distribution: Main switchboard with copper wiring Interior Lighting: T-8, LED, CFL Emergency: none	Fair
Fire Alarm	Alarm panel, smoke detectors, alarms, strobes, pull stations, back-up emergency lights, and exit signs	Fair
Equipment/Special	None	Fair
Key Issues & Findings	Possible fungal growth noted in library

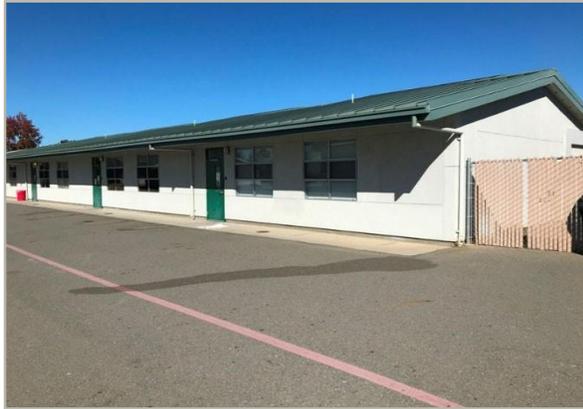
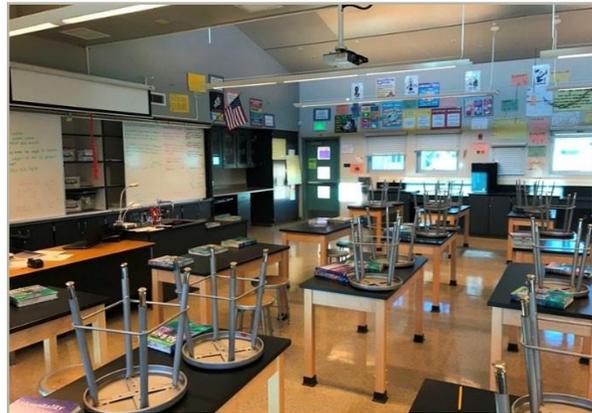
Building Type 2 Information

Electrical	Source & Distribution: Main switchboard with copper wiring Interior Lighting: LED, CFL Emergency: None	Fair
Fire Alarm	Alarm panel, smoke detectors, alarms, strobes, pull stations, back-up emergency lights, and exit signs	Fair
Equipment/Special	None	--
Key Issues & Findings	None noted

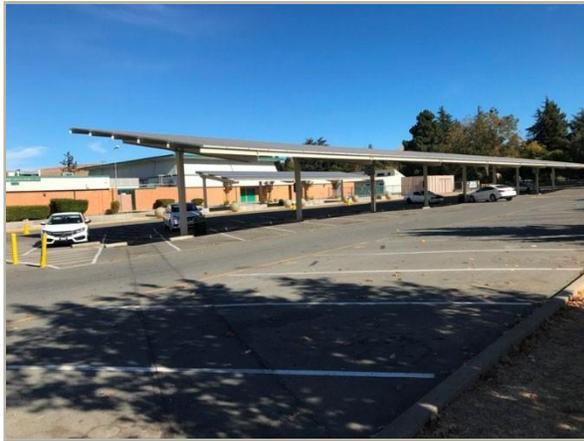
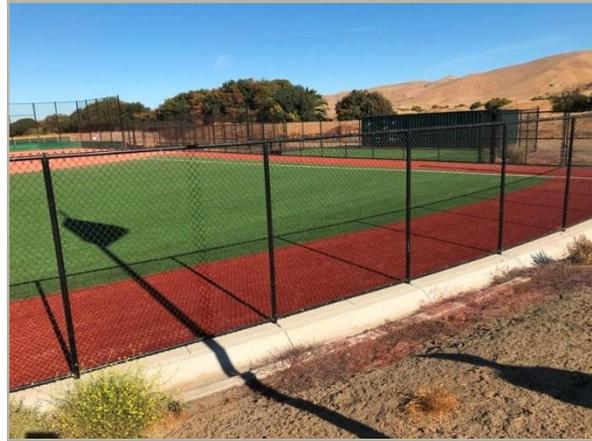
Site Summary Information

Ancillary Structures	Solar carports, pre-fabricated storage sheds, gazebos, storage trailers	Fair
Key Issues & Findings	Damaged parking bumpers
