Eagle Peak Montessori

Property Executive Summary

Facility Condition Index

Summary of Findings

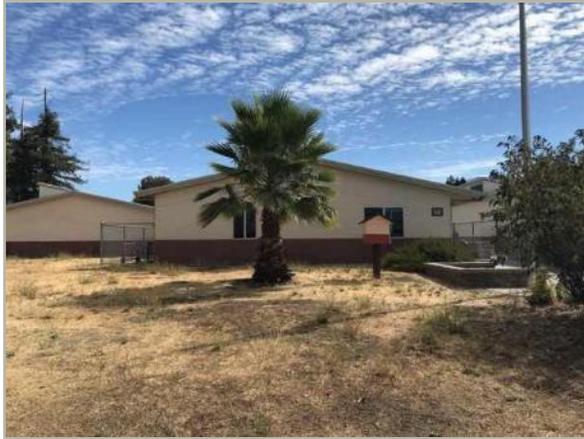
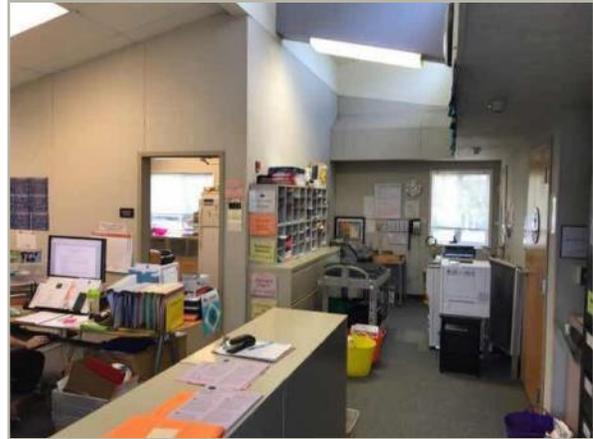
Building Type 1 Information		
Building Locations	Administration	
Constructed/ Renovated	2003	
Building Size	1,400 SF	
Number of Stories	1	
<i>System</i>	<i>Description</i>	<i>Condition</i>
Structure	Conventional wood-framed structure on concreteslab	Good
Façade	Stucco with aluminum-framed windows	Fair
Roof	Primary: Gable construction with metal finish	Good
Interiors	Walls: Painted gypsum board Floors: Carpet, VCT Ceilings: Painted gypsum board, ACT	Good
Elevators	None	--
Plumbing	Copper supply, cast iron waste and vent No hot water	Good
HVAC	Individual package /split-system Supplemental components: ductlesssplit-systems	Fair
Fire Suppression	Fire extinguishers	Fair
Electrical	Source & Distribution: Main switchboard with copperwiring Interior Lighting: T-8 Emergency: None	Good
Fire Alarm	Alarm panel, smoke detectors, alarms, strobes, pull stations, back-up emergency lights, and exit signs	Fair
Equipment/Special	None	--

Key Issues & Findings	None

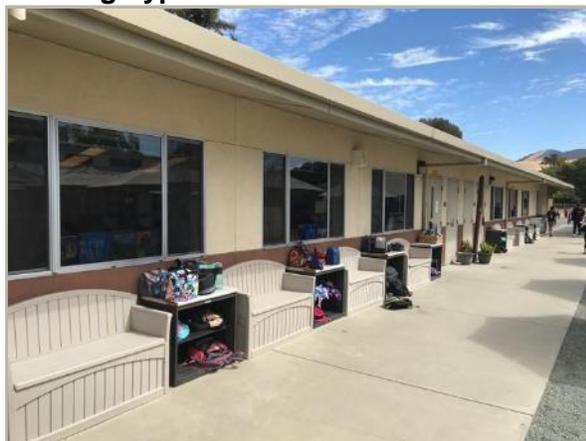
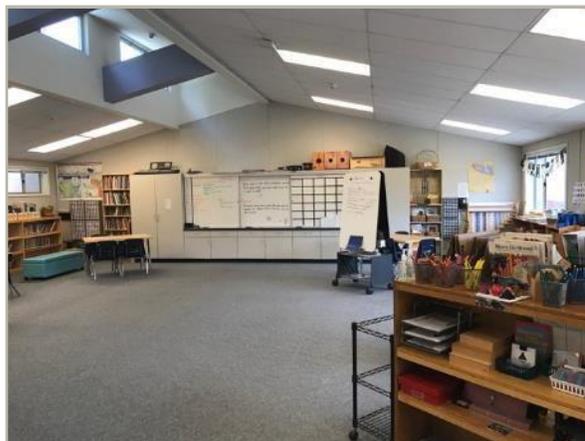
Building Type 2 Information		
Building Locations	Classroom Building 200 with Restroom	
Constructed/ Renovated	2003	
Building Size	4,350 SF	
Number of Stories	1	
<i>System</i>	<i>Description</i>	<i>Condition</i>
Structure	Conventional wood-framed structure on concreteslab	Good
Façade	Stucco with aluminum-framed windows	Fair
Roof	Primary: Gable construction with metal finish	Good
Interiors	Walls: Painted gypsum board Floors: Carpet, VCT Ceilings: Painted gypsum board, ACT	Good
Elevators	None	--
Plumbing	Copper supply, cast iron waste and vent No hot water	Good
HVAC	Individual package units, split systems Supplemental components: ductless split-systems	Fair
Fire Suppression	Fire extinguishers	Fair
Electrical	Source & Distribution: Main switchboard with copper wiring Interior Lighting: T-8 None	Good
Fire Alarm	Alarm panel, smoke detectors, alarms, strobes, pull stations, back-up emergency lights, and exit signs	Fair

Equipment/Special	None	--
Key Issues & Findings	None

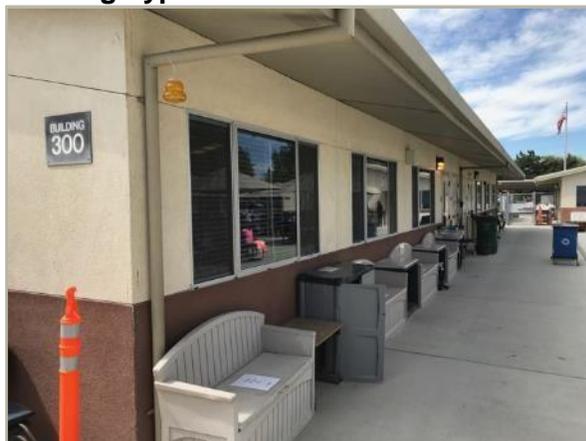
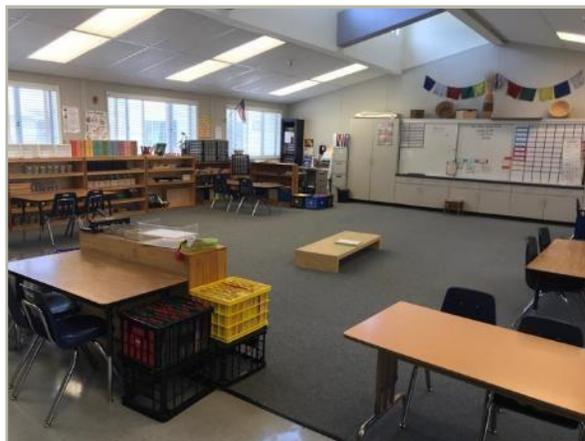
Building Type 3 Information		
Building Locations	Classroom Building 300	
Constructed/ Renovated	2003	
Building Size	3350 SF	
Number of Stories	1	
<i>System</i>	<i>Description</i>	<i>Condition</i>
Structure	Conventional wood-framed structure on concreteslab	Good
Façade	Stucco with aluminum-framed windows	Fair
Roof	Primary: Gable construction with metal finish	Good
Interiors	Walls: Painted gypsum board Floors: Carpet, VCT Ceilings: Painted gypsum board, ACT	Good
Elevators	None	--
Plumbing	Copper supply, cast iron waste and vent No hot water	Good
HVAC	Individual package units, split systems Supplemental components: ductless split-systems	Fair
Fire Suppression	Fire extinguishers	Fair
Electrical	Source & Distribution: Main switchboard with copper wiring Interior Lighting: T-8 None	Good
Fire Alarm	Alarm panel, smoke detectors, alarms, strobes, pull stations, back-up emergency lights, and exit signs	Fair
Equipment/Special	None	--

Key Issues & Findings	None

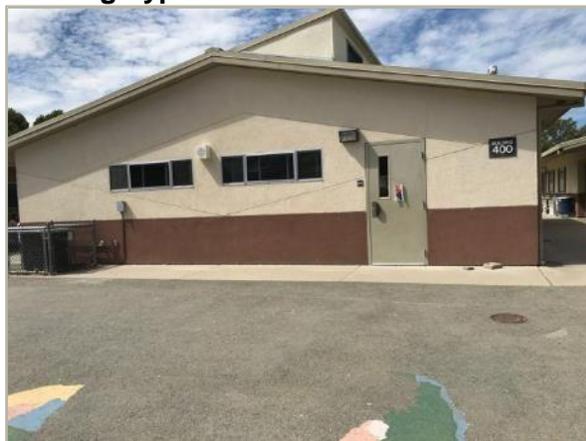
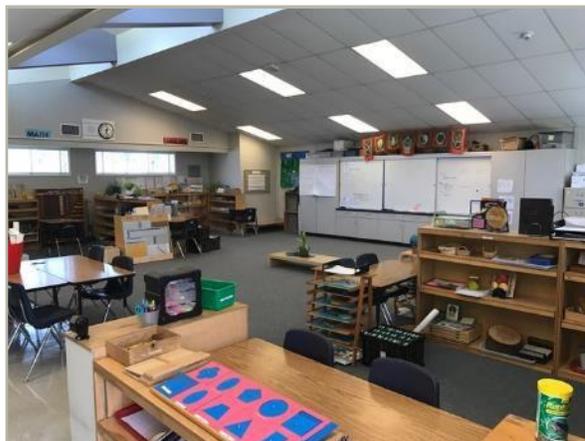
Building Type 4 Information		
Building Locations	Classroom Building 400	
Constructed/ Renovated	2014	
Building Size	1800 SF	
Number of Stories	1	
<i>System</i>	<i>Description</i>	<i>Condition</i>
Structure	Conventional wood-framed structure on concreteslab	Good
Façade	Stucco with aluminum-framed windows	Fair
Roof	Primary: Gable construction with metal finish	Good
Interiors	Walls: Painted gypsum board Floors: Carpet, VCT Ceilings: Painted gypsum board, ACT	Good
Elevators	None	--
Plumbing	Copper supply, cast iron waste and vent No hot water	Good
HVAC	Individual package /split-system Supplemental components: ductless split-systems	Fair
Fire Suppression	Fire extinguishers	Fair
Electrical	Source & Distribution: Main switchboard with copper wiring Interior Lighting: T-8 None	Good
Fire Alarm	Alarm panel, smoke detectors, alarms, strobes, pull stations, back-up emergency lights, and exit signs	Fair
Equipment/Special	None	--

Key Issues & Findings	None

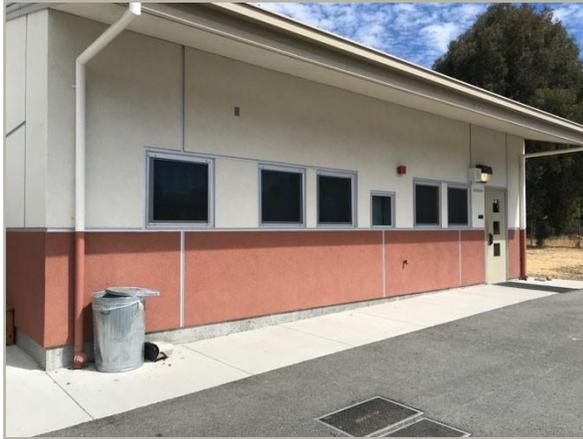
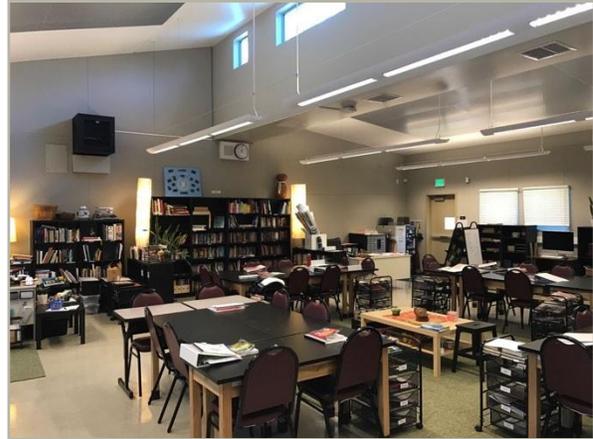
Building Type 5 Information		
Building Locations	Classroom Building 700	
Constructed/ Renovated	2014	
Building Size	1800 SF	
Number of Stories	1	
<i>System</i>	<i>Description</i>	<i>Condition</i>
Structure	Conventional wood-framed structure on concreteslab	Good
Façade	Stucco with aluminum-framed windows	Fair
Roof	Primary: Gable construction with metal finish	Good
Interiors	Walls: Painted gypsum board Floors: Carpet, VCT Ceilings: Painted gypsum board, ACT	Good
Elevators	None	--
Plumbing	Copper supply, cast iron waste and vent No hot water	Good
HVAC	Individual package units, split systems Supplemental components: ductless split-systems	Fair
Fire Suppression	Fire extinguishers	Fair
Electrical	Source & Distribution: Main switchboard with copper wiring Interior Lighting: T-8 Emergency: None	Good
Fire Alarm	Alarm panel, smoke detectors, alarms, strobes, pull stations, back-up emergency lights, and exit signs	Fair

Equipment/Special	None	--
Key Issues & Findings	None

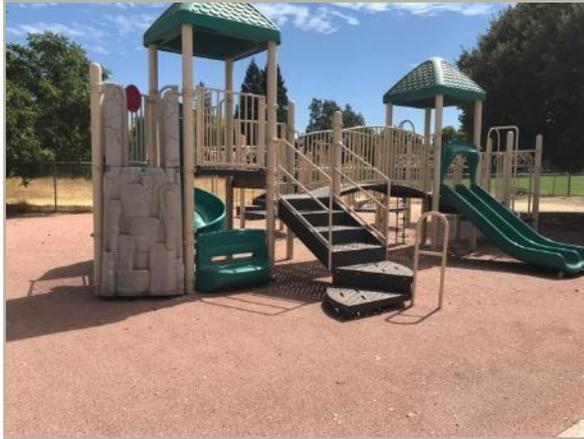
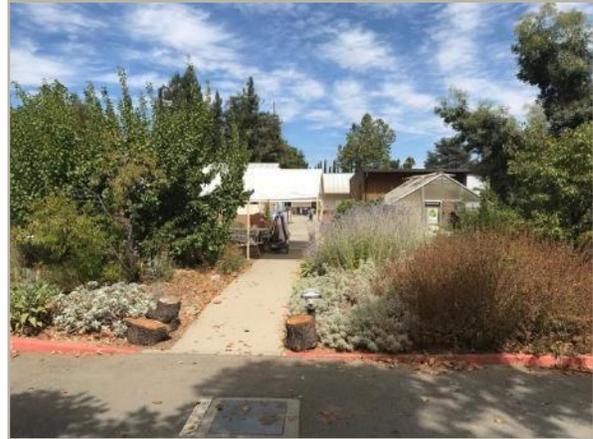
Site Summary Information

Site Information		
Lot Size	3.5 acres (estimated)	
Parking Spaces	38 total spaces all in open lots; three of which are accessible	
<i>System</i>	<i>Description</i>	<i>Condition</i>
Pavement/Flatwork	Asphalt lots with areas of concrete and concrete sidewalks, curbs, ramps, and stairs	Good
Site Development	Property entrance signage, chain link fencing Playgrounds and sports courts Limited park benches, picnic tables, trash receptacles	Fair
Landscaping & Topography	Limited landscaping features Irrigation not present Low to moderate site slopes throughout	Fair
Draining Systems and Erosion Control	Surface flow, inlets, underground piping, municipal system	Good
Utilities	Municipal water and sewer Local utility-provided electric	Good
Site Lighting	Building-mounted: metal halide	Fair
Ancillary Structures	Metal carports, four pre-fabricated storage sheds, one greenhouse	Fair
Key Issues & Findings	Lack of irrigation has led to areas of barren landscaping.
