Clayton Valley High School

Property Executive Summary

Clayton Valley High School Summary of Findings

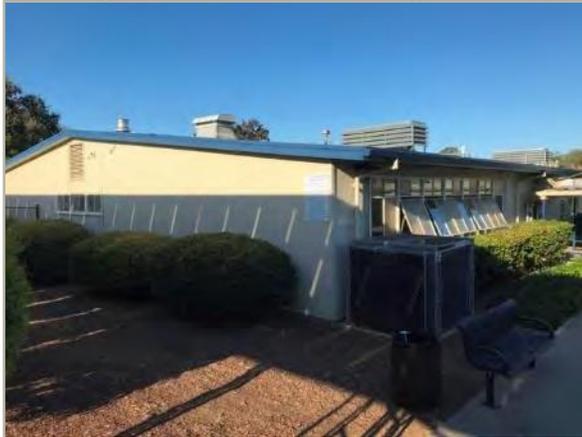
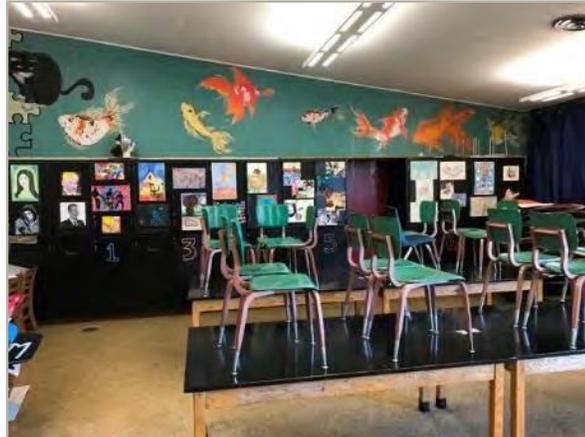
Building Main Office, A-F Wings, Library Information

Fire Alarm	Alarm panel, smoke detectors, alarms, strobes, pull stations, and exit signs	Fair
Equipment/Special	None	--
Key Issues & Findings	Stucco wall failure at S 1-4 building.

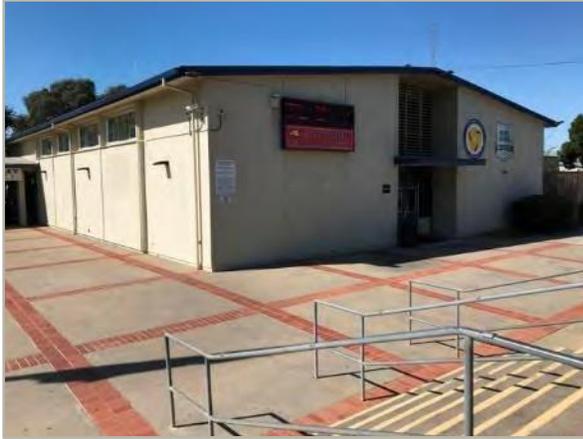
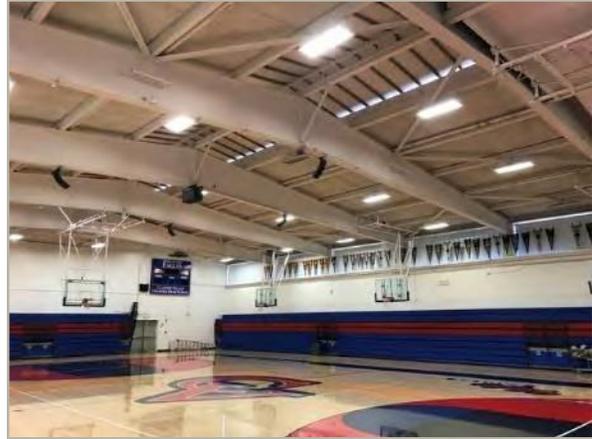
Building M-U, Gym, Locker Room, Music, Boiler Information

Fire Suppression	Hydrants, fire extinguishers	Fair
Electrical	Source & Distribution: Main switchboard with copper wiring Interior Lighting: T-8, CFL Emergency: None	Fair
Fire Alarm	Alarm panel, smoke detectors, alarms, strobes, pull stations, and exit signs	Fair
Equipment/Special	Commercial kitchen equipment	Fair
Key Issues & Findings	One dual convection oven has failed

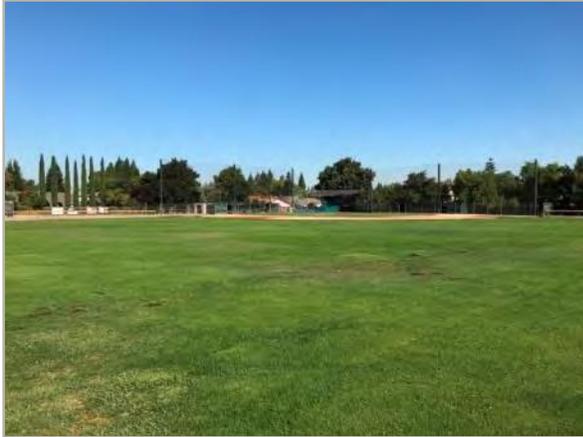
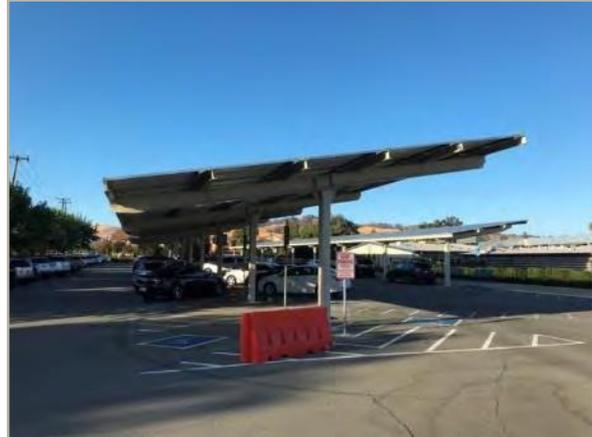
Site Summary Information

Key Issues & Findings	Alligator cracking in parking lots, synthetic turf at football field is worn
