Glenbrook MS (Rocketship Public School)

OVERVIEW

Property Executive Summary

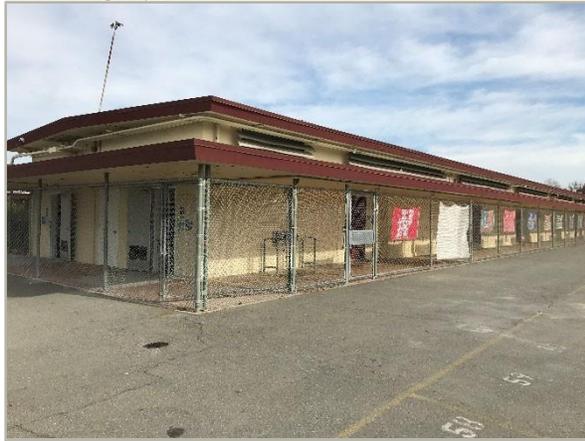
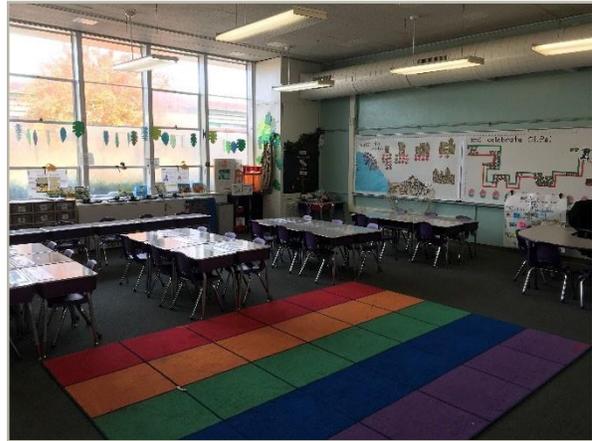
Building Type 1 Information		
Building Locations	Office, Library, Classroom Building 1, 2,3,4, 5, 6, 7, 8 and Restroom.	
Constructed/ Renovated	1955 / 2007	
Total Area	40,294 SF	
Number of Stories	1	
<i>System</i>	<i>Description</i>	<i>Condition</i>
Structure	Conventional wood-framed structure on concrete slabs	Fair
Façade	Stucco with aluminum-framed windows	Fair
Roof	Primary: Flat construction with modified bituminous finish	Fair
Interiors	Walls: Painted gypsum board, vinyl, and ceramic tile Floors: Carpet, VCT, ceramic tile, and wood strips Ceilings: Painted gypsum board, ACT, and adhered tile	Fair
Elevators	None	--
Plumbing	Copper supply, cast iron waste and vent No hot water	Fair
HVAC	Package units Supplemental components: ductless split systems	Fair
Fire Suppression	Wet-pipe sprinkler system; hydrants, and fire extinguishers	Fair
Electrical	Source & Distribution: Main switchboard Interior Lighting: T-8 and CFL Emergency: none	Fair

Fire Alarm	Alarm panel, smoke detectors, alarms, strobes, pull stations, back-up emergency lights, and exit signs	Fair
Equipment/Special	None	--
Key Issues & Findings	Building lacks complete fire suppression coverage

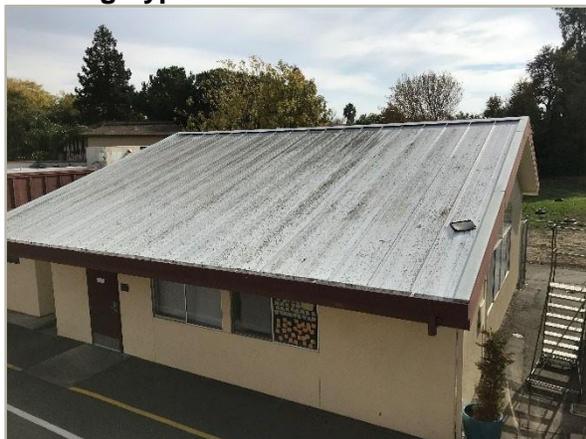
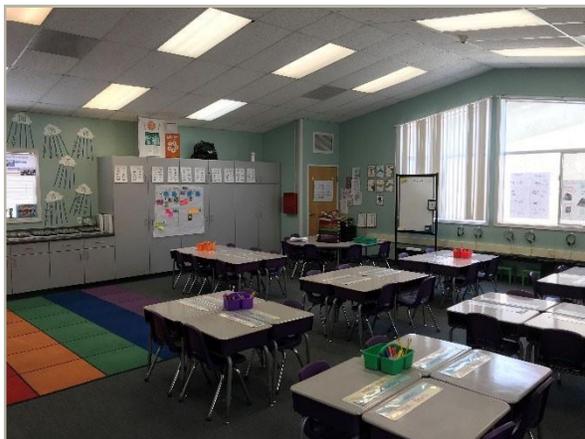
Building Type 2 Information		
Building Locations	Classroom Building 11,12, and 13	
Constructed/ Renovated	2000s	
Total Area	3,506 SF	
Number of Stories	1	
<i>System</i>	<i>Description</i>	<i>Condition</i>
Structure	Conventional wood-framed structure on concreteslabs	Fair
Façade	Stucco with aluminum-framed windows	Fair
Roof	Primary: Gable construction with metal finish	Fair
Interiors	Walls: Painted gypsum board and vinyl Floors: Carpet and VCT Ceilings: ACT	Fair
Elevators	None	--
Plumbing	Copper supply, cast iron waste and vent No hot water	Fair
HVAC	Split systems Supplemental components: Gas furnaces	Fair
Fire Suppression	Fire extinguishers	Fair
Electrical	Source & Distribution: panel with copper wiring Interior Lighting: T-8 Emergency: none	Fair
Fire Alarm	Alarm panel, smoke detectors, alarms, strobes, pull stations, back-up emergency lights, and exit signs	Fair
Equipment/Special	None	--
Key Issues & Findings	Building lacks complete fire suppression coverage

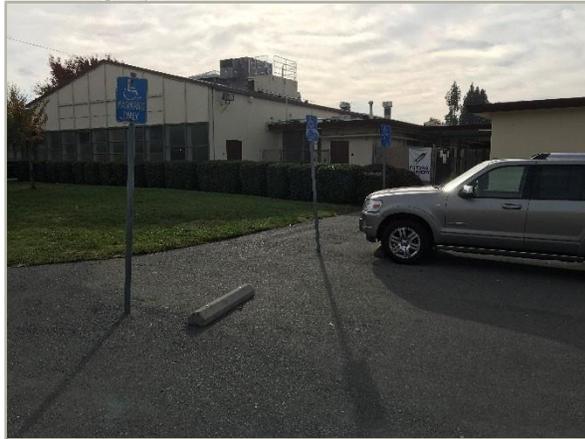
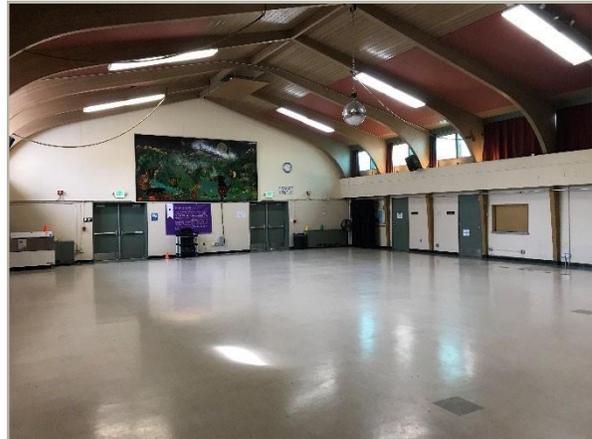
Building Type 3 Information		
Building Locations	Multi-Use	
Constructed/ Renovated	1955	
Building Size	7,197 SF	
Number of Stories	1	
<i>System</i>	<i>Description</i>	<i>Condition</i>
Structure	Heavy timber structure on concrete slab Conventional wood framing and wood-framed roofs	Fair
Façade	Stucco with aluminum-framed windows	Fair
Roof	Primary: Gable construction with modified bituminous finish Secondary: Flat construction with modified bituminous finish	Fair
Interiors	Walls: Painted gypsum board Floors: Carpet, VCT, and ceramic tile Ceilings: Painted gypsum board, adhered tile, and wood strip	Fair
Elevators	Wheelchair lifts	Fair
Plumbing	Copper supply, cast iron waste and vent Gas-fired water heaters	Fair
HVAC	Package units Supplemental components: ductless splitsystems	Fair
Fire Suppression	Wet-pipe sprinkler system; fire extinguishers, and kitchen hood system	Fair

Building Type 3 Information		
Electrical	Source & Distribution: Main switchboard Interior Lighting: T-8 Emergency: none	Fair
Fire Alarm	Alarm panel, smoke detectors, alarms, strobes, pull stations, back-up emergency lights, and exit signs	Fair
Equipment/Special	Commercial kitchen equipment	Fair
Key Issues & Findings	Building and kitchen lacks fire suppression

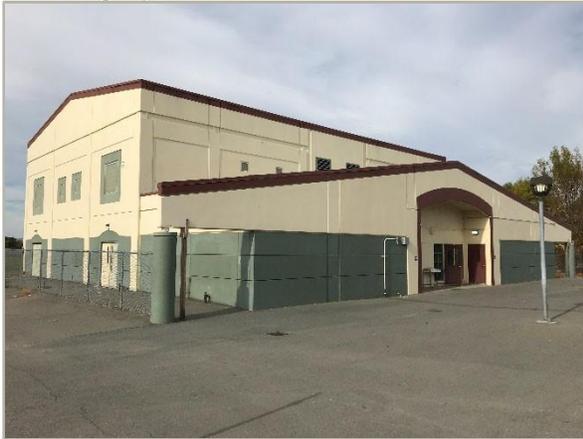
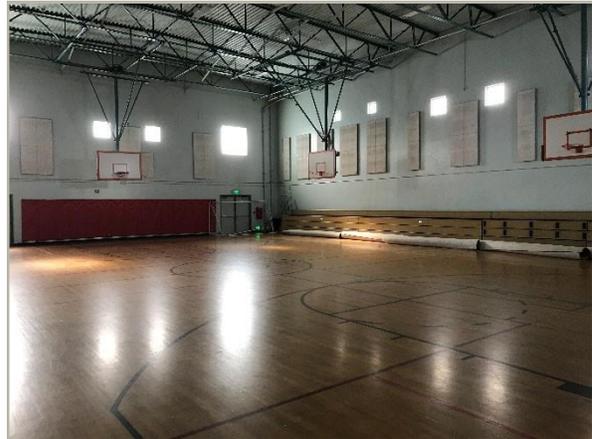
Building Type 4 Information		
Building Locations	Gymnasium	
Constructed/ Renovated	1993	
Building Size	7,253 SF	
Number of Stories	1	
<i>System</i>	<i>Description</i>	<i>Condition</i>
Structure	Steel frame structure on concrete slab Steel frame with bar joists topped metal decks	Fair
Façade	Stucco with glass block windows	Fair
Roof	Primary: Flat construction with modified bituminous finish	Fair
Interiors	Walls: Painted gypsum board Floors: Carpet, VCT, and ceramic tile Ceilings: Painted gypsum board, adhered tile, and exposed metal decks	Fair
Elevators	None	--
Plumbing	Copper supply, cast iron waste and vent No hot water	Fair
HVAC	Package units Supplemental components: none	Fair
Fire Suppression	Fire extinguishers	Fair
Electrical	Source & Distribution: Main switchboard Interior Lighting: T-8 Emergency: none	Fair
Fire Alarm	Alarm panel, smoke detectors, alarms, strobes, pull stations, back-up emergency lights, and exit signs	Fair

Equipment/Special	None	--
Key Issues & Findings	Building lacks fire suppression

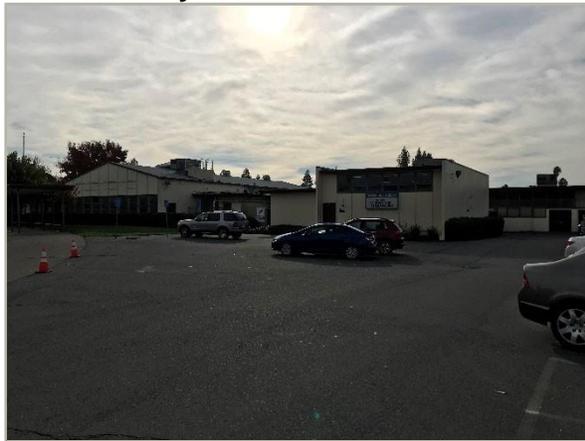
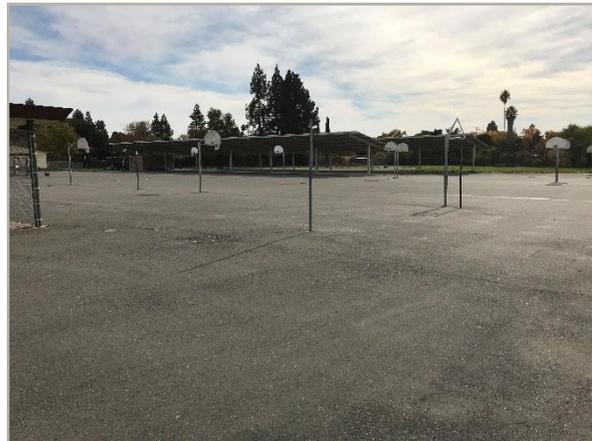
Site Summary Information

Site Information		
Lot Size	15.5 acres	
Parking Spaces	79 total spaces all in open lots; Two accessible (included in total above), one van-accessible	
<i>System</i>	<i>Description</i>	<i>Condition</i>
Pavement/Flatwork	Asphalt lots with areas of concrete and concrete sidewalks, curbs, ramps, and stairs	Fair
Site Development	Property entrance signage, chain link fencing, chain link dumpster enclosures Playgrounds and sports courts with, fencing, and site lights Limited park benches and trash receptacles	Fair
Landscaping & Topography	Limited landscaping features Irrigation present No retaining walls Low to moderate site slopes throughout	Fair
Draining Systems and Erosion Control	Surface flow	Fair
Utilities	Municipal water and sewer Local utility-provided electric and natural gas	Fair
Site Lighting	Pole-mounted: CFL Building-mounted: LED	Fair
Ancillary Structures	Solar panel steel shade structure	Fair

Key Issues & Findings	Significant sidewalk trip hazards, inadequate site lighting
