Shadelands Preschool

Property Executive Summary

Summary of Findings

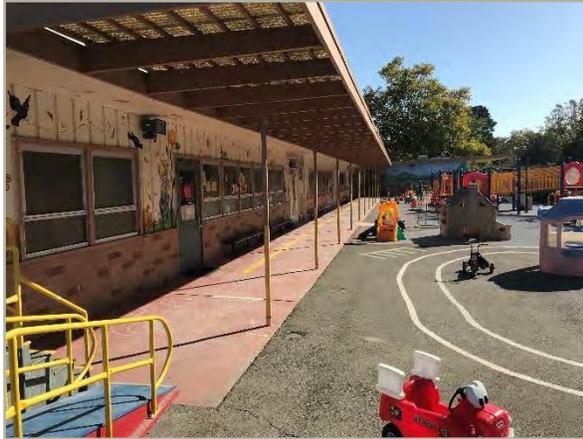
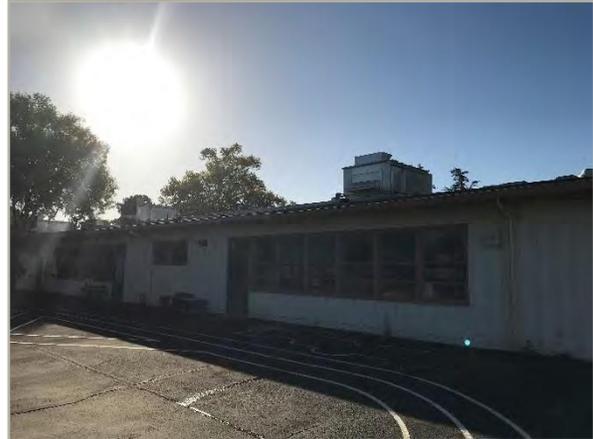
Building 1 Information		
Building Locations	Main Building	
Constructed/ Renovated	1956 / 2013	
Building Size	15,268 SF	
Number of Stories	1	
<i>System</i>	<i>Description</i>	<i>Condition</i>
Structure	Conventional wood-framed structure on concrete slab	Good
Façade	Wood siding and brick with aluminum-framed windows	Fair
Roof	Primary: Flat construction with built-up finish	Fair
Interiors	Walls: Painted gypsum board Floors: VCT Ceilings: Painted gypsum board, ACT	Fair
Elevators	None	--
Plumbing	Copper supply, cast iron waste and vent Gas-fired water heaters	Fair
HVAC	Fan coils fed by individual heat pump split-system Supplemental components: ductless split-system	Fair
Fire Suppression	Fire extinguishers	Fair
Electrical	Source & Distribution: Main switchboard and panels with copper wiring Interior Lighting: T-8	Fair
Fire Alarm	Alarm panel, heat detectors, alarms, strobes, and exit signs	Fair
Equipment/Special	None	--

Key Issues & Findings	Damaged window panels, ACM flooring

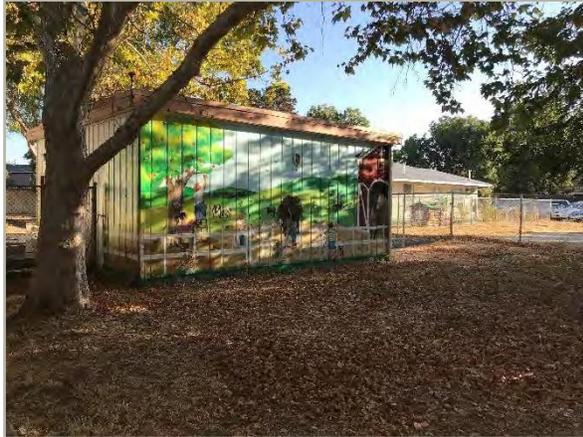
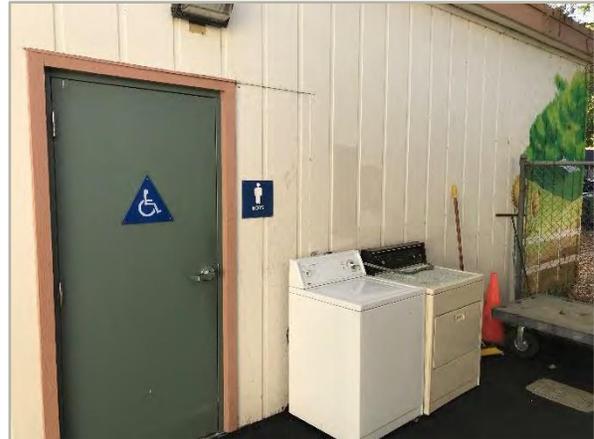
Building 2 Information		
Building Locations	Restroom Building	
Constructed/ Renovated	1956	
Building Size	650 SF	
Number of Stories	1	
<i>System</i>	<i>Description</i>	<i>Condition</i>
Structure	Conventional wood-framed structure on concrete slab	Good
Façade	Wood siding	Fair
Roof	Primary: Flat construction with built-up finish	Fair
Interiors	Walls: Wood paneling Floors: CT Ceilings: Painted gypsum board, plywood	Fair
Elevators	None	--
Plumbing	Copper supply, cast iron waste and vent No hot water	Fair
HVAC	Supplemental components: suspended gas unit heaters	Fair
Fire Suppression	None	--
Electrical	Source & Distribution: Fed from main building with copper wiring Interior Lighting: T-8	Fair
Fire Alarm	Heat detectors, alarms, strobes	Fair
Equipment/Special	None	--
Key Issues & Findings	None

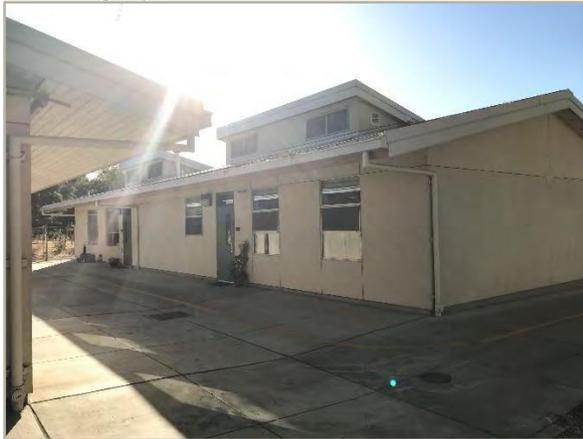
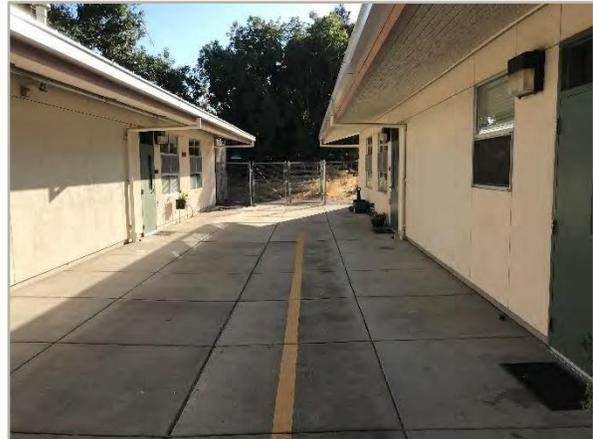
Portable Building Information		
Building Locations	Portable Classroom Building 1, 2	
Constructed/ Renovated	2007	
Total Area	6,328 SF	
Number of Stories	1	
<i>System</i>	<i>Description</i>	<i>Condition</i>
Structure	Conventional wood-framed structure on concrete slab	Good
Façade	EIFS with aluminum-framed windows	Fair
Roof	Primary: Gable construction with metal finish	Fair
Interiors	Walls: Ceramic tile, fabric acoustic panels Floors: VCT, ceramic tile Ceilings: Painted gypsum board, ACT	Fair
Elevators	None	--
Plumbing	Copper supply, cast iron waste and vent Electric water heaters	Fair
HVAC	Individual split-systems	Fair
Fire Suppression	Fire extinguishers	Fair
Electrical	Source & Distribution: Main panel with copper wiring Interior Lighting: T-8	Fair
Fire Alarm	Alarm panel, smoke detectors, alarms, strobes, pull stations, back-up emergency lights, and exit signs	Fair
Equipment/Special	None	--
Key Issues & Findings	None

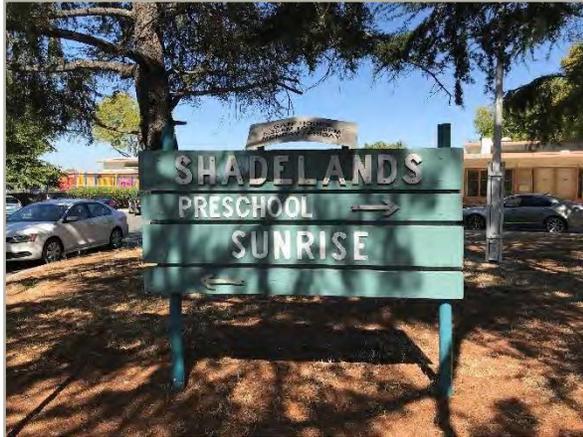
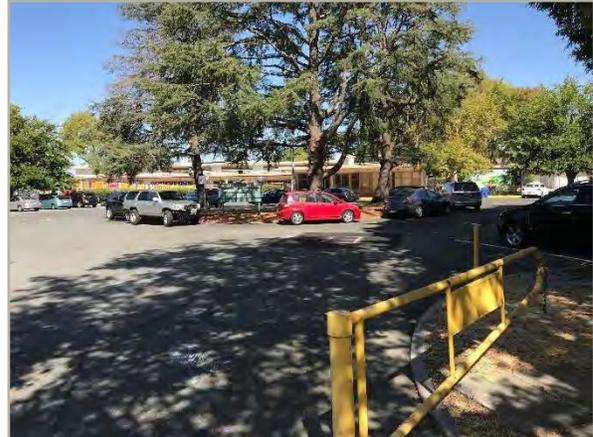
Site Information		
Lot Size	3.00 acres (estimated)	
Parking Spaces	66 total spaces all in open lots; 3 of which are accessible 3 accessible (included in total above), 2 van-accessible	
<i>System</i>	<i>Description</i>	<i>Condition</i>
Pavement/Flatwork	Asphalt lots with areas of concrete and concrete sidewalks, curbs, and ramps	Fair
Site Development	Building-mounted and property entrance signage, chain link fencing Playgrounds	Fair
Landscaping & Topography	No significant landscaping features Irrigation not present Low to moderate site slopes throughout	Fair
Draining Systems and Erosion Control	Municipal system	Fair
Utilities	Municipal water and sewer Local utility-provided electric and natural gas	Fair
Site Lighting	Building-mounted: LED, metal halide	Fair
Ancillary Structures	Wood-framed storage sheds	Fair
Key Issues & Findings	Significant sidewalk cracking
