Olympic Continuation High School
 EXISTING SITE INFORMATION

Property Executive Summary

Property Condition

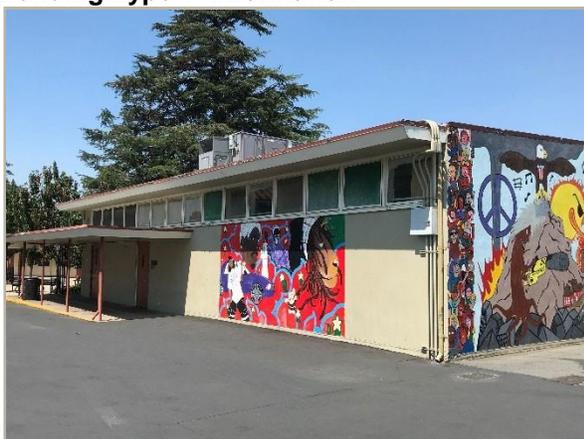
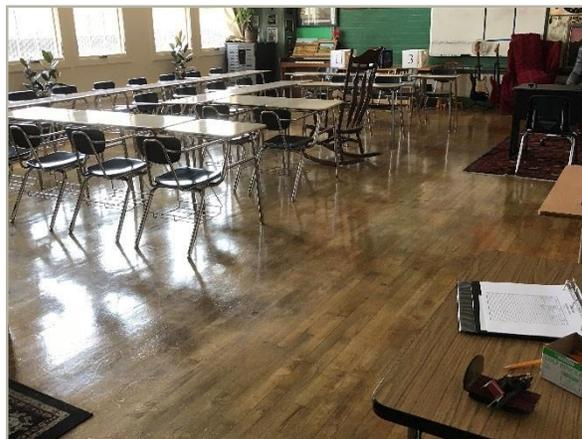
Building Type 1 Information

Fire Alarm	Alarm panel, smoke detectors, alarms, strobes, pull stations,	Fair
Equipment/Special	Commercial kitchen equipment	Fair
Key Issues & Findings	Antiquated HVAC components and infrastructure, building lacks fire suppression.

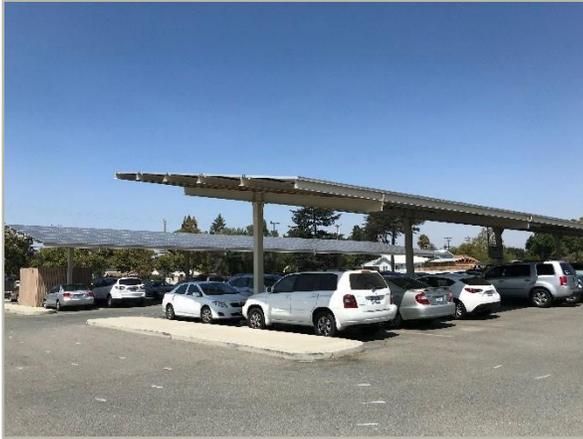
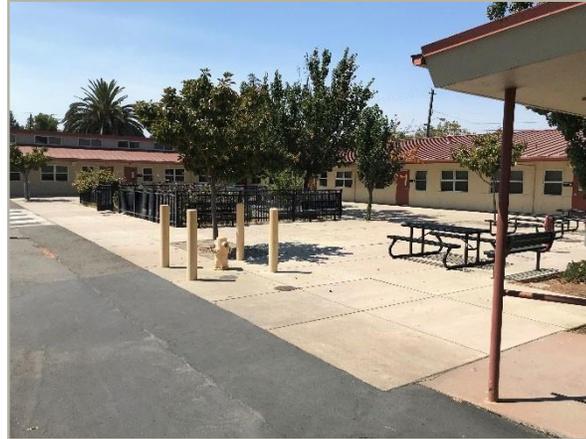
Site Summary Information

Key Issues & Findings	Isolated area of alligator cracking at parking lot
