FACILITIES MASTER PLAN 2022
PLEASANTON UNIFIED SCHOOL DISTRICT

SITE FUNCTIONALITY ASSESSMENT
HORIZON EARLY EDUCATION

FACILITY CONDITION ASSESSMENT

Horizon Preschool
245 Abbie Street
Pleasanton, California 94566

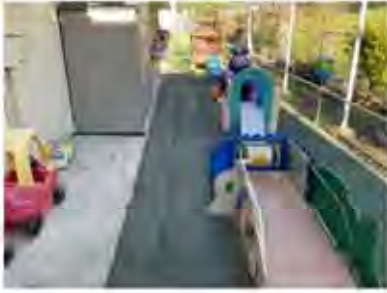
The Horizon building has an adjoining toddler's playground that is in need to modernization, the turf floor is extremely aged beyond its recommended useful life; the turf also has a lot of cracks, bumps and potholes that are creating trip hazards for toddlers, staff, and the public. The shade structure over toddlers playground is also aged beyond its recommended useful life and it's in need of extreme makeover.

Playfield Surfaces in Poor condition.

Artificial Play Turf
Horizon Preschool Site

Surface has cracking and potholes and poses trip hazards. Recommend resurfacing and modernizing. - AssetCALC ID: 3470792

Uniformat Code: G2050
Recommendation: **Replace in 2022**

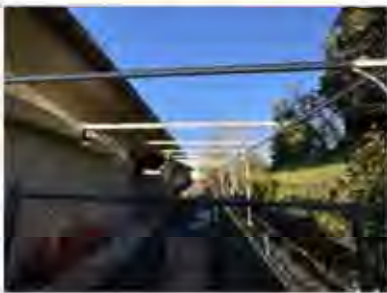
Shade Structure in Poor condition.

Wood or Metal-Framed, Standard
Horizon Preschool Site

Playground shade structure is falling apart (detaching from wall) and it's unsafe to be under it. Shade material has aged beyond recommended useful life and it's tearing apart in various areas. - AssetCALC ID: 3470821

Uniformat Code: F1020
Recommendation: **Replace in 2022**
