**FACILITIES MASTER PLAN 2022**  
PLEASANTON UNIFIED SCHOOL DISTRICT

SITE FUNCTIONALITY ASSESSMENT

# ALISAL ELEMENTARY SCHOOL

# FACILITY CONDITION ASSESSMENT

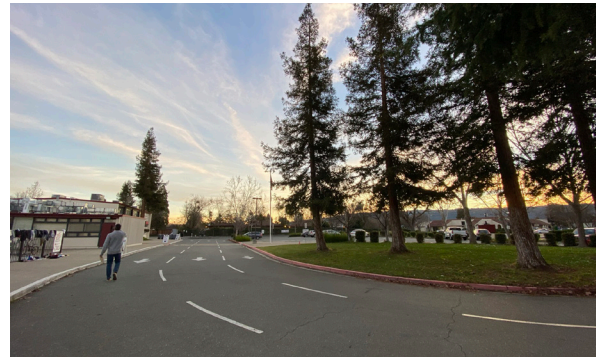
Drop-Off Lane / Parking

The parking lot at the front of the campus is limited for visitor and volunteers. Additional staff parking is desired in a separate location in order alleviate parking for visitors and volunteers at the front.

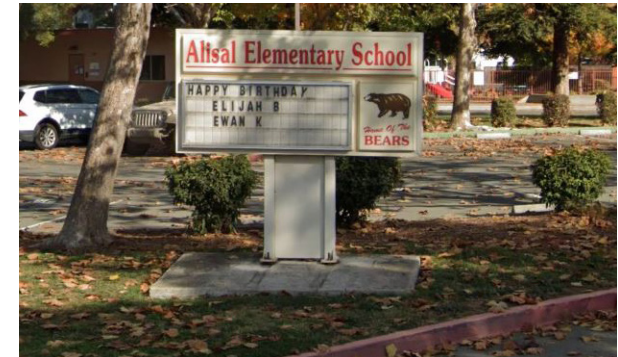
Site Identification and Announcements

The principal notes that drop-off/pick-up signage is damaged and not visible to drivers and would also like two (2) new, functional electronic marquees.

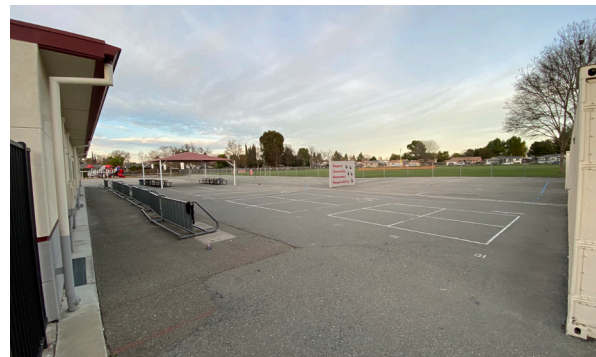
Hardcourts

Shade is desired at the hardcourts to accommodate PE classes during hot and rainy days.

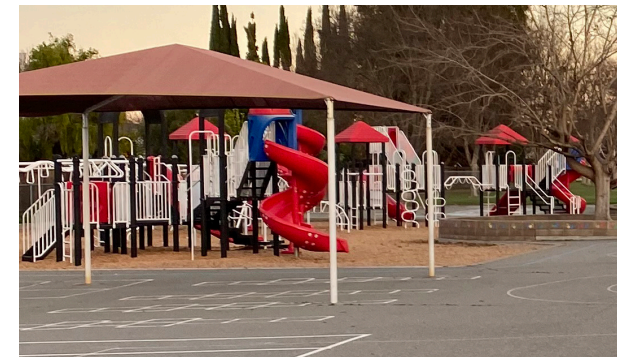
Play Structure

The principal would like the play equipment to be replaced with new, all-inclusive equipment and groundcover.

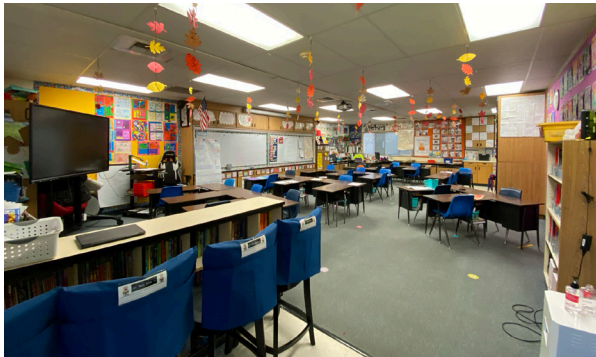
Typical Classroom

Many classrooms are at-grade, permanent, modular structures. Classroom interiors have built-in teaching walls, areas of casework, and a sink. Backpack hooks are available along the classroom exterior wall.

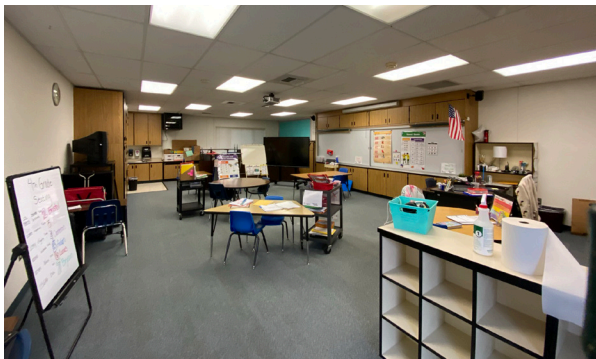
Student Services / Counseling (RISS)

Intervention and RISS (Reading Intervention Specialist) typically share a space but are currently utilizing separate classrooms due to classroom availability.

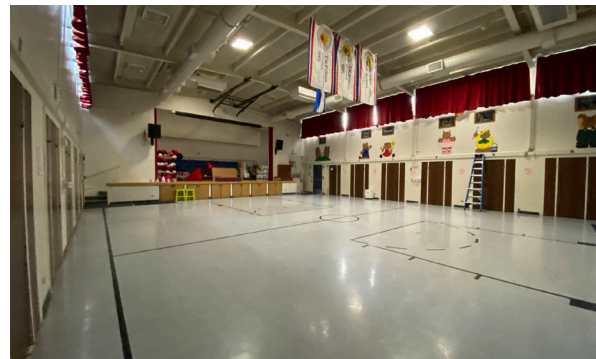
Multi-Purpose Room

The MPR is used mainly for PE. The principal notes it is too small to comfortably accommodate the whole student body.

The MPR has in-wall tables. Additional tables are stored at one end of the assembly space. The MPR has a stage with a wheelchair lift and contains one (1) basketball hoop and backstop. Presentation technology includes a wall-mounted projector, pull-down screen, and voice amplification/speaker system.

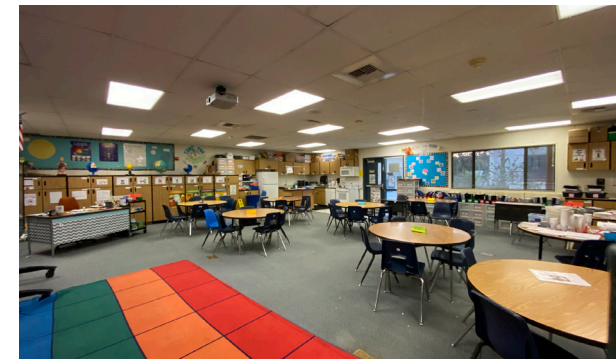
Electives Room (Exploration Lab)

The Exploration Lab is larger than a typical classroom and has a teaching wall, perimeter casework, and a kitchenette with oven, stove, microwave, two (2) refrigerators, and a dishwasher.

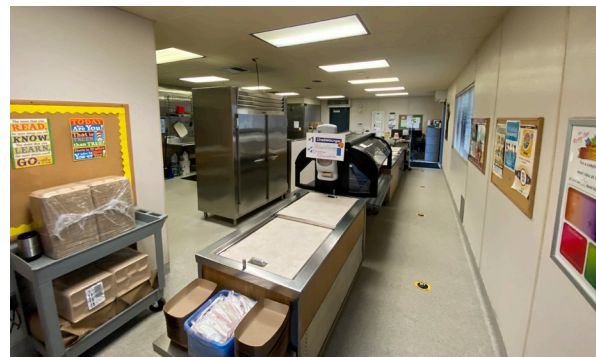
Food Service: Student Serving Line

The kitchen and student serving area is separate from the MPR/cafeteria. The two functions are within the same room, separated by a pony wall. Students have clear circulation from the entry at one end of the serving line to the exit at the other end.

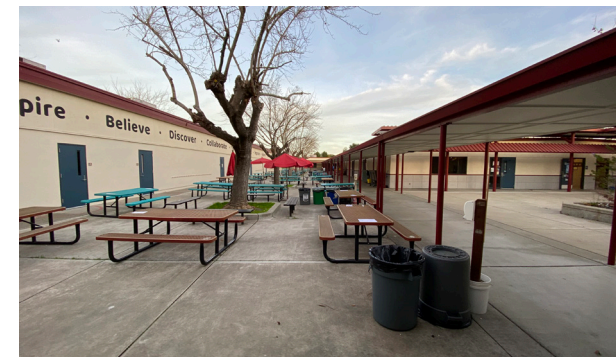
Student Dining Area

Students dine at tables outdoors. Trees and a few umbrellas provide little protection from sun and rain.
