FACILITIES MASTER PLAN 2022
PLEASANTON UNIFIED SCHOOL DISTRICT

SITE FUNCTIONALITY ASSESSMENT

DONLON ELEMENTARY SCHOOL

FACILITY CONDITION ASSESSMENT

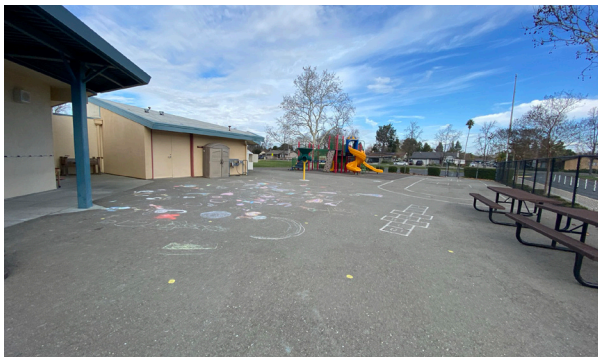
Kindergarten Play Yard

The principal notes the Kindergarten play yard as being too small for the current population. The principal also identified an area of poor drainage within the Kindergarten play yard.

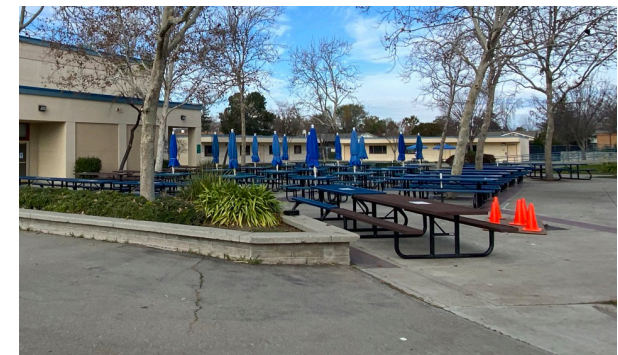
Student Dining Area

Students dine at tables outdoors. Trees and umbrellas provide pleasant protection from sun but provide no protection for rain and trees create a bird nuisance.

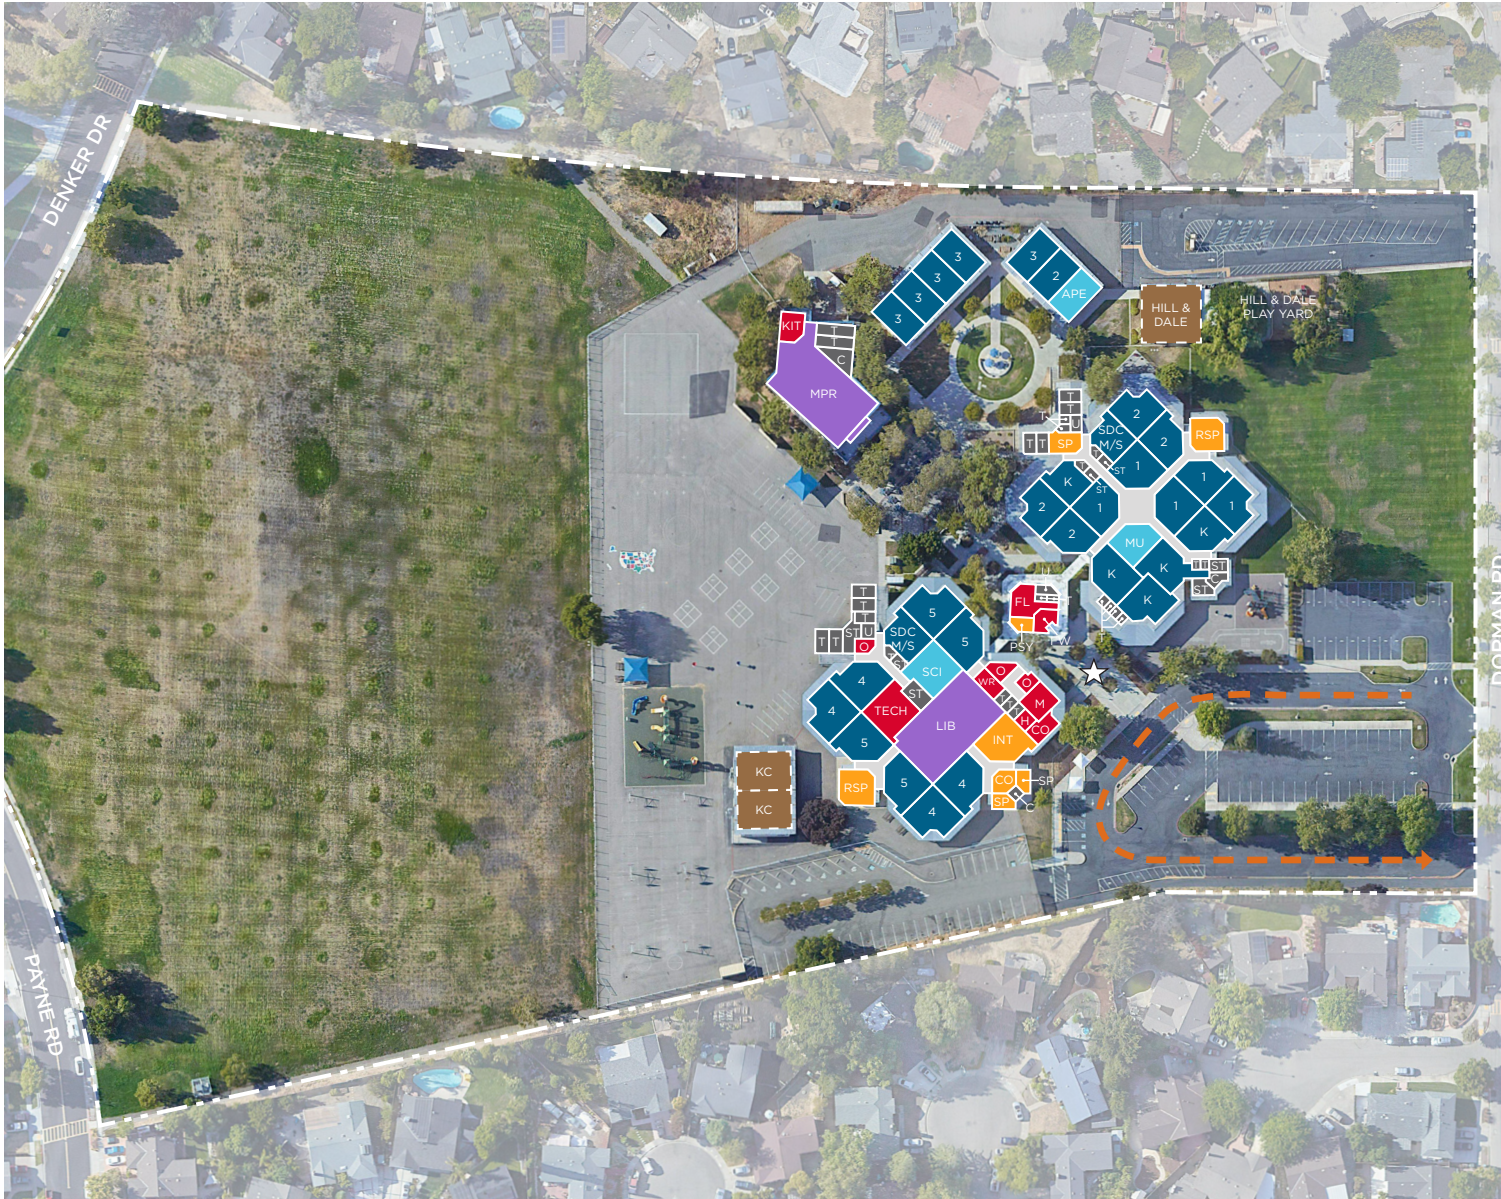
Existing Site Plan | DONLON ELEMENTARY SCHOOL

Teaching Stations:	
PS (Preschool)	0
TK (Transitional Kinder)	0
Kindergarten	5
Grades 1-3	15
Grades 4-5	8
SDC mild/mod	0
SDC mod/sev	2
Sub-Total:	30
Additional Spaces:	
Exploration Lab / Music / Art	3
After School Care	2
Total:	35

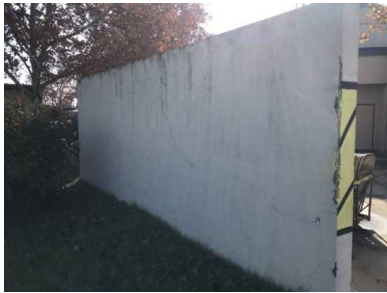
Exterior Walls in Poor condition.

Stucco
 Multipurpose Donlon Elementary School
 Building exterior-MPR

Wall has been hit by vehicles multiple times - AssetCALC ID: 3513247

Uniformat Code: B2010
 Recommendation: **Replace in 2022**

Cost Estimate: \$9,400

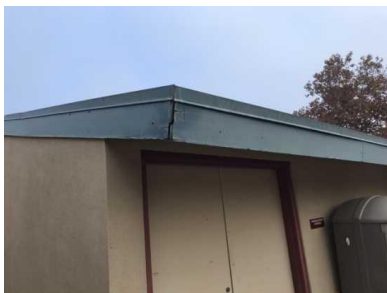
Exterior Walls in Poor condition.

Wood Siding
 A, B, and C Buildings Donlon Elementary
 School Building exterior-B Building

Dry-rotting throughout - AssetCALC ID: 3512891

Uniformat Code: B2010
 Recommendation: **Replace in 2022**

Cost Estimate: \$4,100

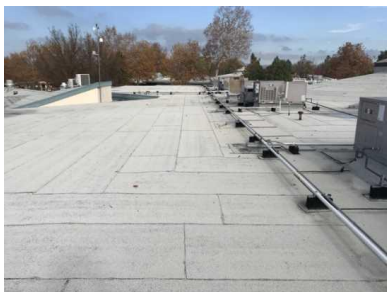
Roofing in Poor condition.

Modified Bitumen
 A, B, and C Buildings Donlon Elementary
 School Roof

The roof is aging. Leaks are present throughout the building. Wood fascia is dry-rotting. - AssetCALC ID: 3513188

Uniformat Code: B3010
 Recommendation: **Replace in 2023**

Cost Estimate: \$618,000

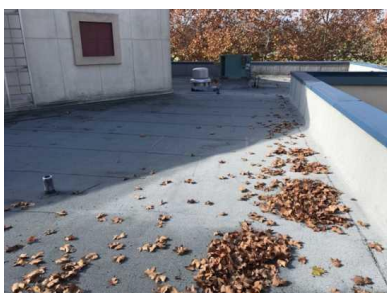
Roofing in Poor condition.

Modified Bitumen
 Multipurpose Donlon Elementary School Roof-
 MPR

Blisters throughout - AssetCALC ID: 3513235

Uniformat Code: B3010
 Recommendation: **Replace in 2023**

Cost Estimate: \$79,200

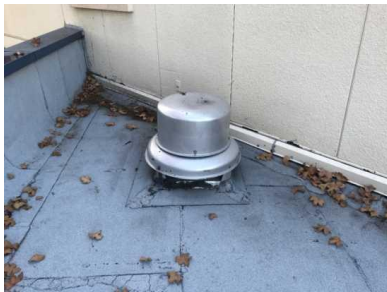
Exhaust Fan in Poor condition.

Centrifugal, 16" Damper
 Multipurpose Donlon Elementary School Roof-MPR

Loud, squeaking, significant vibration - AssetCALC ID: 3513212

Uniformat Code: D3060
 Recommendation: **Replace in 2022**

Cost Estimate: \$2,800

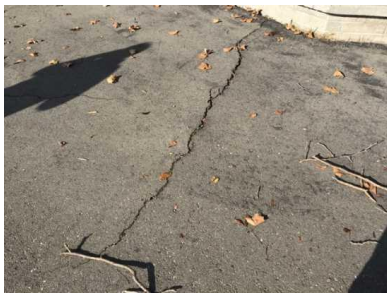
Parking Lots in Poor condition.

Pavement, Asphalt
 Site Donlon Elementary School Site

Large crack over 1/2" wide - AssetCALC ID: 3512899

Uniformat Code: G2020
 Recommendation: **Cut & Patch in 2022**

Cost Estimate: \$100

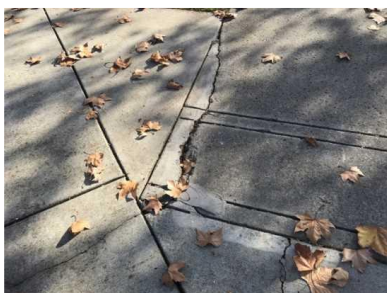
Parking Lots in Poor condition.

Pavement, Concrete
 Site Donlon Elementary School Site

Large cracks in concrete in front of MPR - AssetCALC ID: 3512854

Uniformat Code: G2020
 Recommendation: **Replace in 2022**

Cost Estimate: \$500

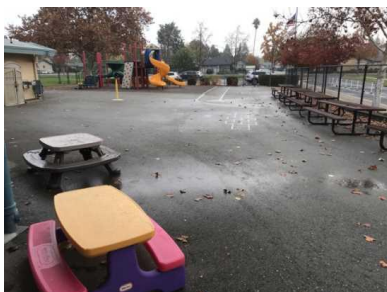
Parking Lots in Poor condition.

Pavement, Asphalt
 Site Donlon Elementary School Site

Large areas of longitudinal cracking with alligator cracking in spots. - AssetCALC ID: 3512822

Uniformat Code: G2020
 Recommendation: **Mill & Overlay in 2023**

Cost Estimate: \$517,400
