SITE FUNCTIONALITY ASSESSMENT

FAIRLANDS ELEMENTARY SCHOOL

FACILITY CONDITION ASSESSMENT

Fairlands Elementary School
4151 West Las Positas Boulevard
Pleasanton, California 94588

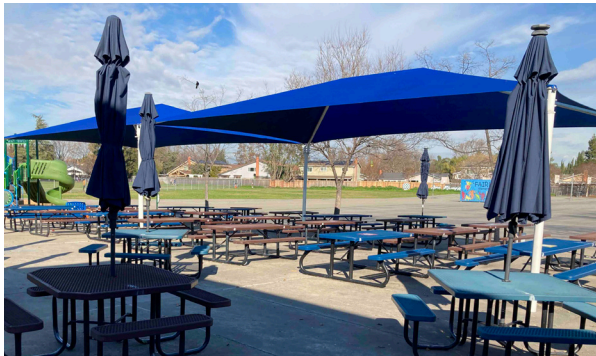
Shade Structure

Students dine at tables outdoors. The area is partially covered with shade structures. Expansion of the lunch shelter is desired so that all tables are covered.

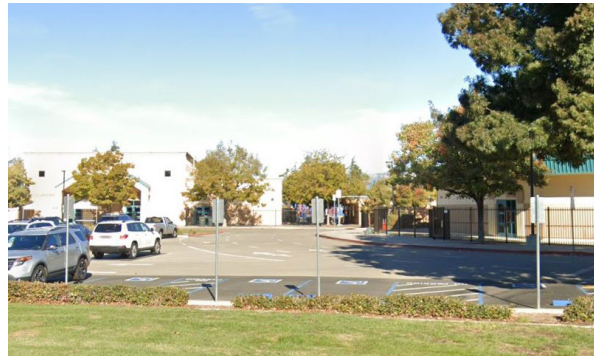
Drop-Off Lane / Parking

Some drop-off occurs along the street which creates conflict with bicyclists, parked cars, and pedestrian crossings. The main crosswalk is at W Las Positas Boulevard and Suffolk Way; this location is monitored by a crossing guard. The intersection of W Las Positas Boulevard and Montpelier Court is challenging to cars turning right or left to exit the campus drop-off lane. These concerns may be out of the scope of the master plan and should be studied further by the district and City of Pleasanton.

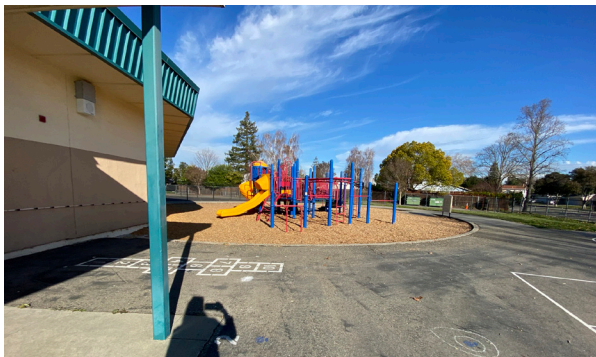
Kindergarten Play Yard

The upper/lower primary grade play structures have recently been replaced. It is reported that the Kindergarten play structure needs to be replaced.

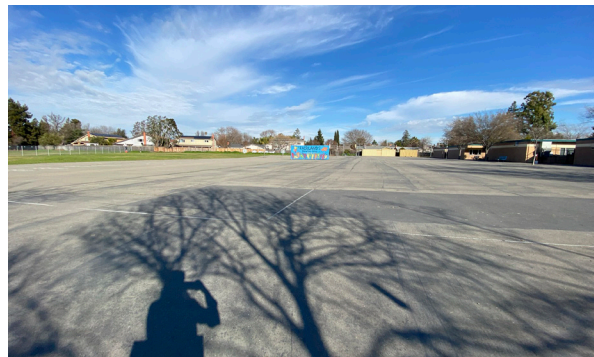
Hardcourts

Shade is desired at the hardcourts (for PE as previously noted) as is an additional ball wall.

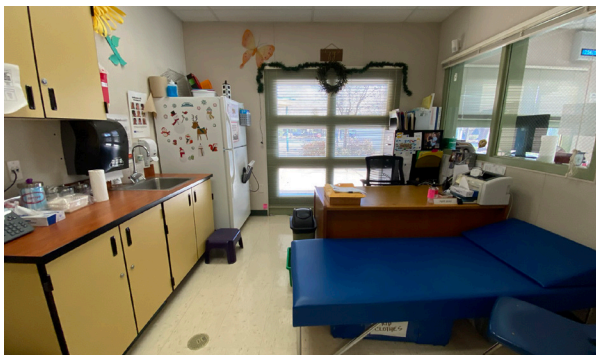
An exterior door to the Health Office is desired as well as a window into the Site Tech office.

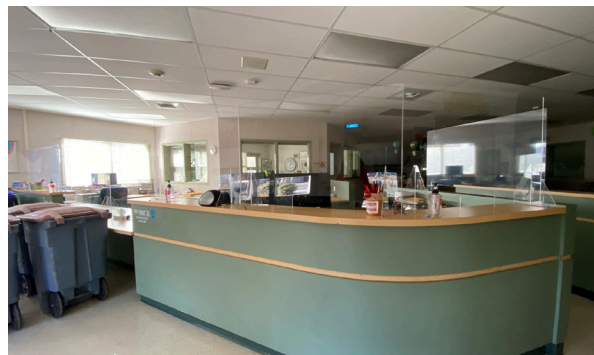
Administration Office

The Administration and front office are clearly identified and as the main point of entry. The principal notes that much of the open office and circulation area could be re-designed to

locate the mail room / work area up front and gain additional offices in the current work room location.

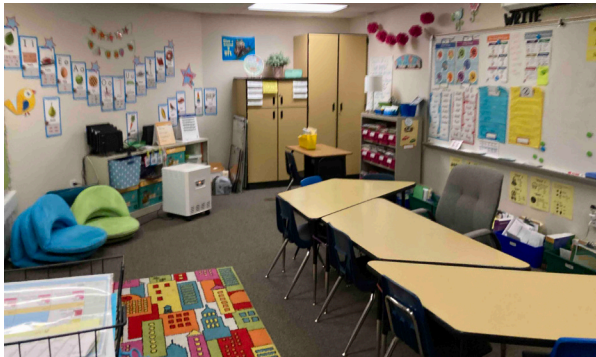
Student Services / Counseling

Spaces for Speech, Psychologist, Reading, Intervention, and RSP are centrally located near the front office, within the original building. Resources, offices, and conference spaces are shared; dedicated space is desired.

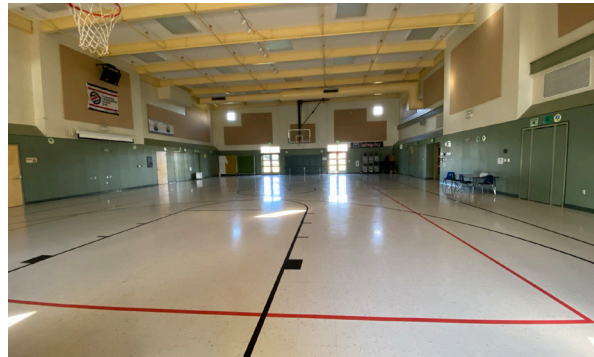
Multi-Purpose Room

The MPR has in-wall tables and two (2) retractable basketball hoops and backstops. Built-in presentation technology is limited to a pull-down screen and voice amplification/speaker system mounted to the side wall.

This site does not have a permanent stage. A temporary stage is stored in a room of the MPR building.

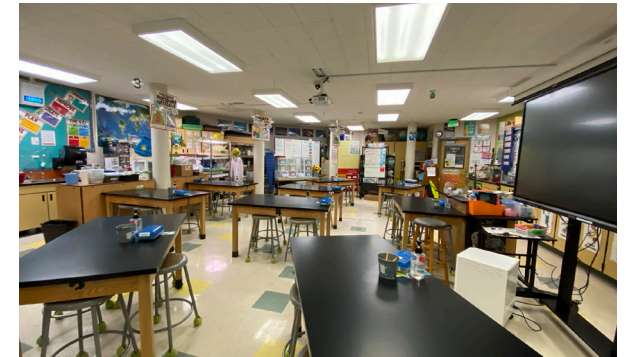
Exploration Room

The Science / Exploration Lab is located at the center of the upper primary classrooms. The room has a teaching wall, perimeter casework, and a kitchenette with oven, stove, microwave, refrigerator, and a dishwasher. Furniture within

this room is comprised of science-grade tables and stools. A center-mount projector and drop-down screen are present, as is a mobile LCD monitor.

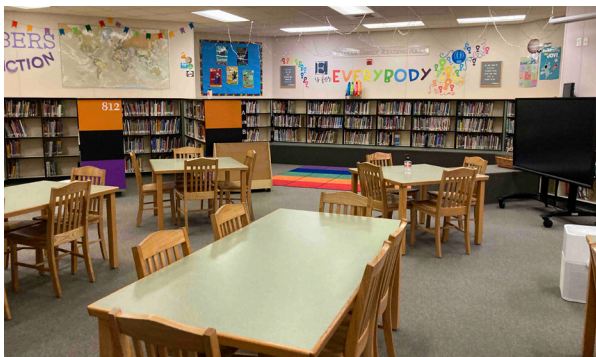
The Library is a spacious room within the center of the original building with low, permanent book stacks. It is furnished with sturdy, wood tables and chairs and some soft seating. Due to its location, the Library does not have any windows to provide natural light or views to the exterior. The Library has a mobile LCD monitor as well as a ceiling-mount projector and pull-down screen.

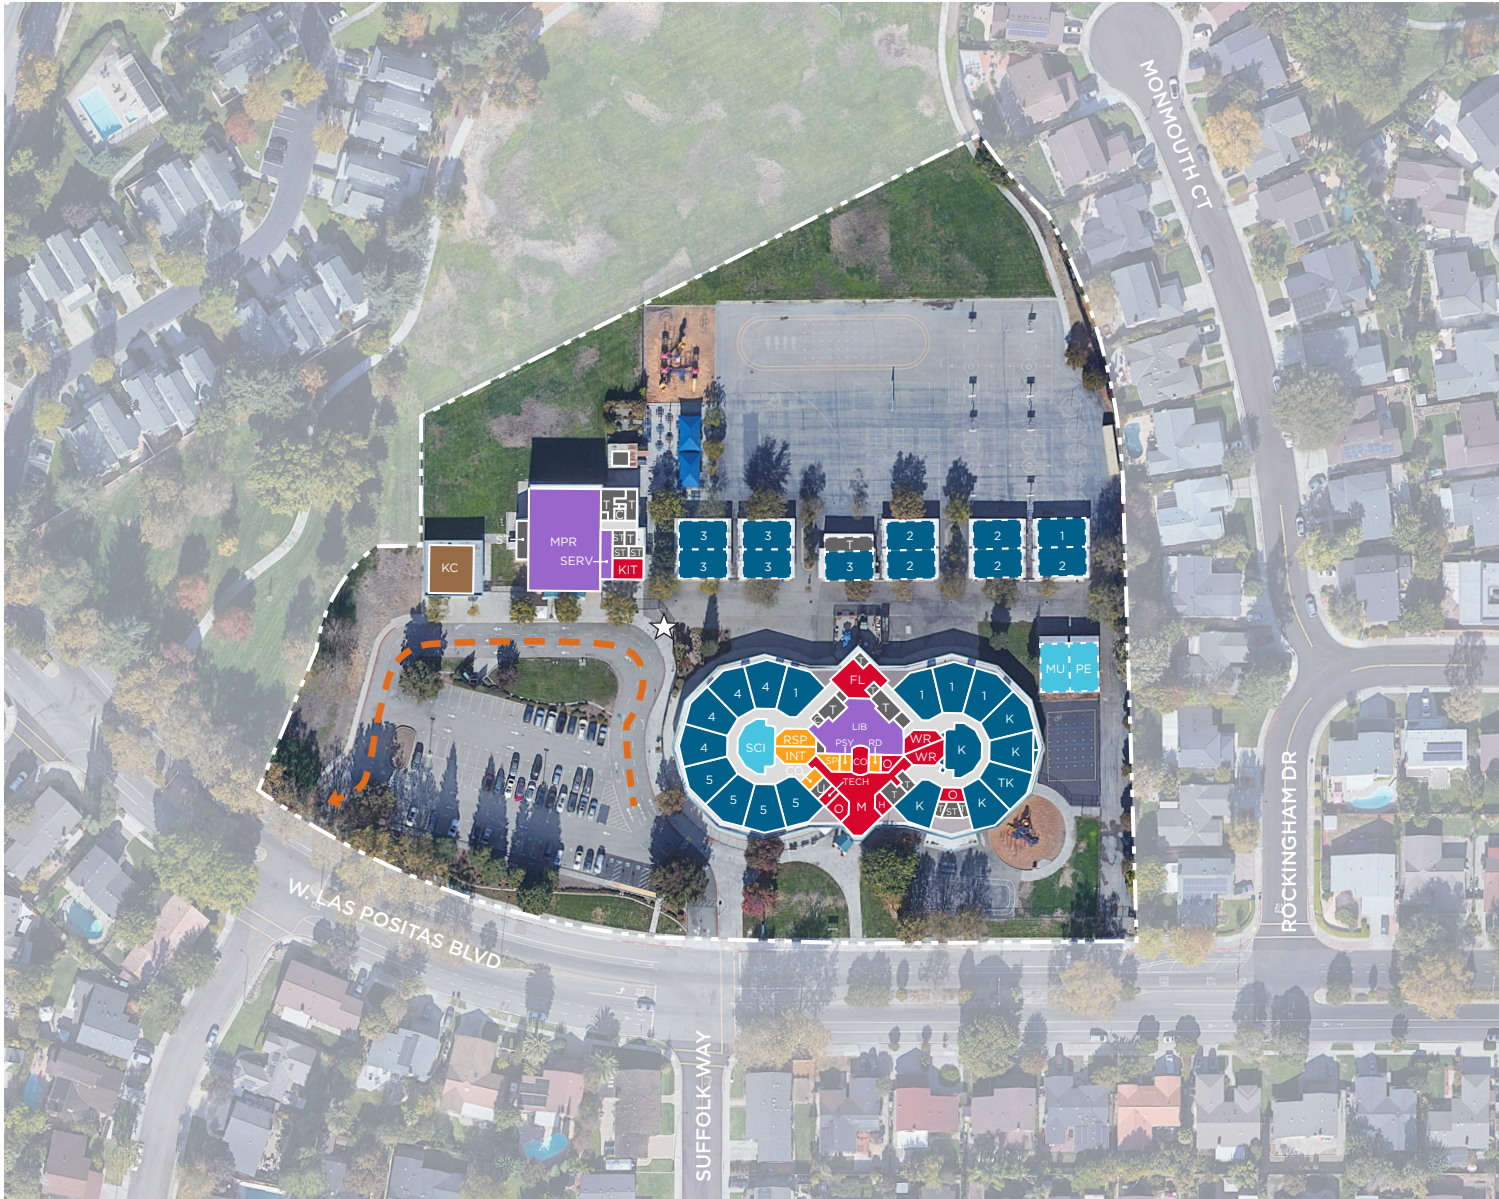
Existing Site Plan | FAIRLANDS ELEMENTARY SCHOOL

Classrooms

#	Indicates Grade Level
TK	Transitional Kindergarten
K	Kindergarten

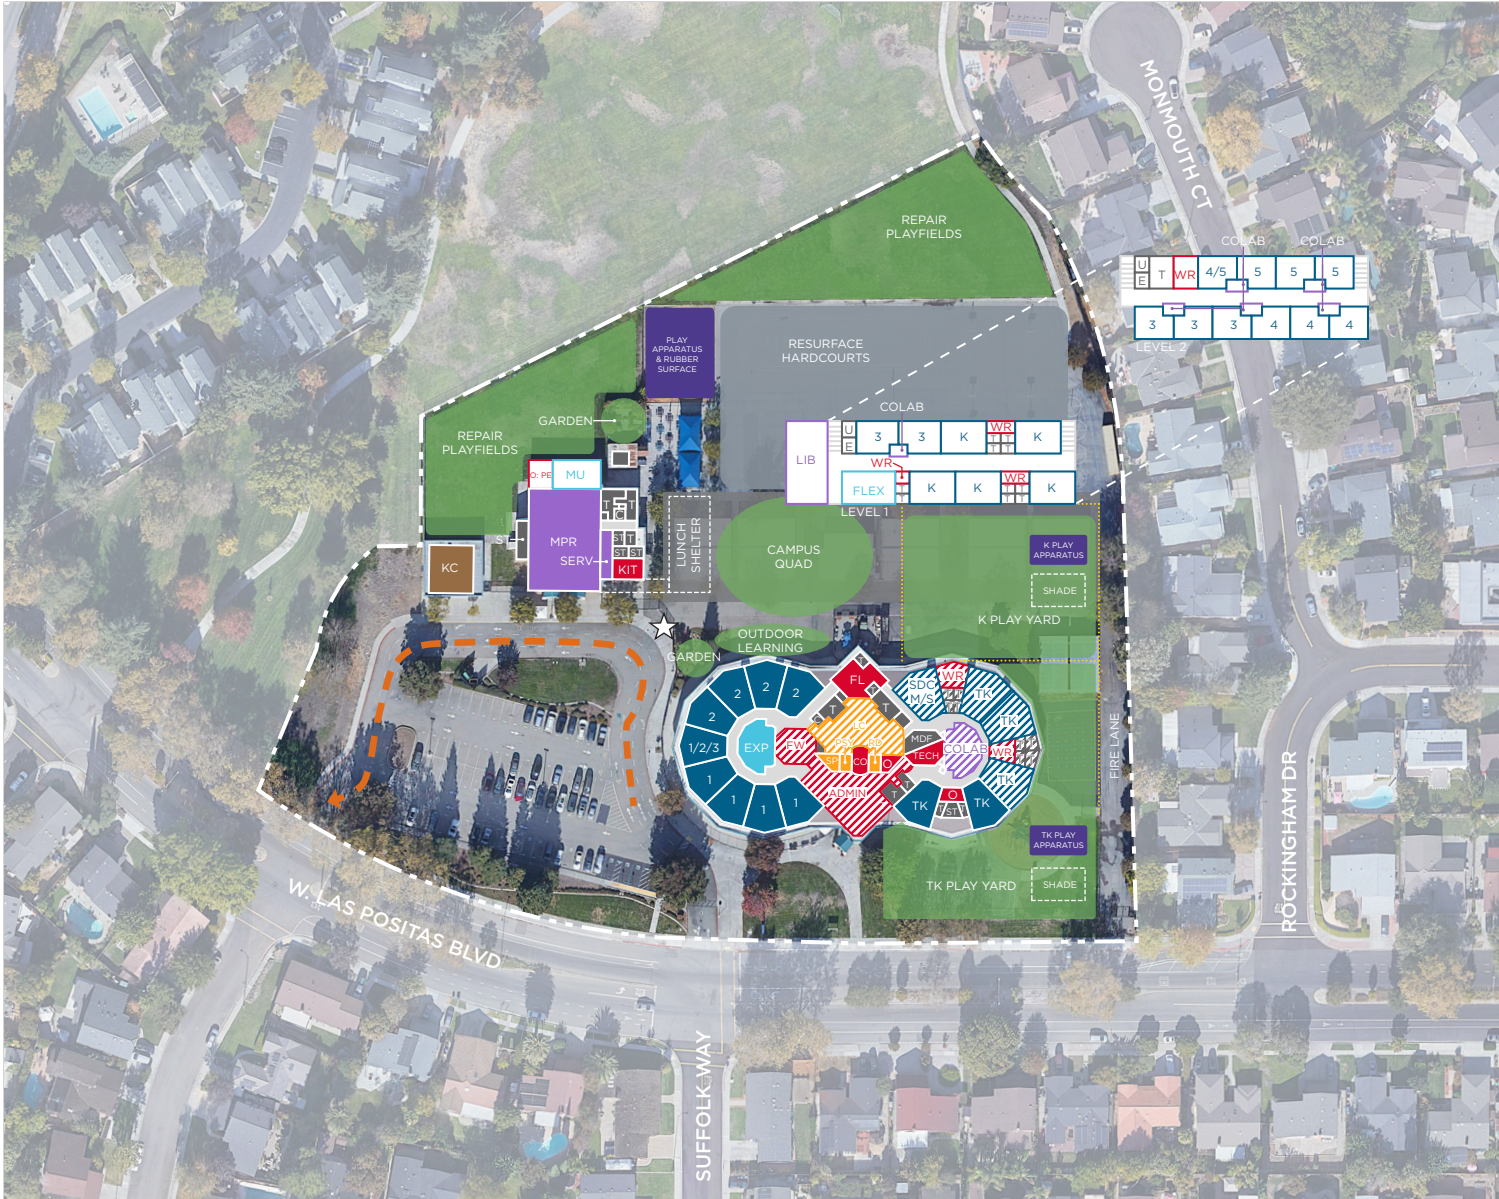
Proposed Master Plan Diagram | FAIRLANDS ELEMENTARY SCHOOL

Classrooms

#	Indicates Grade Level
TK	Transitional Kindergarten
K	Kindergarten
SDC:	Special Education:
M/S	Moderate/Severe
