SITE FUNCTIONALITY ASSESSMENT
MOHR ELEMENTARY SCHOOL

MOHR ELEMENTARY SCHOOL

FACILITY CONDITION ASSESSMENT

Mohr Elementary School
3300 Dennis Drive
Pleasanton, California 94588

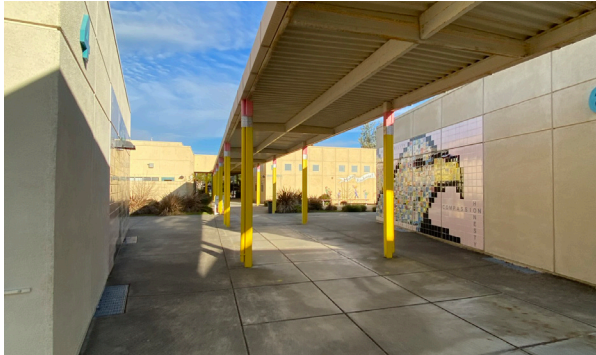
Shade Structure

Students dine at tables outdoors. Trees and a few umbrellas provide little protection from sun and rain. The principal would like better shelter/coverage of this area.

1. Replace tables/shade structure for dining area
2. Build-in designated areas for hands-on activities
3. Working heating and air

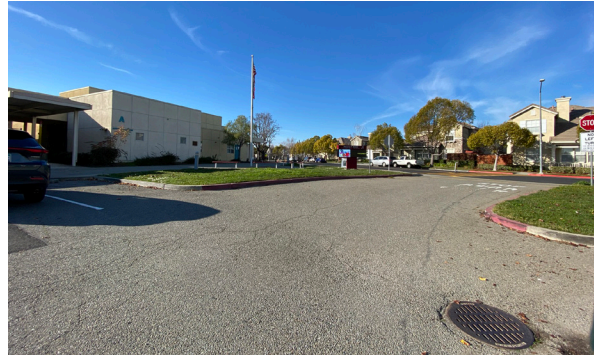
Drop-Off Lane / Parking

The parking lot along the eastern edge of the campus is sufficient for staff, however visitor parking is limited.

Drop-off occurs in a pull-out along Dennis Drive.

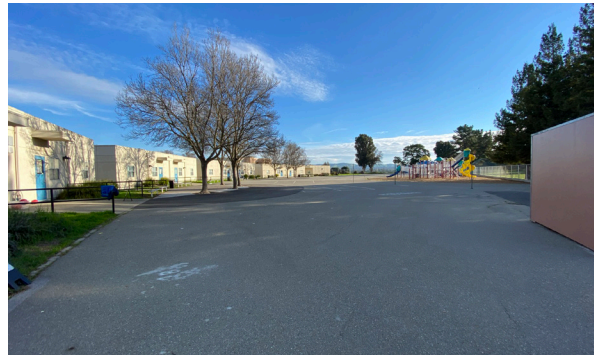
Hardcourts

The principal notes an underutilized area at the south end of the hardcourt and expresses a desire to transform it into an area for outdoor projects and maker-type play that can be used by students during recess.

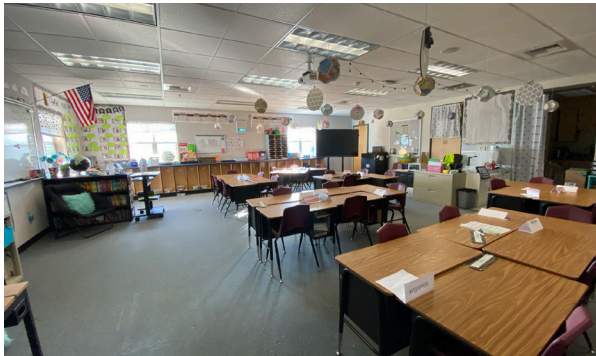
Typical Classroom

Classrooms are at-grade, permanent modular construction. Backpack hooks are provided along the single-story classroom exteriors and cubbies are provided as built-in casework at the two-story classroom interiors. An open work room, storage, and sink area are built into each classroom. Remaining built-in casework is minimal. Students have individual desks and detached chairs. Technology includes a ceiling-mount projector with pull-down screen as well as a mobile LCD monitor.

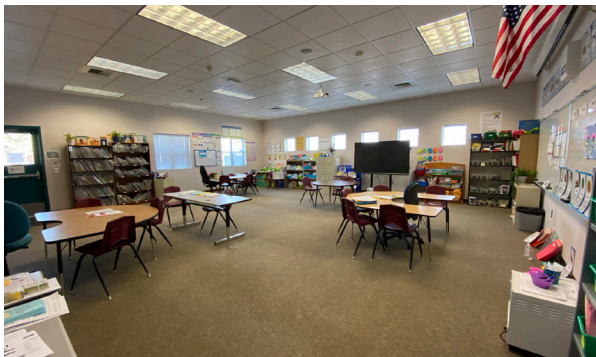
Student Services / Counseling (reading and intervention)

Counseling is located within small offices and utilize vacant classrooms for group sessions.

The Computer Lab is now used for reading and intervention.

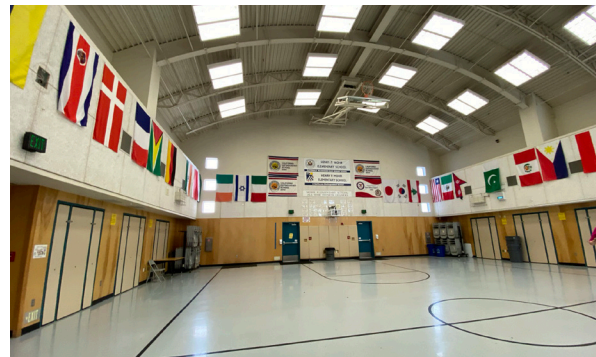
Multi-Purpose Room

The MPR has in-wall tables and two (2) retractable basketball hoops and backstops. There is a long-throw projector and pull-down screen at opposite ends of the MPR. Speakers are wall-mount.

This site does not have a permanent stage. A temporary stage is stored in a room of the MPR building.

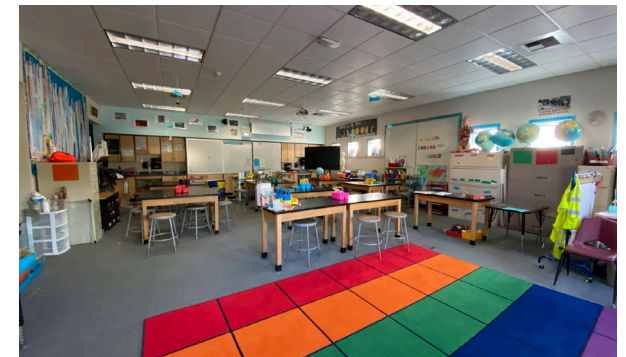
Exploration Room

The Exploration Lab has a teaching wall with a sink on either side as well as a work room/storage nook that has a kitchenette with oven, stove, microwave, refrigerator, and a dishwasher. Furniture within this room is comprised of science-grade tables and stools. A ceiling-mount projector and drop-down screen are present, as is a mobile LCD monitor.

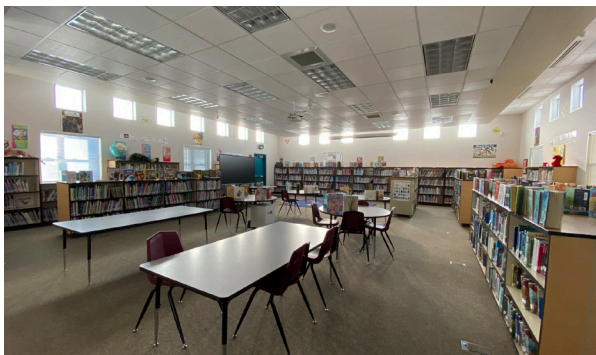
The Library has ample natural light. The perimeter is lined with tall book stacks and free-standing, stationary book stacks are organized throughout the room to frame a central, open area. It is furnished with both rectangular and circular tables and chairs. The Library has a mobile LCD monitor as well as a ceiling-mount projector.

The principal notes a desire for a 'book nook' and window seats for reading as well as additional space for a teacher resource center that has curriculum and materials storage.

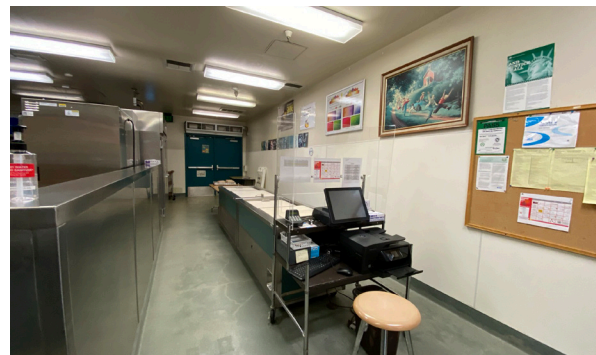
Food Service: Serving Area

The kitchen and student serving area are attached to the Multi-Purpose Room. The two functions are within the same room, separated by a pony wall. Students have clear circulation through the serving line.

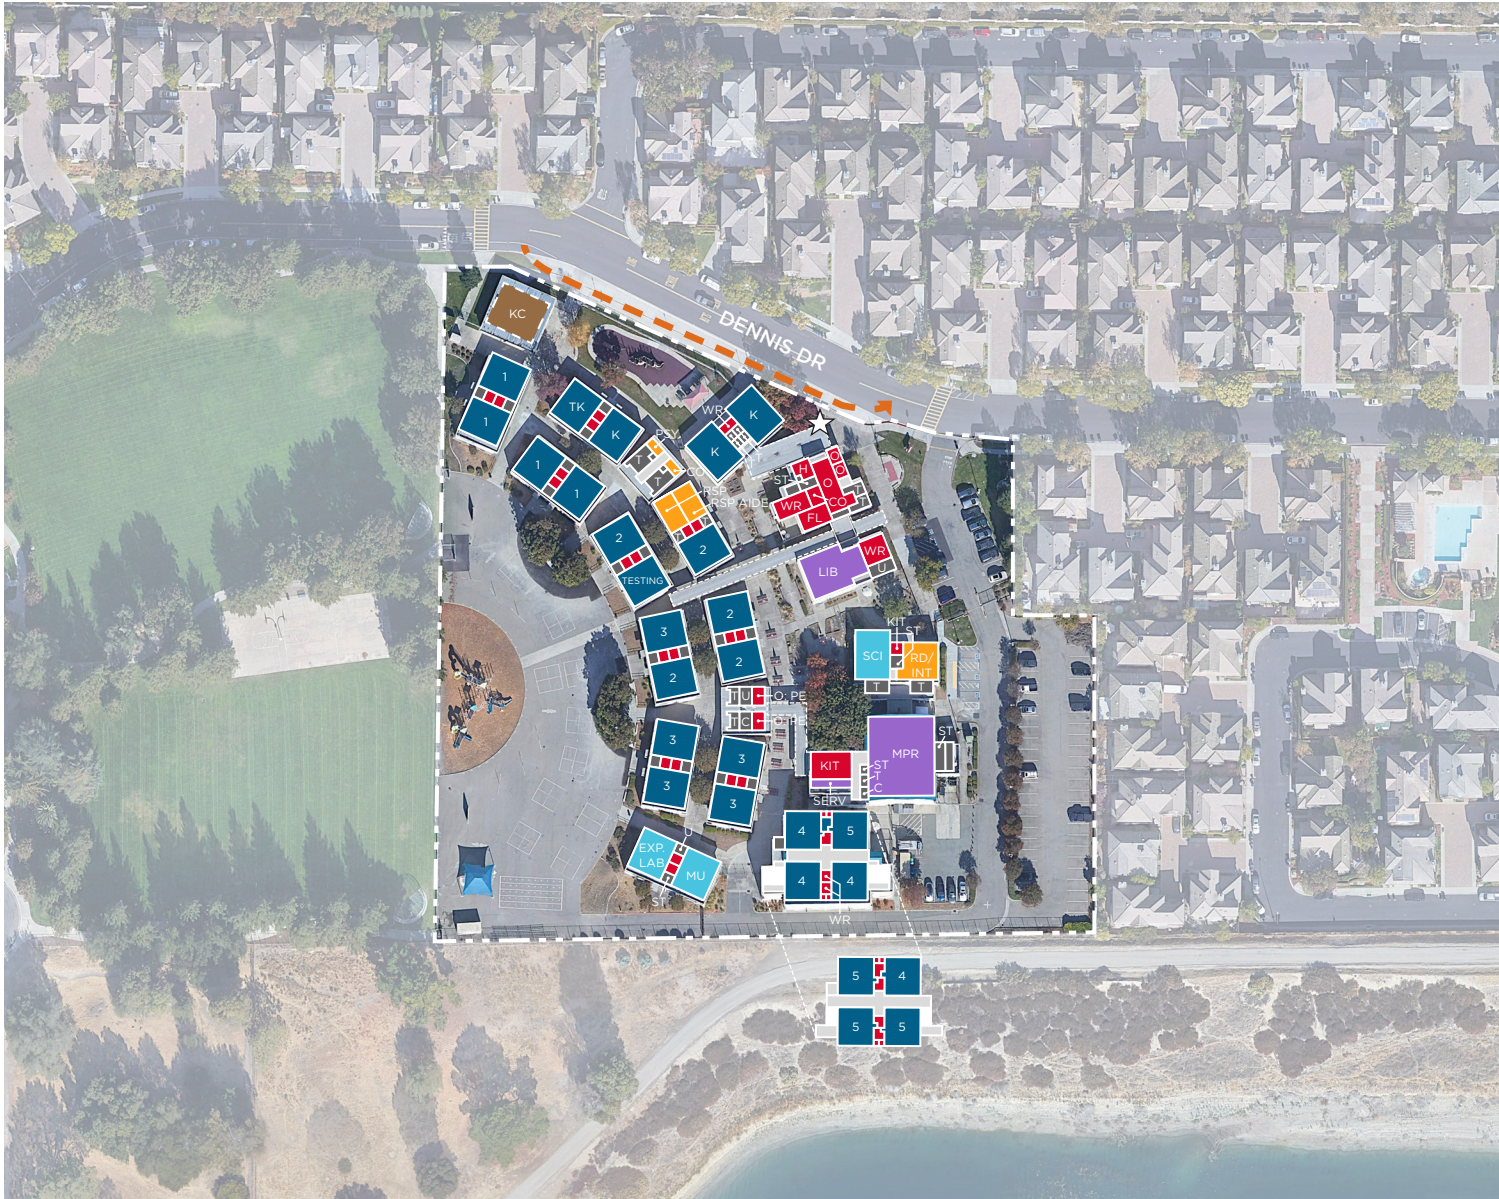
Existing Site Plan | MOHR ELEMENTARY SCHOOL

PS (Preschool)	0
TK (Transitional Kinder)	1
Kindergarten	3
Grades 1-3	14
Grades 4-5	8
SDC mild/mod	0
SDC mod/sev	1
Sub-Total:	26

Exploration Lab / Music / Art	3
After School Care	1
Total:	30

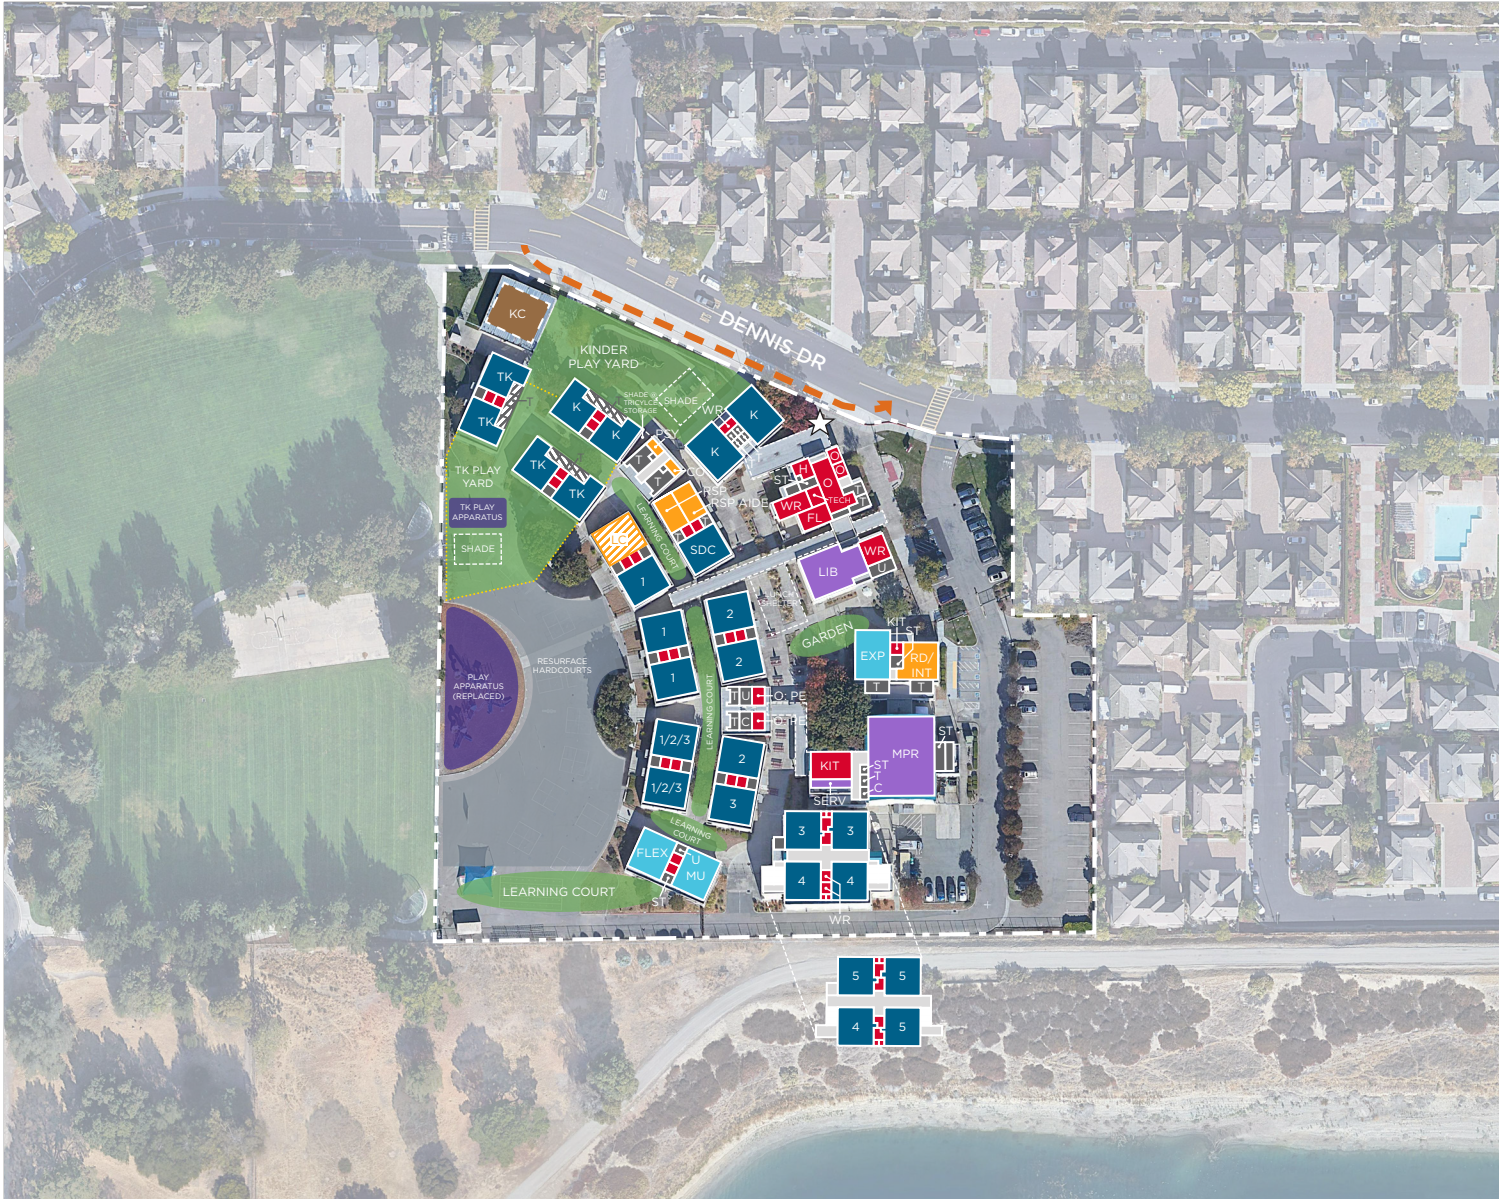
Proposed Master Plan Diagram | MOHR ELEMENTARY SCHOOL

No Work
 Modernization
 Reconfiguration
 New Construction

PS (Preschool)	0
TK (Transitional Kinder)	4
Kindergarten	4
Grades 1-3	11
Grades 4-5	6
SDC mild/mod	0
SDC mod/sev	1
Sub-Total:	26

Exploration Lab / Music / Art	3
After School Care	1
Total:	30

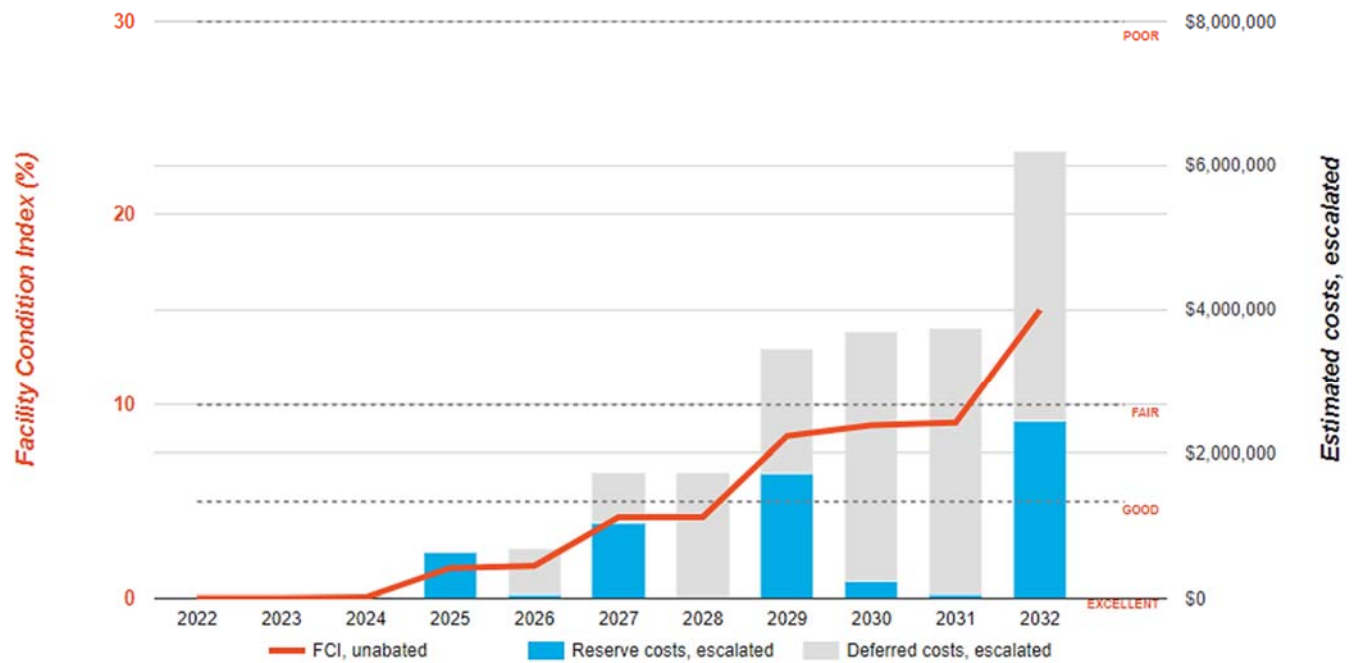
Needs by Year with Unaddressed FCI Over Time

The vertical bars below represent the year-by-year needs identified for the entire campus. The orange line in the graph below forecasts what would happen to the campus FCI (left Y axis) over time, assuming zero capital expenditures over the next ten years. The dollar amounts allocated for each year (blue bars) are associated with the values along the right Y axis.

Replacement Value: \$41,327,000

Inflation Rate: 3.0%

Average Needs per Year: \$562,600
