**FACILITIES MASTER PLAN 2022**  
PLEASANTON UNIFIED SCHOOL DISTRICT

# VALLEY VIEW ELEMENTARY SCHOOL

# FACILITY CONDITION ASSESSMENT

Valley View Elementary School  
480 Adams Way  
Pleasanton, California 94566

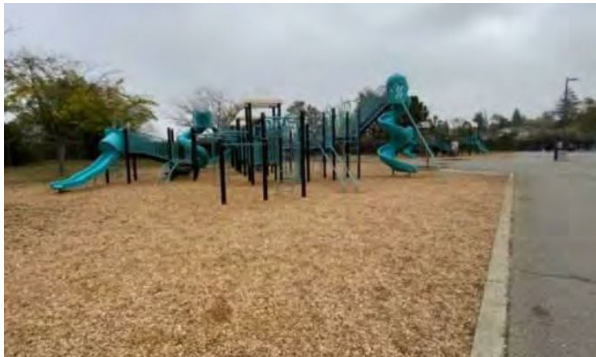
Play Structure

The Kindergarten play structure is fairly new, in good condition, and has rubber surfacing. The lower and upper primary play structures are also noted by the principal to be in good condition and have bark mulch on the groundplane.

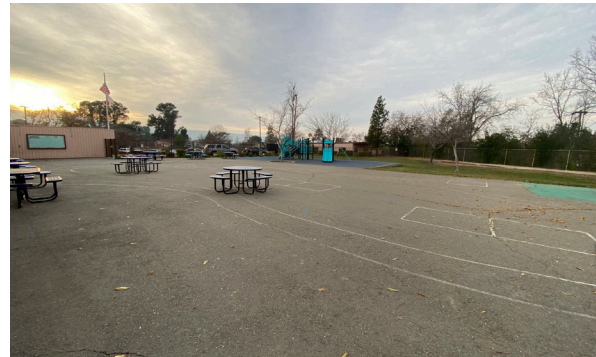
Hardcourts

The principal notes that the hardcourts need to be resurfaced and new striping painted.

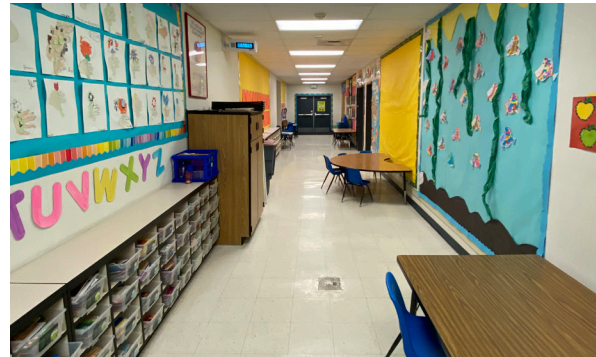
Interior Hallway and Pull-Out Tables

Classrooms are organized along double-loaded interior corridors that are used for organized storage and pull-out services.

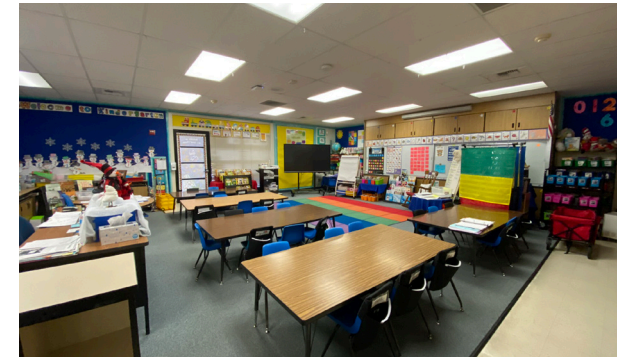
Kindergarten Classroom

Not all TK/Kindergarten classrooms have interior restrooms. Students within those classrooms use restrooms at the end of the shared hallway.

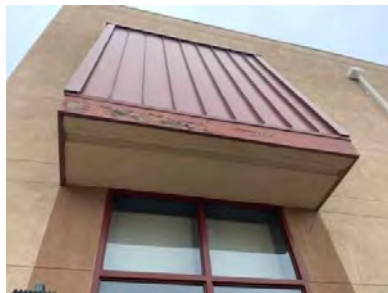
### Exterior Walls in Poor condition.

Wood Siding  
Multipurpose Room (MPR) Valley View  
Elementary School Building Exterior

Wood siding is very weathered. - AssetCALC ID: 3489873

Uniformat Code: B2010  
Recommendation: **Replace in 2023**

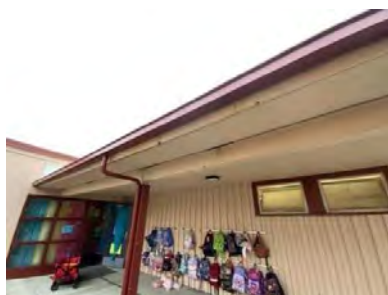
### Exterior Walls in Poor condition.

Wood Siding  
Northeast Classrooms Valley View Elementary  
School Building Exterior

Wood siding is weathered and deteriorating along building perimeter. - AssetCALC ID: 3489988

Uniformat Code: B2010  
Recommendation: **Replace in 2023**

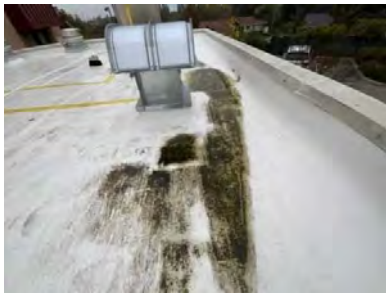
**Roofing in Poor condition.**

Modified Bitumen  
 Multipurpose Room (MPR) Valley View  
 Elementary School Roof

Roof has water accumulation that may be causing damage to ceiling tiles. - AssetCALC ID: 3489974

Uniformat Code: B3010  
 Recommendation: **Replace in 2024**

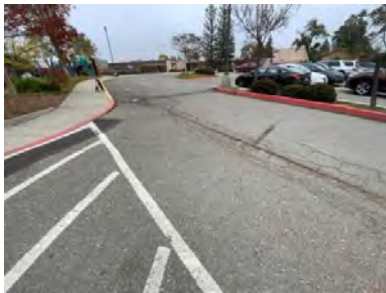
**Parking Lots in Poor condition.**

Pavement, Asphalt  
 Site Valley View Elementary School Site

Asphalt is cracked and worn in various locations. - AssetCALC ID: 3490029

Uniformat Code: G2020  
 Recommendation: **Cut & Patch in 2022**
