FACILITIES MASTER PLAN 2022
PLEASANTON UNIFIED SCHOOL DISTRICT

SITE FUNCTIONALITY ASSESSMENT

VINTAGE HILLS ELEMENTARY SCHOOL

FACILITY CONDITION ASSESSMENT

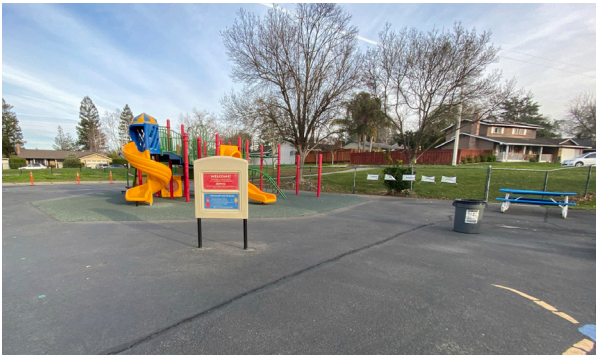
Kindergarten Play Yard

The Kindergarten play yard area has been expanded which provides opportunity for additional enhancements to the play equipment. The principal suggests equipment that is sized appropriately for TK students. The upper/lower primary play structure was replaced with rubberized surfacing in September of 2021 and includes inclusive/accessible features.

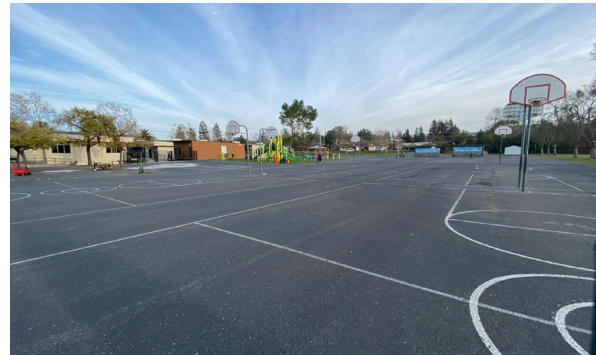
Hardcourts

The principal notes that the hardcourts need to be resurfaced and new striping painted. He also notes opportunity to create an outdoor amphitheater/assembly area at the northwest portion of the site which is already sloped.

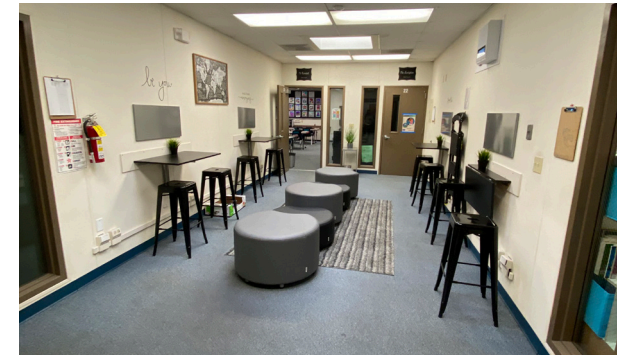
Collaboration Space

Classroom hallways are utilized as collaboration areas and have been outfitted with various furniture types.

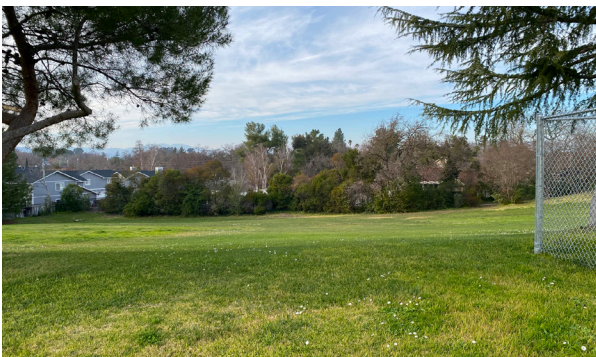
Field Identified as Potential Amphitheater

1. New Library / Media Center
2. Outdoor amphitheater
3. New 2nd/3rd grade building to replace portables

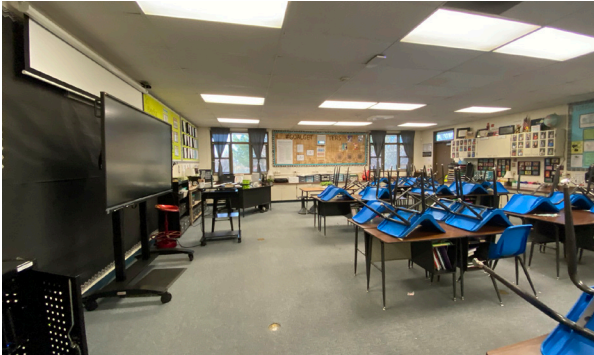
Typical Classroom

Classrooms have one wall of low and full-height built-in casework with a sink. Students have individual desks and chairs. Technology includes a mobile LCD monitor. Backpack hooks are available along the exterior wall of the classroom.

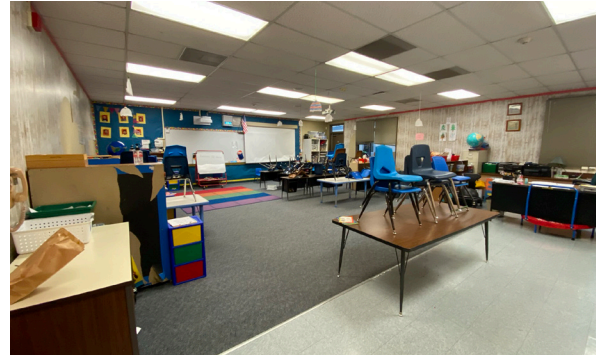
Special Education Classroom

This site accommodates two (2) SDC classes for students with moderate/severe needs. Principal recommendations for improvement include adding a sensory room, padding and other soft edges, and areas of interactive, sensory play.

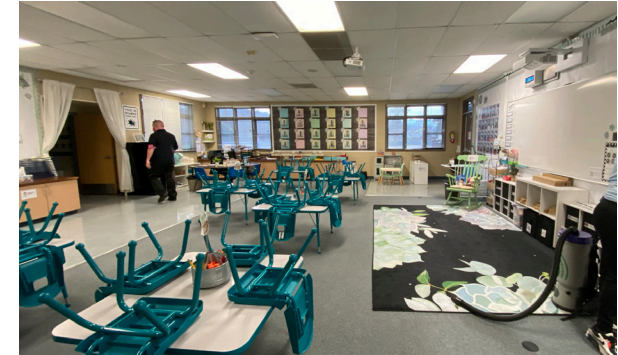
Kindergarten Classroom

Not all TK/Kindergarten classrooms have interior restrooms.

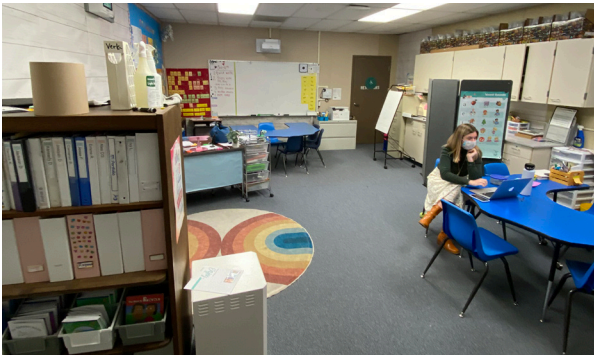
Student Services / Counseling

The site has a cluster of counselors and sensory space that works well for collaboration and student access.

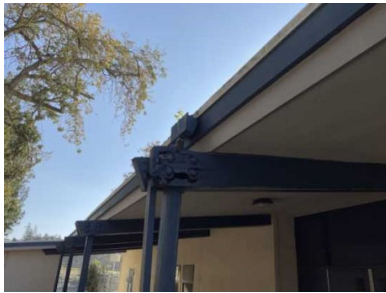
Roof Structure in Poor condition.

Pitched, Wood Heavy Timber
Administration Building Village High School
Building A - Building exterior

Canopy beam has deteriorated and in need of replacement. - AssetCALC ID: 3465468

Uniformat Code: B1020
Recommendation: **Replace in 2022**

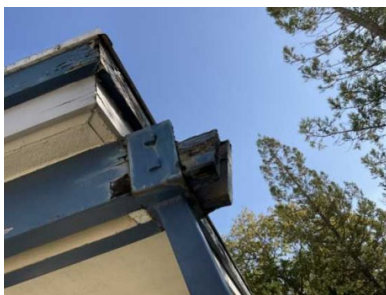
Roof Structure in Poor condition.

Pitched, Wood Heavy Timber
Classroom Wings Village High School Building
exterior

Wood beams have aged and look unsafe. - AssetCALC ID: 3465524

Uniformat Code: B1020
Recommendation: **Replace in 2022**

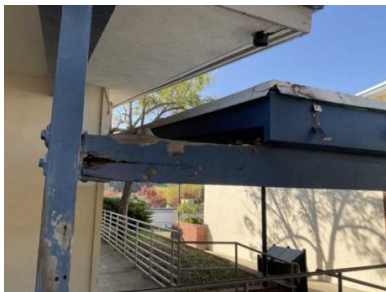
Roof Structure in Poor condition.

Pitched, Wood Rafters
Administration Building Village High School
Building A - Building exterior

Walkway canopy beam is deteriorated. Recommend replacing. - AssetCALC ID: 3465459

Uniformat Code: B1020
Recommendation: **Replace in 2022**

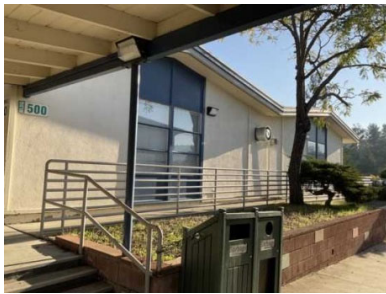
Window in Poor condition.

Wood Historical, 16-25 SF
Classroom Wings Village High School Building
Exterior

Window frames have either cracked damaged surfaces. - AssetCALC ID: 3465489

Uniformat Code: B2020
Recommendation: **Restore in 2022**

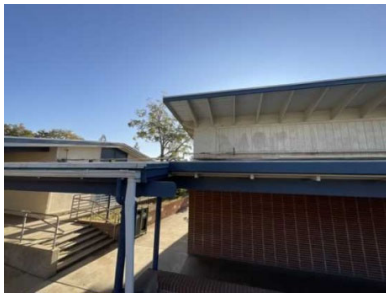
Roof Appurtenances in Poor condition.

Gutters and Downspouts, Aluminum w/ Fittings
Classroom Wings Village High School Building
exterior

Missing or damaged gutters - AssetCALC ID: 3465424

Uniformat Code: B3020
Recommendation: **Replace in 2022**

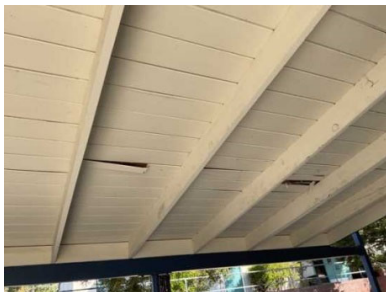
Soffit in Poor condition.

Wood
Classroom Wings Village High School Building
exterior

Canopy ceiling has aged and is falling apart. - AssetCALC ID: 3465528

Uniformat Code: B3080
Recommendation: **Replace in 2022**

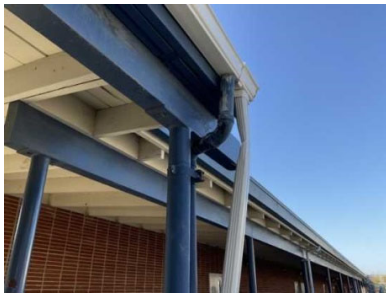
Roof Appurtenances in Poor condition.

Gutters and Downspouts, Aluminum w/ Fittings
Administration Building Village High School
Building A - Roof

Downpipes are damaged and in need of replacement, some are more damaged than others. - AssetCALC ID: 3465469

Uniformat Code: B3020
Recommendation: **Replace in 2022**

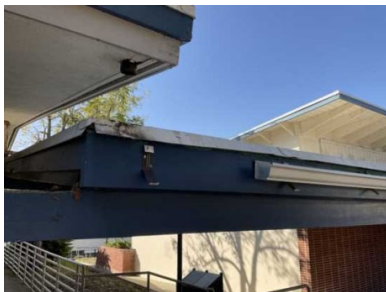
Roof Appurtenances in Poor condition.

Gutters and Downspouts, Aluminum w/ Fittings
Administration Building Village High School
Building A - Building exterior

A portion of the roof gutters are aged, damaged or missing. - AssetCALC ID: 3465449

Uniformat Code: B3020
Recommendation: **Replace in 2022**

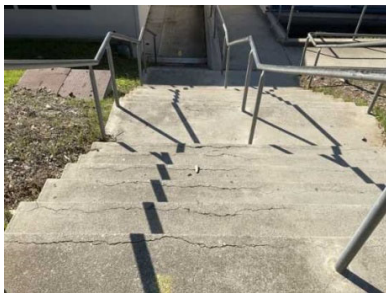
Stairs in Poor condition.

Concrete, Exterior
Site Village High School Site

Concrete stairs are aged and has excessive cracking at nosing(s) in various areas. - AssetCALC ID: 3465448

Uniformat Code: B1080
Recommendation: **Replace in 2023**
