**FACILITIES MASTER PLAN 2022**  
PLEASANTON UNIFIED SCHOOL DISTRICT

SITE FUNCTIONALITY ASSESSMENT

# WALNUT GROVE ELEMENTARY SCHOOL

# FACILITY CONDITION ASSESSMENT

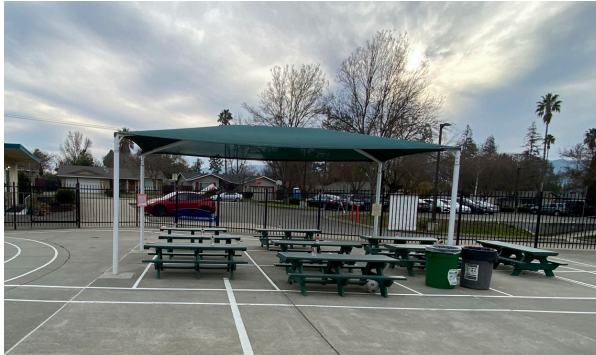
Shade Structure

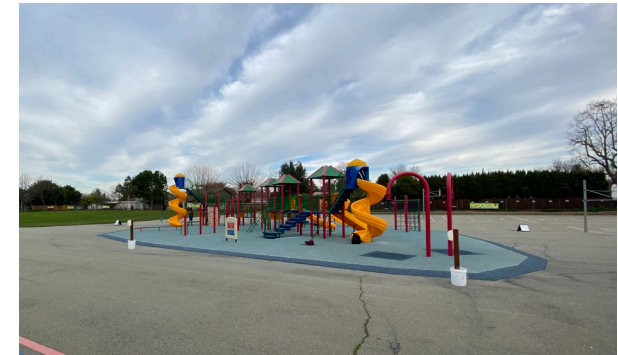
All play structures are fairly new, in good condition, and has rubber surfacing.

Play Structure

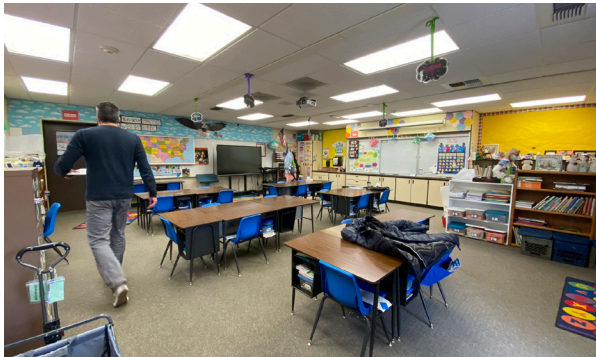
Classrooms have a teaching wall, other built-in casework for storage, and a sink area. Students have individual desks and chairs. Technology includes a ceiling-mount projector with pull-down screen and a mobile LCD monitor. Backpack hooks are available along the exterior wall of the classroom.

Typical Classroom

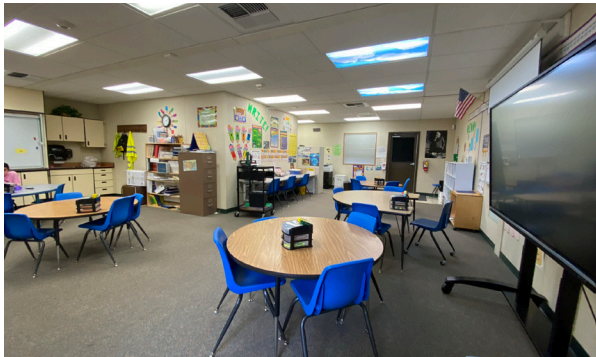
Speech and RSP share a classroom (separated by partitions) and would like acoustic separation. The principal would also like a space conducive to group sessions and suggests a lounge-style wellness center.

Student Services / Counseling (RSP)

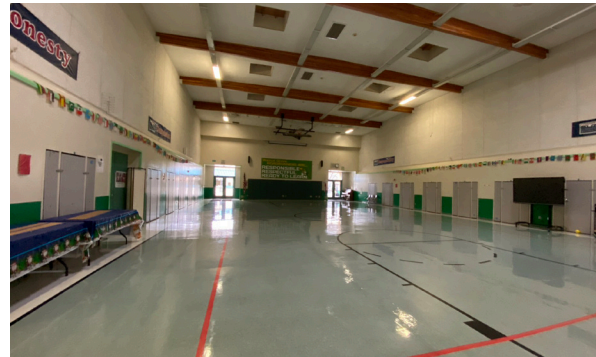
The MPR has in-wall tables and two (2) retractable basketball hoops and backstops. Presentation technology includes a mobile LCD monitor.

Multi-Purpose Room

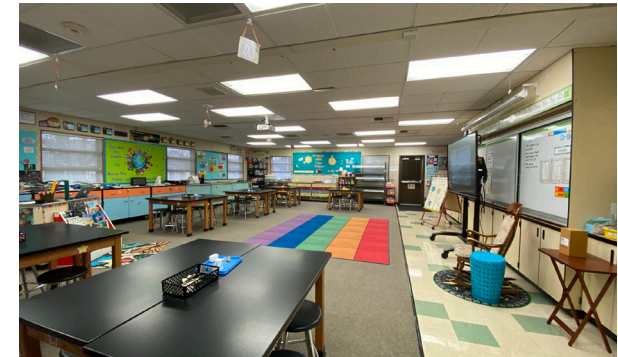
The Science / Exploration Lab is a spacious room located at the end of the upper primary grades wing. This space has a teaching wall, perimeter casework with sinks, and a storage room. Furniture within this room is comprised of science-grade tables and stools. The room is equipped with a mobile LCD monitor and ceiling-mount projector with drop-down screen at the teaching wall.

Exploration Room

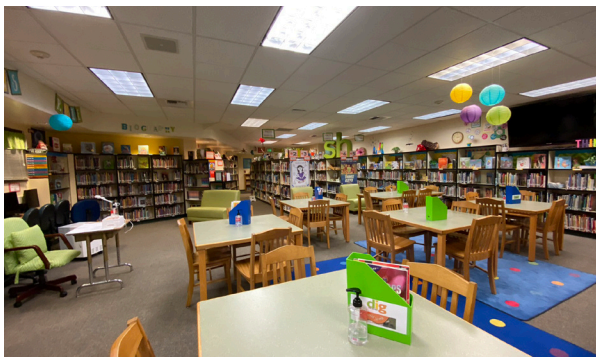
The Library is a spacious room with tall book stacks lining the perimeter and creating aisles. The Library space is furnished with wood tables and chairs with some soft seating. Students can access computer stations. Presentation technology includes a wall-mount as well as a mobile LCD monitor.

Library

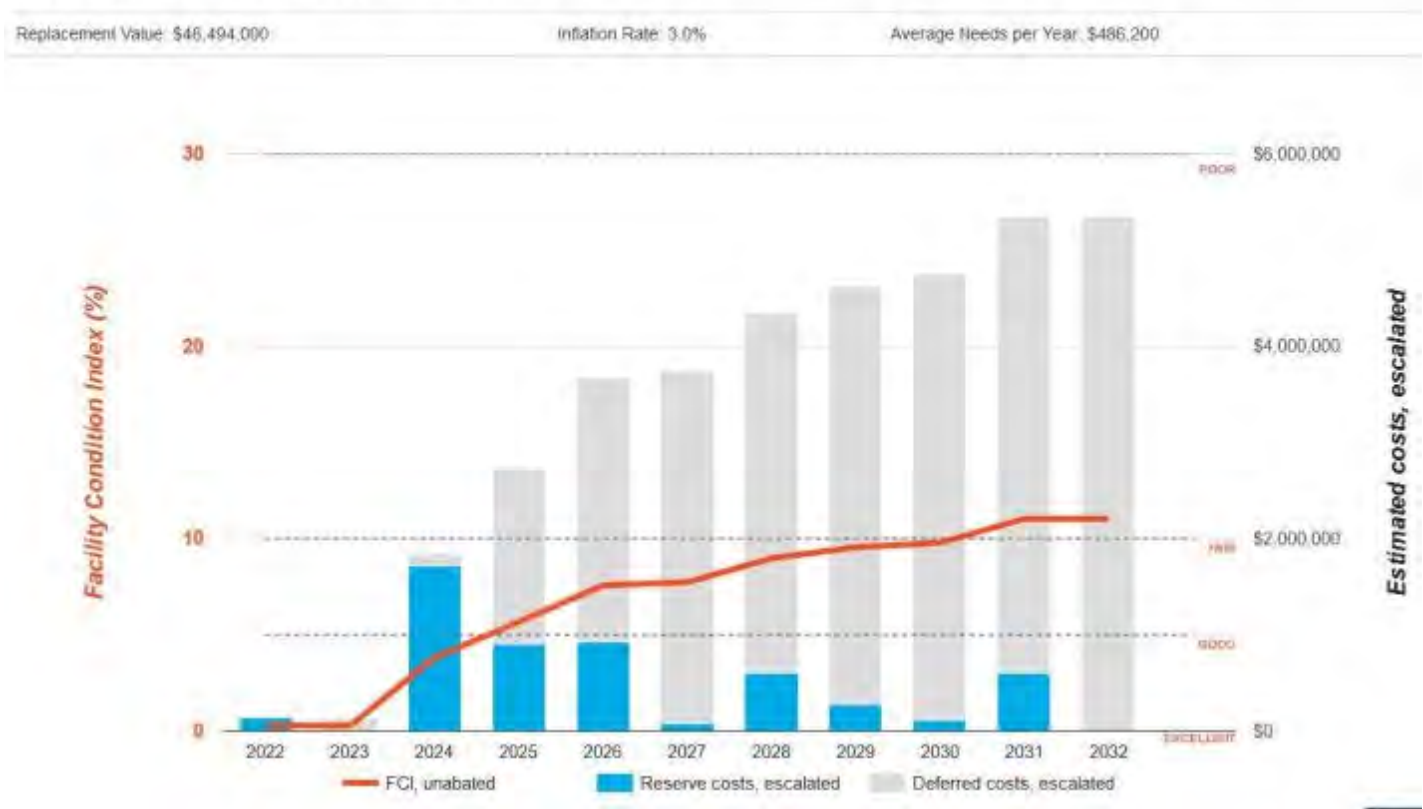
**FCI Analysis: Walnut Grove Elementary School**

The vertical bars below represent the year-by-year needs identified for the entire campus. The orange line in the graph below forecasts what would happen to the campus FCI (left Y axis) over time, assuming zero capital expenditures over the next ten years. The dollar amounts allocated for each year (blue bars) are associated with the values along the right Y axis.

**Needs by Year with Unaddressed FCI Over Time**

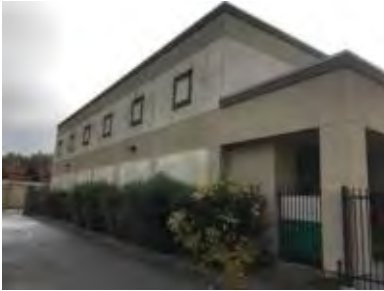
**Exterior Walls in Poor condition.**

Priority Score: **89.9**

any surface  
C - Multi Purpose Room Walnut Grove Elementary School Building Exterior

Cleaning needed - AssetCALC ID: 3498856

Cost Estimate: \$43,200

Uniformat Code: B2010  
Recommendation: **Clean in 2022**

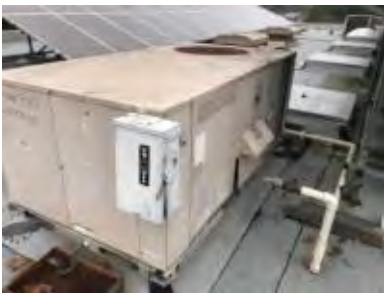
**Packaged Unit in Failed condition.**

Priority Score: **81.9**

RTU, Pad or Roof-Mounted, 6 to 7.5 TON  
C - Multi Purpose Room Walnut Grove Elementary School Upper roof

Abandoned in place - AssetCALC ID: 3498839

Cost Estimate: \$17,600

Uniformat Code: D3050  
Recommendation: **Replace in 2022**

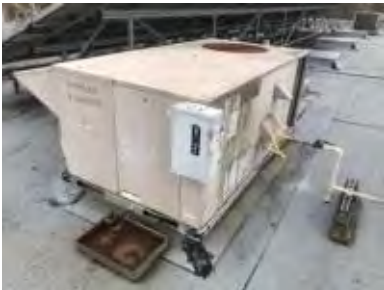
**Packaged Unit in Poor condition.**

Priority Score: **81.9**

RTU, Pad or Roof-Mounted  
C - Multi Purpose Room Walnut Grove Elementary School Upper roof

These RTUs are worn out - AssetCALC ID: 3498853

Cost Estimate: \$52,700

Uniformat Code: D3050  
Recommendation: **Replace in 2022**

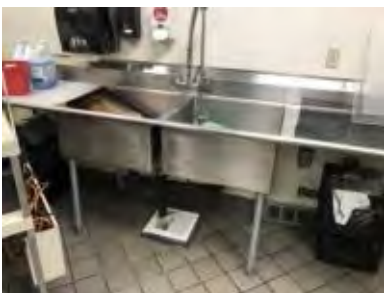
**Sink/Lavatory in Failed condition.**

Priority Score: **56.9**

Commercial Kitchen, 3-Bowl  
C - Multi Purpose Room Walnut Grove Elementary School Kitchen

A three compartment sink is code required, this one is only two - AssetCALC ID: 3498805

Cost Estimate: \$2,900

Uniformat Code: D2010  
Recommendation: **Replace in 2022**
