FACILITIES MASTER PLAN 2022
PLEASANTON UNIFIED SCHOOL DISTRICT

SITE FUNCTIONALITY ASSESSMENT
HART MIDDLE SCHOOL

FACILITY CONDITION ASSESSMENT

Hart Middle School
4433 Willow Road
Pleasanton, California 94588

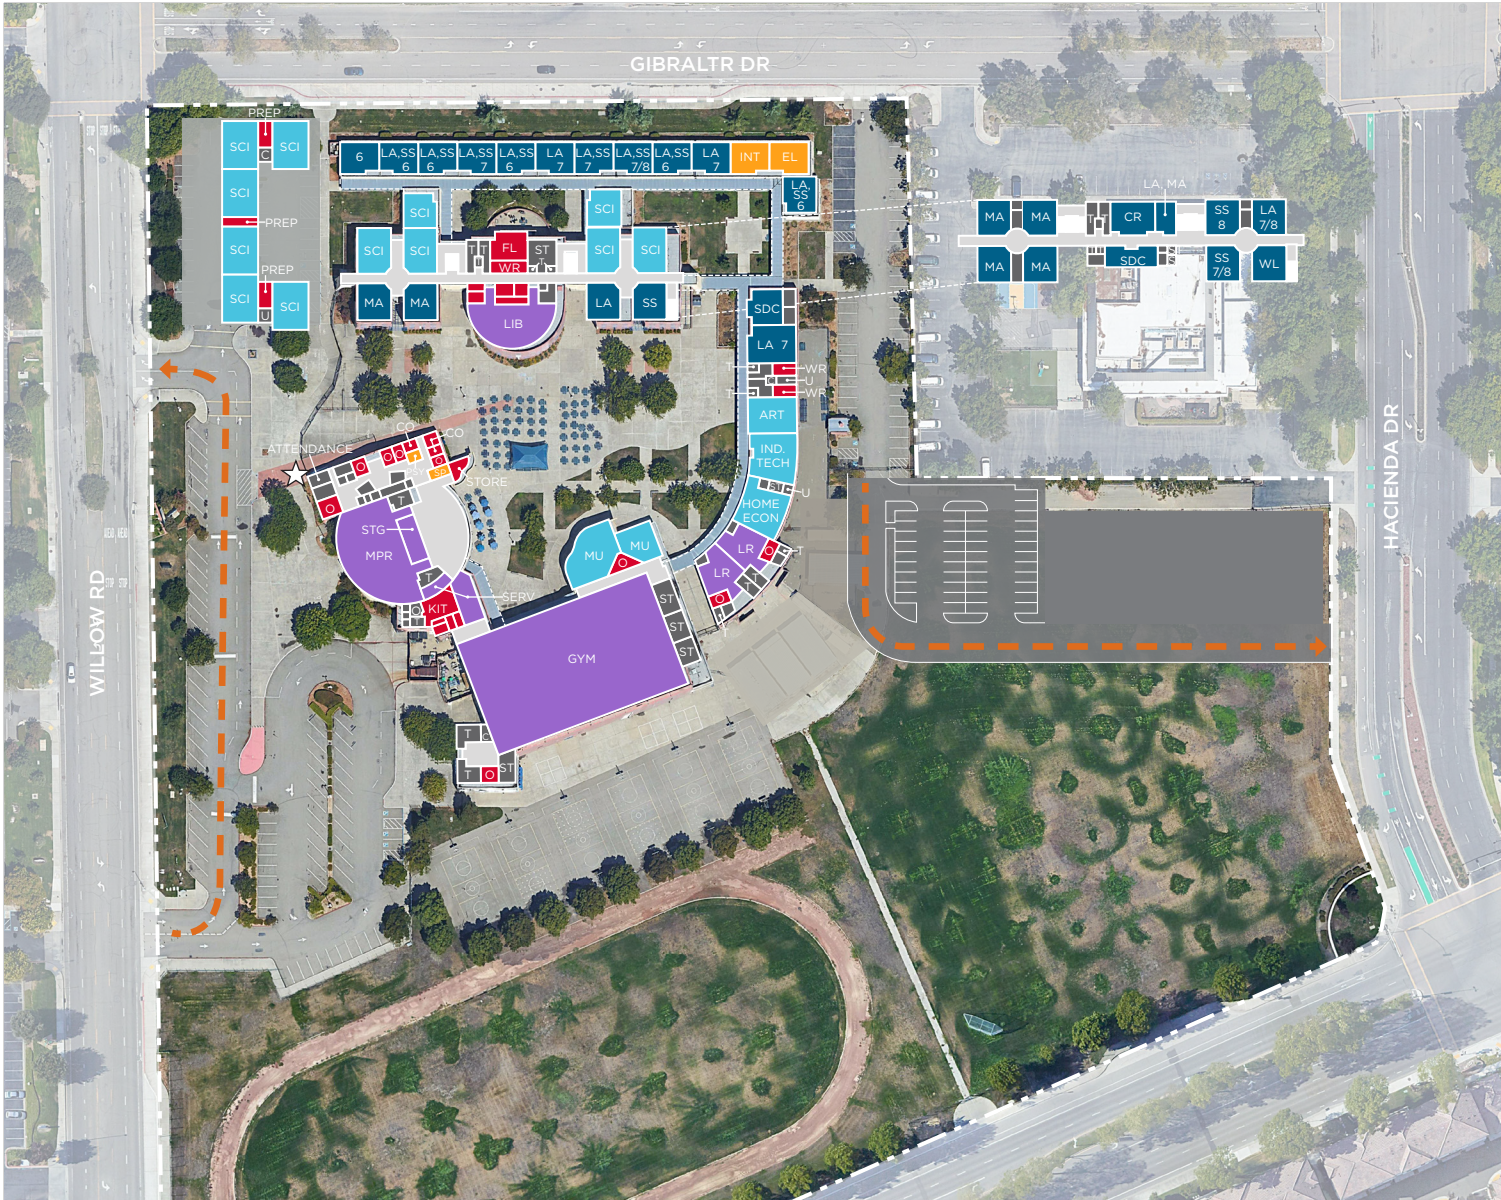
Existing Site Plan | HART MIDDLE SCHOOL

Classrooms

- # Indicates Grade Level
- SS Social Studies
- LA Language Arts
- WL World Language
- MA Math
- SDC: Special Education:
- M/M Mild/Moderate
- M/S Moderate/Severe

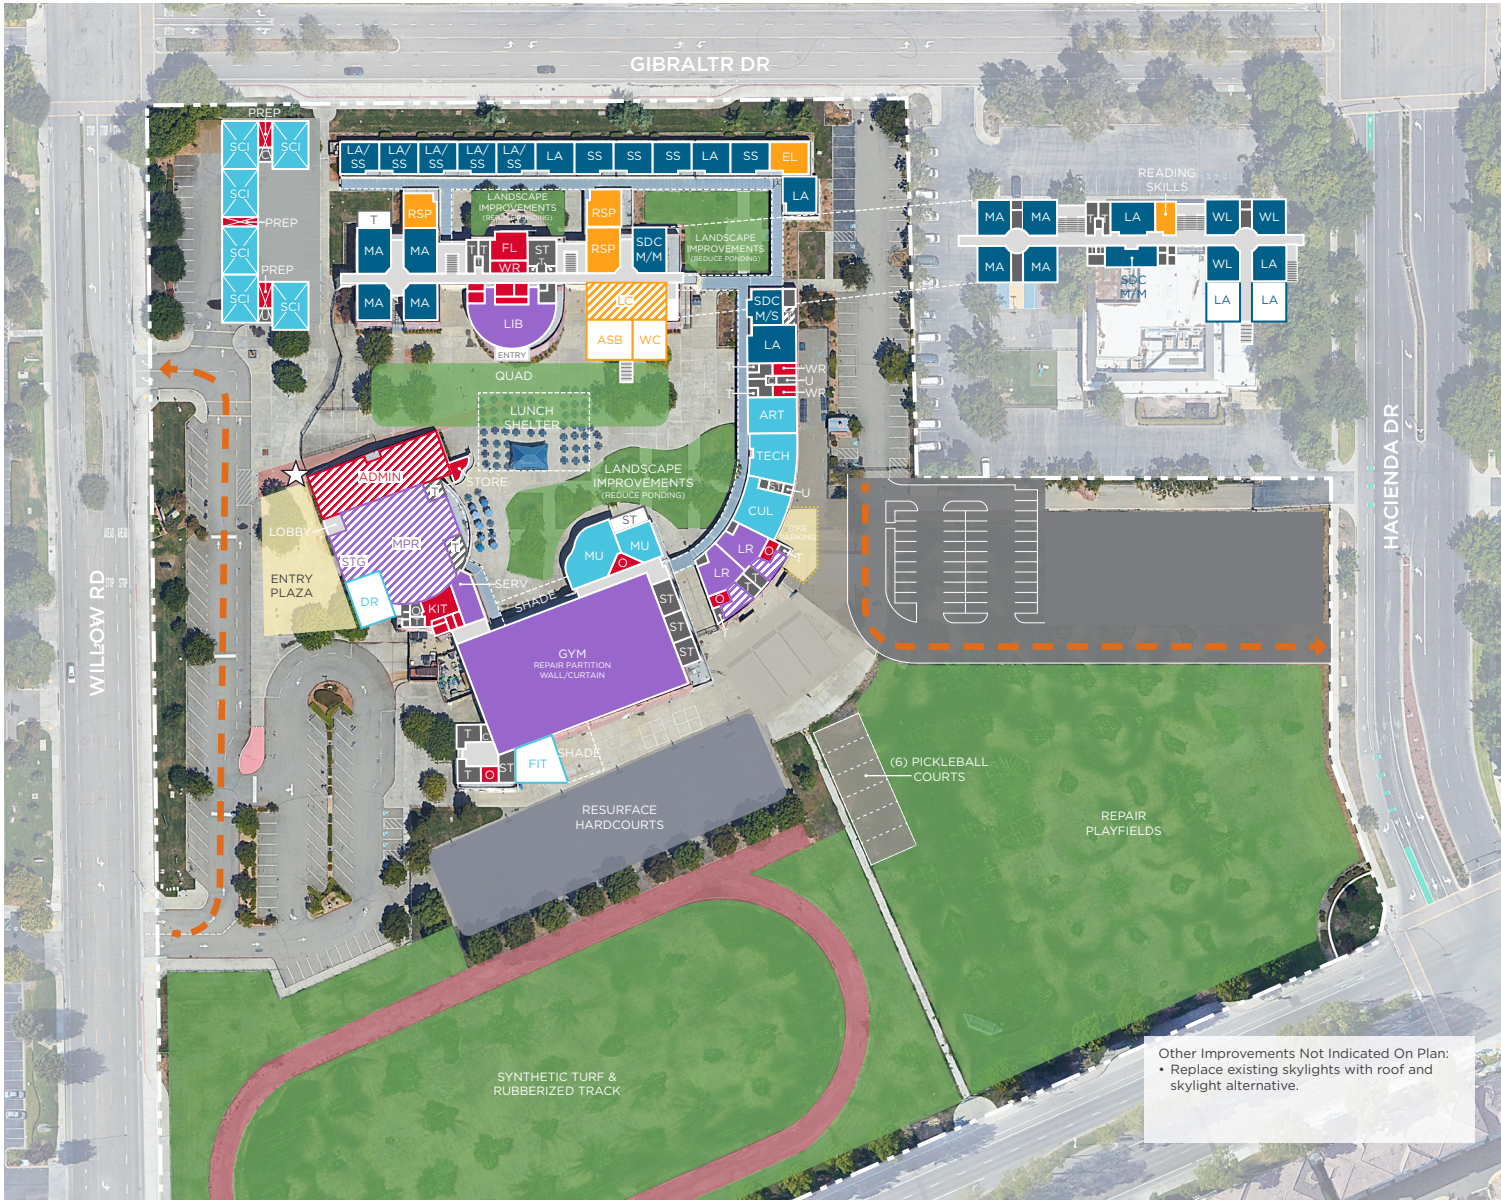
Proposed Master Plan Diagram | HART MIDDLE SCHOOL

- ☐ No Work
- Modernization
- ▨ Reconfiguration
- New Construction

Other Improvements Not Indicated On Plan:
• Replace existing skylights with roof and skylight alternative.

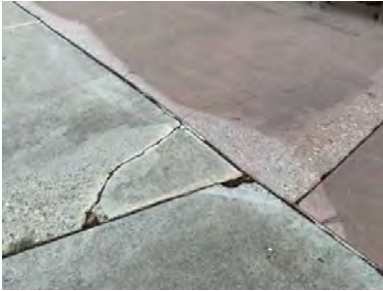
Parking Lots in Poor condition.

Pavement, Concrete
Site Hart Middle School Site

Alligator cracks and settlement, potential trip hazards. - AssetCALC ID: 3469705

Uniformat Code: G2020
Recommendation: **Repair in 2022**

Cost Estimate: \$561,600

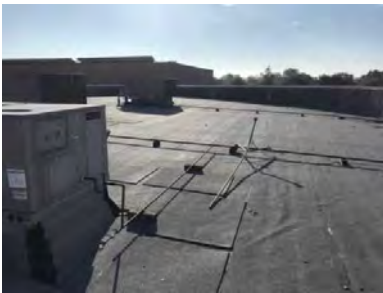
Roofing in Poor condition.

Modified Bitumen
Administration/MPR Hart Middle School Roof

Chronic leaks - AssetCALC ID: 3497432

Uniformat Code: B3010
Recommendation: **Replace in 2023**

Cost Estimate: \$180,800

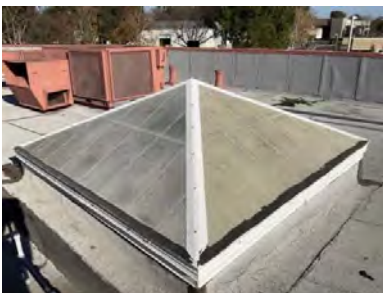
Roof Skylight in Poor condition.

any type
Classroom Wing - Original Hart Middle School
Roof

Sealant is cracking and peeling off, potential leakage will occur in the very near future. - AssetCALC ID: 3469672

Uniformat Code: B3060
Recommendation: **Repair in 2022**

Cost Estimate: \$500
