FACILITIES MASTER PLAN 2022

SITE FUNCTIONALITY ASSESSMENT

PLEASANTON MIDDLE SCHOOL

FACILITY CONDITION ASSESSMENT

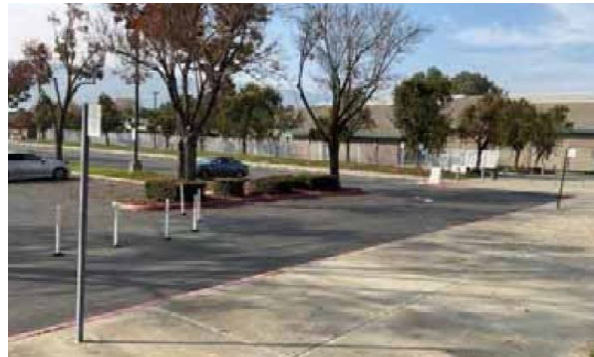
Drop-Off Lane

Drop-off occurs in the parking lot along Case Avenue. The site directs the drop-off lane differently than the striping indicates, consideration should be given to restripe the parking lot.

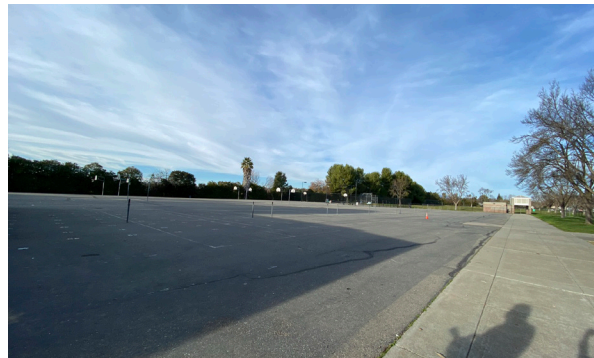
Hardcourts

The hardcourts and fields are in need of repair and upgrade.

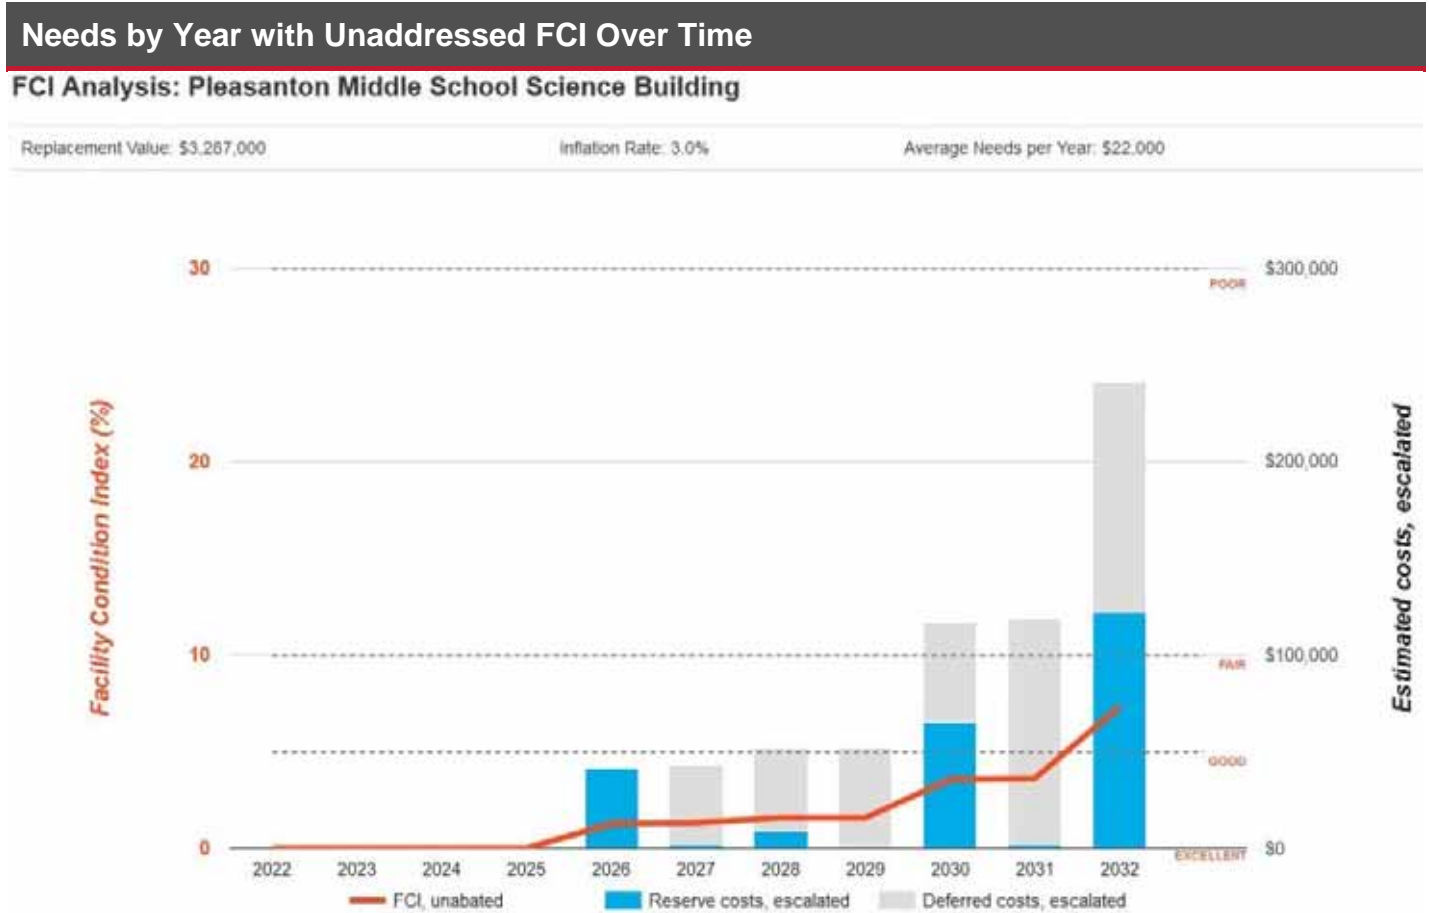
The vertical bars below represent the year-by-year needs identified for the entire campus. The orange line in the graph below forecasts what would happen to the campus FCI (left Y axis) over time, assuming zero capital expenditures over the next ten years. The dollar amounts allocated for each year (blue bars) are associated with the values along the right Y axis.

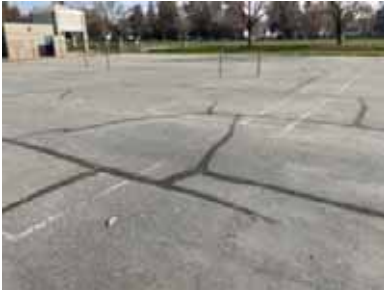
Parking Lots in Poor condition.

Pavement, Asphalt
Site Pleasanton Middle School Site

Cracks throughout - AssetCALC ID: 3480719

Uniformat Code: G2020
Recommendation: **in 2024**

Cost Estimate: \$161,500

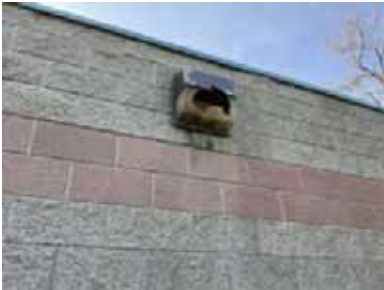
Standard Fixture w/ Lamp in Poor condition.

any type, w/ LED Replacement
Site Pleasanton Middle School

Broken fixture - AssetCALC ID: 3480711

Uniformat Code: D5040
Recommendation: **Replace in 2022**

Cost Estimate: \$700

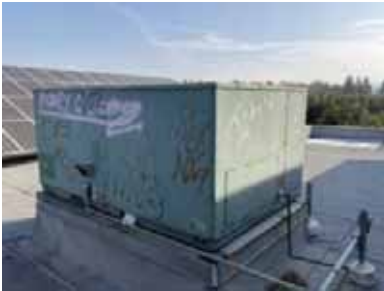
Air Handler in Poor condition.

Exterior AHU, 6000 CFM
MPR Building 13 Pleasanton Middle School

Old and damaged unit - AssetCALC ID: 3482700

Uniformat Code: D3050
Recommendation: **Replace in 2023**

Cost Estimate: \$43,500

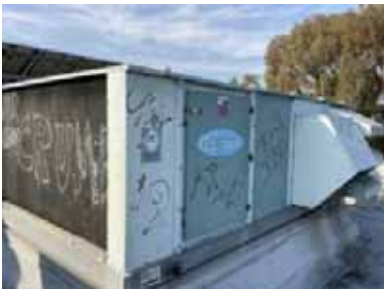
Air Handler in Poor condition.

Exterior AHU, 6000 CFM
MPR Building 13 Pleasanton Middle School

Old and damaged unit - AssetCALC ID: 3482678

Uniformat Code: D3050
Recommendation: **Replace in 2023**

Cost Estimate: \$43,500
