FACILITIES MASTER PLAN 2022
PLEASANTON UNIFIED SCHOOL DISTRICT

SITE FUNCTIONALITY ASSESSMENT
FOOTHILL HIGH SCHOOL

FACILITY CONDITION ASSESSMENT

Foothill High School
4375 Foothill Road
Pleasanton, California 94588

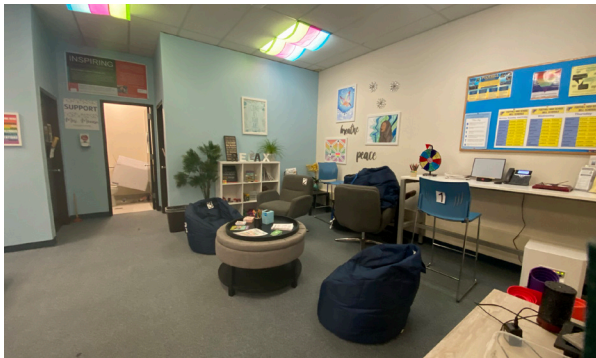
There is a counseling and wellness suite to the rear of the Administration building. The Wellness Center has open shelving and varied seating types including a large group table with chairs and a cluster of soft seating options. The group table and chairs are on casters and can be moved to the side so the room may be used for activities such as yoga.

The principal would like to expand the Wellness Center so that more students can access it at any given time.

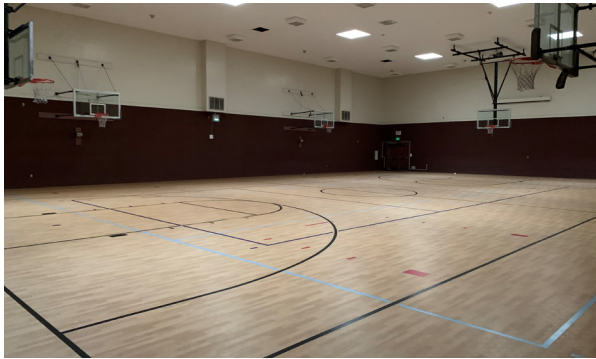
Small Gymnasium

Small Gym: Located behind the Locker Rooms, this is a practice gym with one full-size basketball court and two cross courts. There are no bleachers within this space.

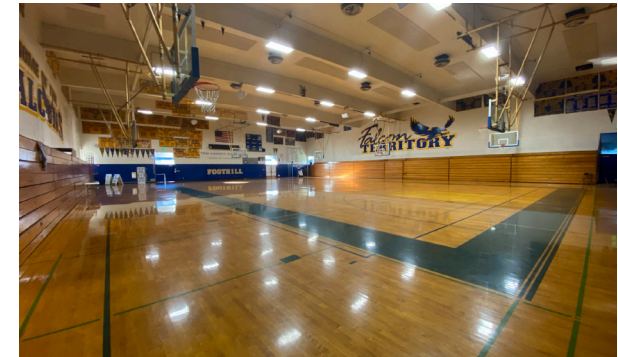
Gymnasium

The principal notes that the gym will be receiving acoustical treatments and improvements to the sound system. The MPR functions well but could use a modernization to improve its function.

Main Gym: Located at the terminus of the Quad, this is a competition gym with retractable, wooden bleacher seating on the long edges. The wrestling room is at the back of the Gym.

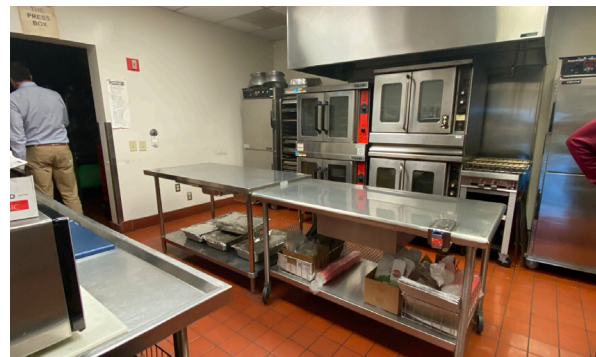
Food Service: Kitchen

The kitchen and serving area sit at the southern edge of the Quad. The kitchen is very small and has limited equipment.

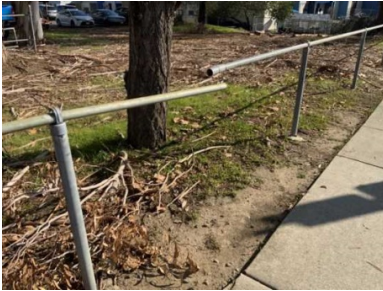
Stair/Ramp Rails in Failed condition.

Metal
Site Foothill High School Site

Uncoupled railing poses a safety hazard to those passing by on the street frontage sidewalk - AssetCALC ID: 3480311

Uniformat Code: B1080
Recommendation: **Repair in 2022**

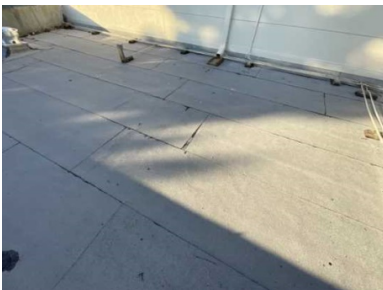
Roofing in Poor condition.

Modified Bitumen
Group 5 (Building H, I) Foothill High School
Roof - H

Staff indicated that roof has undergone several leak repairs and the problem is still occurring, water was also found beneath portions of the roofing material - AssetCALC ID: 3480264

Uniformat Code: B3010
Recommendation: **Replace in 2022**

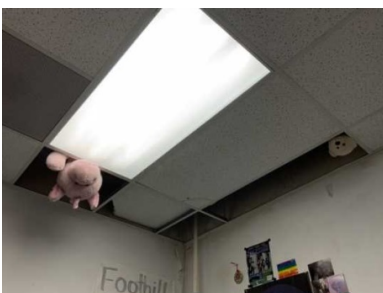
Roofing in Poor condition.

Any Type, Repairs per Man-Day
Group 5 (Building H, I) Foothill High School
Roof

Staff indicated that roof has undergone several leak repairs and the problem is still occurring - AssetCALC ID: 3479838

Uniformat Code: B3010
Recommendation: **Repair in 2022**

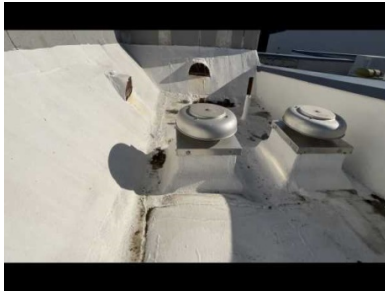
Roofing in Poor condition.

Any Type, Repairs per Man-Day
Group 5 (Building H, I) Foothill High School
Roof - H

Water underneath the roof finishing, the client was made aware - AssetCALC ID: 3480263

Uniformat Code: B3010
Recommendation: **Repair in 2022**

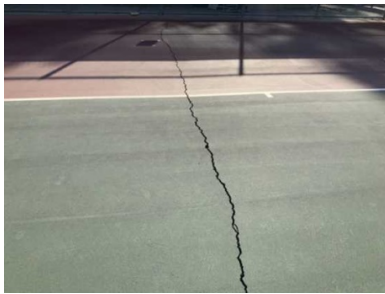
Play Surface in Failed condition.

Pavement, Concrete
Site Foothill High School Site

Areas of surface cracking on concrete pavement were observed. - AssetCALC ID: 3480498

Uniformat Code: G2020
Recommendation: **Crack Fill and Stripe in 2022**

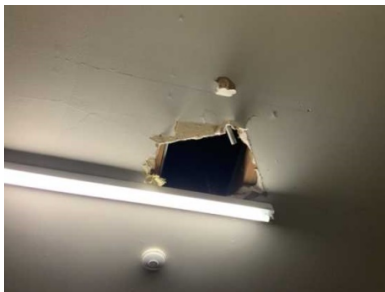
Ceiling Finishes in Failed condition.

Gypsum Board/Plaster
Group 4 (Building F, Main Gym, Small Gym)
Foothill High School Main gym

Ceiling damage was observed. - AssetCALC ID: 3479602

Uniformat Code: C2050
Recommendation: **Repair in 2022**
