Sunrise Special Education School

OVERVIEW

Property Executive Summary

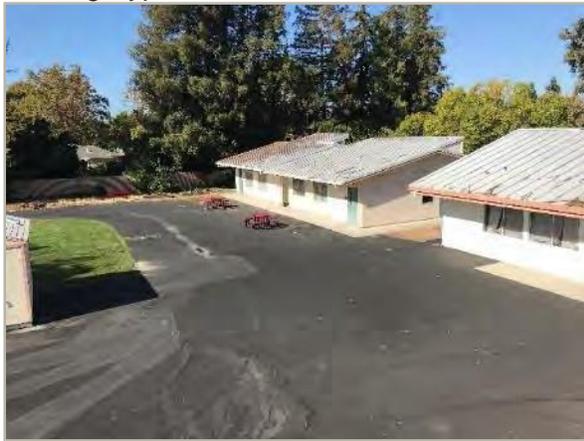
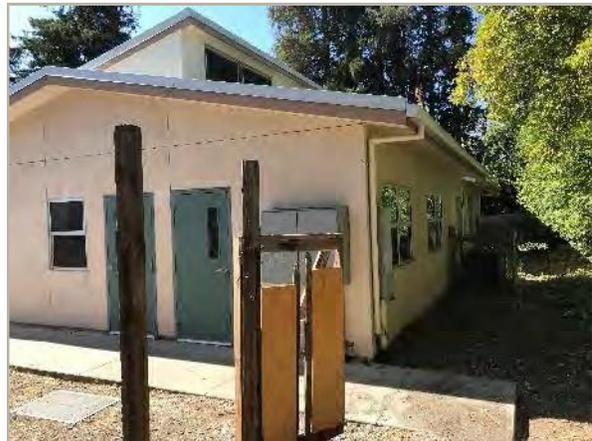
Sunrise Special Education School
 Building Type 2 Information

Separate Classrooms Information		
Building Locations	Classrooms 7 through 9	
Constructed/ Renovated	2007	
Building Size	968 SF each	
Number of Stories	1	
<i>System</i>	<i>Description</i>	<i>Condition</i>
Structure	Conventional wood frame structure on concreteslab	Good
Façade	EIFS with aluminum-framed windows	Fair
Roof	Primary: Gable construction with metal finish	Fair
Interiors	Walls: Painted gypsum board & fabric-faced acoustical tile Floors: Carpet & VCT Ceilings: ACT	Fair
Elevators	None	--
Plumbing	Copper supply, cast iron waste and vent No hot water	Fair
HVAC	Individual split-systems	Fair
Fire Suppression	Fire extinguishers	Good
Electrical	Fed from adjacent buildings with copper wiring Interior Lighting: T-8	Fair
Fire Alarm	Alarm panel, smoke/heat detectors, alarms, strobes, and exit signs	Fair
Equipment/Special	None	--
Key Issues & Findings	None

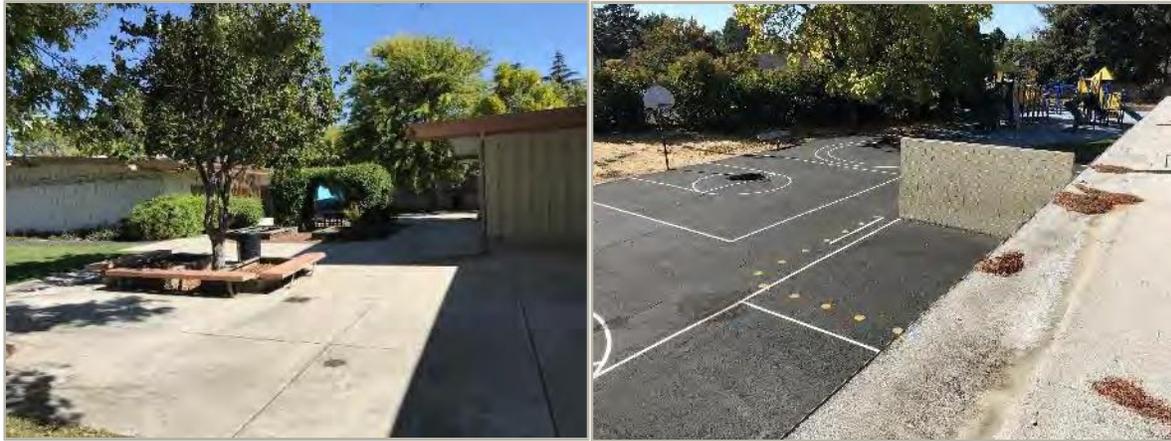
Site Summary Information

Site Information		
Lot Size	2.00 acres (estimated)	
Parking Spaces	32 total spaces all in open lots; 3 of which are accessible 3 accessible (included in total above), 1 van-accessible	
<i>System</i>	<i>Description</i>	<i>Condition</i>
Pavement/Flatwork	Asphalt lots with areas of concrete and concrete sidewalks, curbs, ramps	Fair
Site Development	Building-mounted and property entrance signage, chain link fencing Playgrounds and sports courts with basketball backstop and ball wall Limited park benches, picnic tables	Fair
Landscaping & Topography	Limited landscaping features Irrigation not present No retaining walls Low to moderate site slopes throughout	Fair
Draining Systems and Erosion Control	Municipal system Soil erosion occurs near rear of separate classroom buildings	Fair
Utilities	Municipal water and sewer Local utility-provided electric and natural gas	Fair
Site Lighting	Building-mounted: LED, HID	Fair

Ancillary Structures	Pre-fabricated storage shed	Fair
Key Issues & Findings	No major findings
