FACILITY NEEDS ASSESSMENT

BLUE HILLS ELEMENTARY SCHOOL

FACILITY CONDITION ASSESSMENT

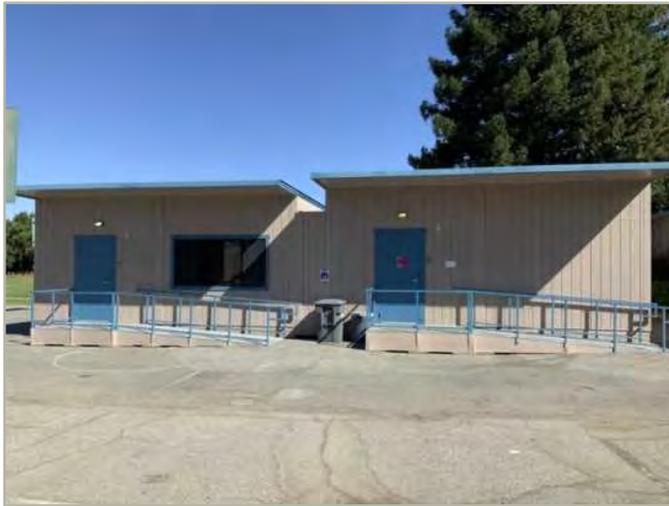
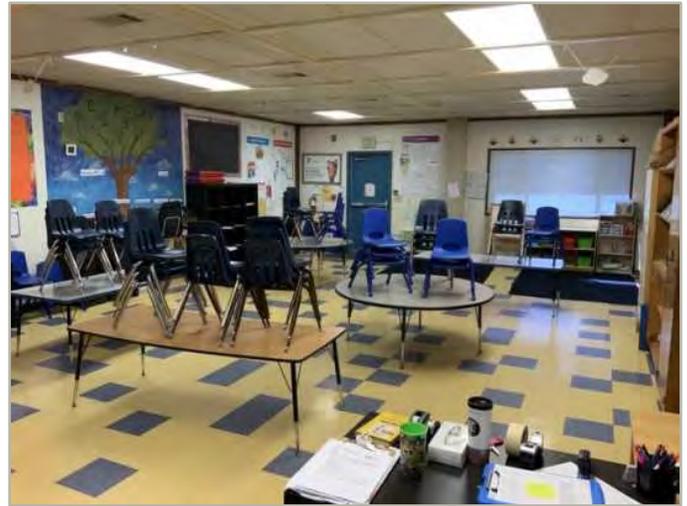
3. Classrooms

Accessibility	Presently it does not appear an accessibility study is needed for this property.
Key Issues and Findings	None

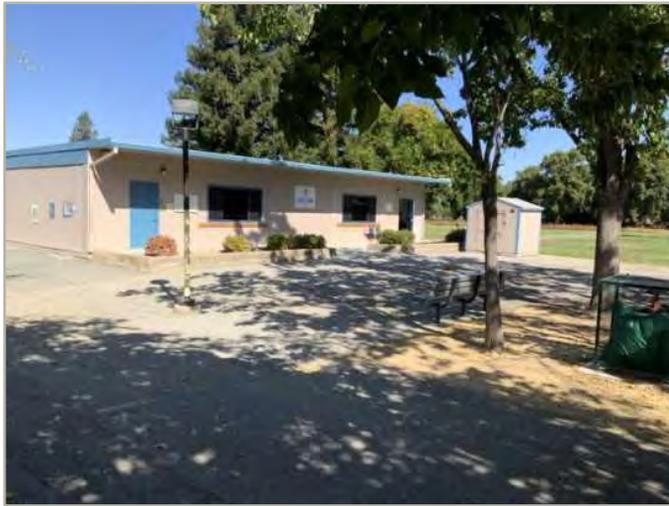
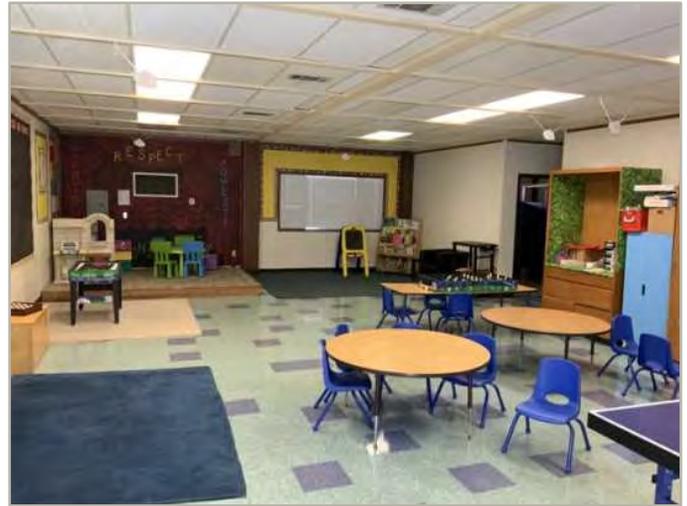
4. YMCA

Accessibility	Presently it does not appear an accessibility study is needed for this property.
Key Issues and Findings	None

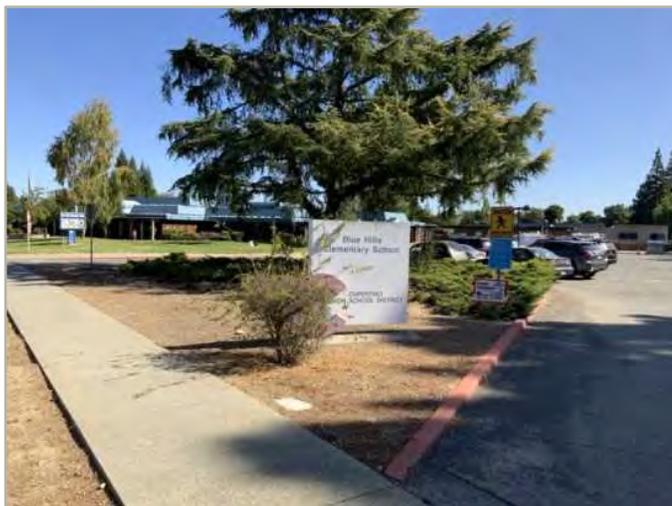
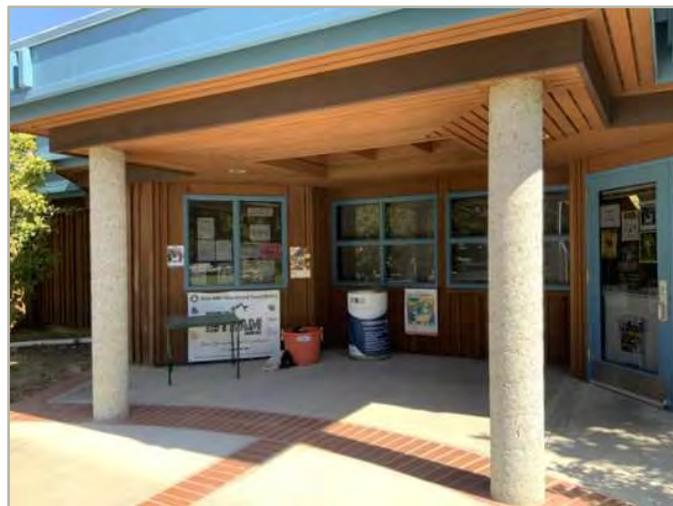
5. Site Summary

Lot Size	8.7 acres (estimated)	
Parking Spaces	43 total spaces all in open lots; two of which are accessible	
<i>System</i>	<i>Description</i>	<i>Condition</i>
Pavement/Flatwork	Asphalt lots with areas of concrete and concrete sidewalks, curbs, ramps, and stairs	Fair
Site Development	Property entrance signage, chain link fencing, a sound wall, and site lights	Fair
Landscaping and Topography	Landscaping features Irrigation present Low site slopes throughout	Fair
Utilities	Municipal water and sewer Local utility-provided electric	Fair
Site Lighting	Pole-mounted: HPS Building-mounted: LED, CFL, HPS	Fair
Ancillary Structures	Wood-framed storage structures, prefabricated storage sheds, play structures, and shade structures	Fair
Accessibility	Presently it does not appear an accessibility study is needed for the exterior site areas. See Section 7.	
Key Issues and Findings	None
