# **COLLINS ELEMENTARY SCHOOL**

**2020** | FACILITIES MASTER PLAN

# FACILITY CONDITION ASSESSMENT

L.P. COLLINS ELEMENTARY SCHOOL

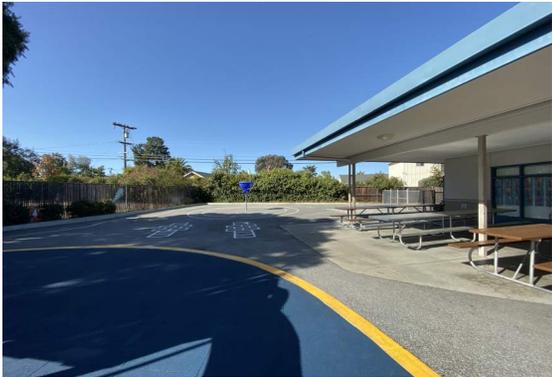
Kindergarten Play Yard

The principal identified two (2) areas of poor drainage. The Kindergarten play structure should be replaced with one that is more age-appropriate. The principal would like an additional play structure for primary grades, as well as a track to accommodate the running club. The field is shared with outside uses and is maintained by the city.

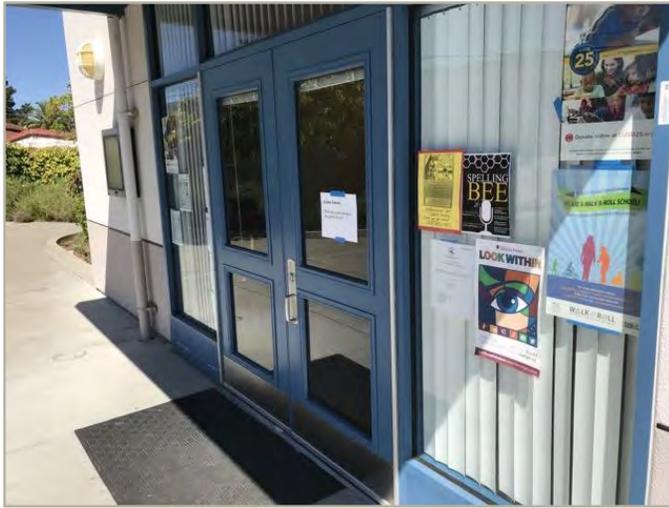
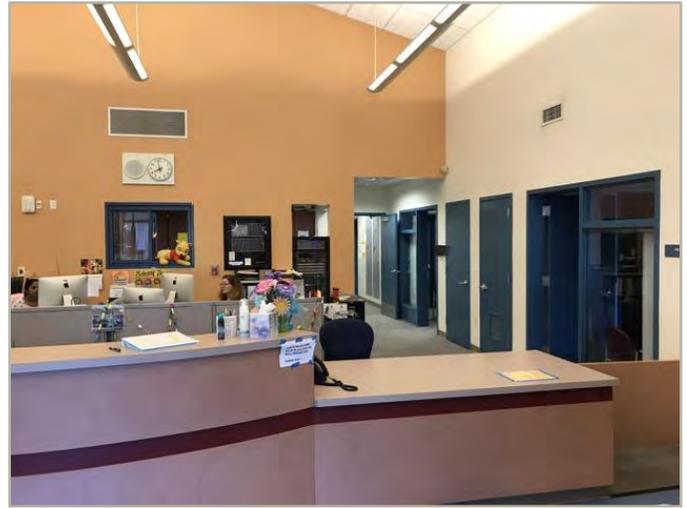
## 2. Administration Building

<b>HVAC</b>	Individual package units Supplemental components: ductless split-systems	Fair
<b>Fire Suppression</b>	Wet-pipe sprinkler system; hydrants, fire extinguishers	Fair
<b>Electrical</b>	Source & Distribution: Building panels with copper wiring. Fed from exterior service entrance section at transformer. Interior Lighting: T-12, LED, CFL	Fair
<b>Fire Alarm</b>	Main Fire Alarm panel for all buildings, smoke detectors, alarms, strobes, pull stations, back-up emergency lights, and exit signs	Fair
<b>Equipment/Special</b>	None	--
<b>Accessibility</b>	Presently it does not appear an accessibility study is needed for this property.	
<b>Key Issues and Findings</b>	Wood trim to be replaced at metal roof fascia. Possible galvanized water pipes remain and replacement is recommended. Up-grades to fire alarm system and building automation systems for HVAC units.

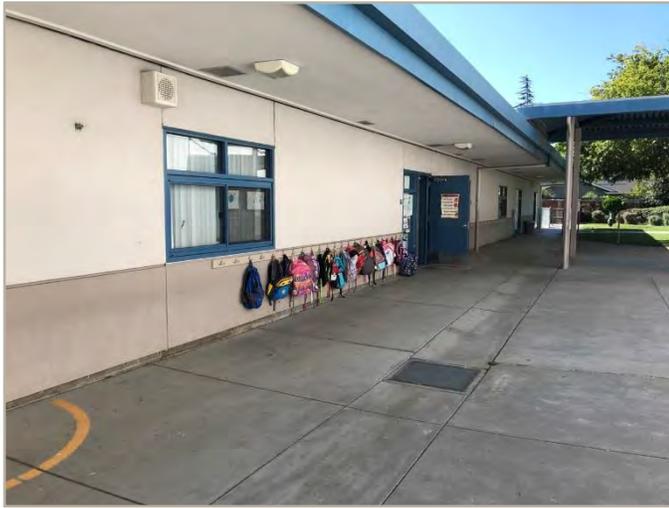
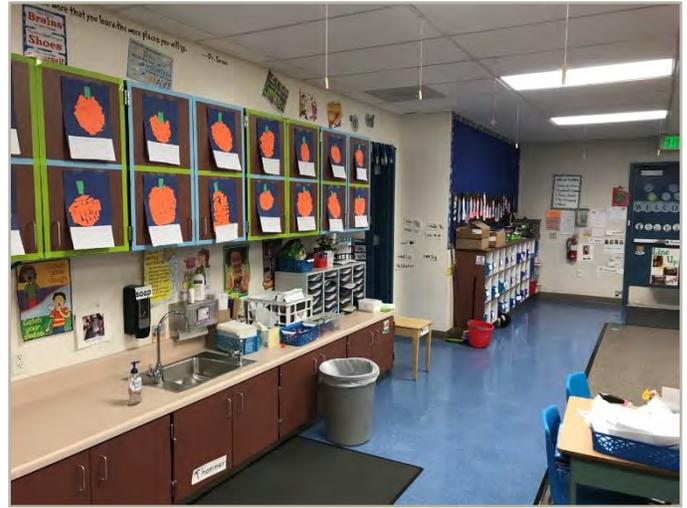
### 3. Classrooms B-C-D Building

<b>HVAC</b>	Individual wall mounted heat pump units (large PTAC) Building automation system on all HVAC units	Fair
<b>Fire Suppression</b>	Wet-pipe sprinkler system; hydrants, fire extinguishers	Fair
<b>Electrical</b>	Source and Distribution: Building panels with copper wiring and step-down transformers. Fed from exterior service entrance section at transformer. Interior Lighting: T-12, CFL	Fair
<b>Fire Alarm</b>	Smoke detectors, alarms, strobes, pull stations, back-up emergency lights, and exit signs	Fair
<b>Equipment/Special</b>	None	--
<b>Accessibility</b>	Presently it does not appear an accessibility study is needed for this property.	
<b>Key Issues and Findings</b>	Possible galvanized water pipes remain and replacement is recommended.

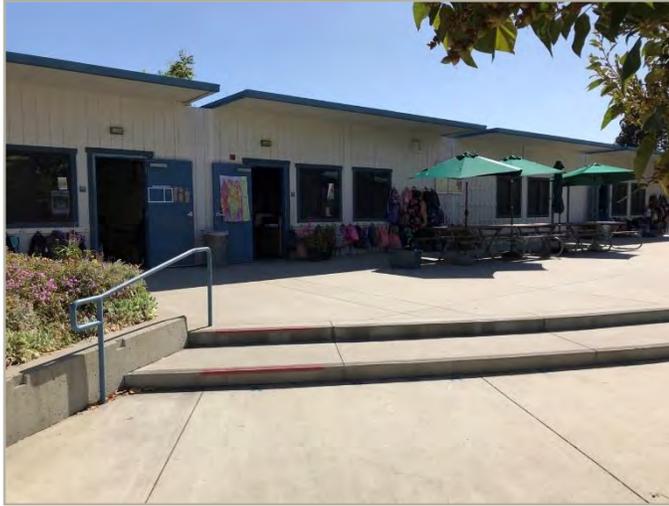
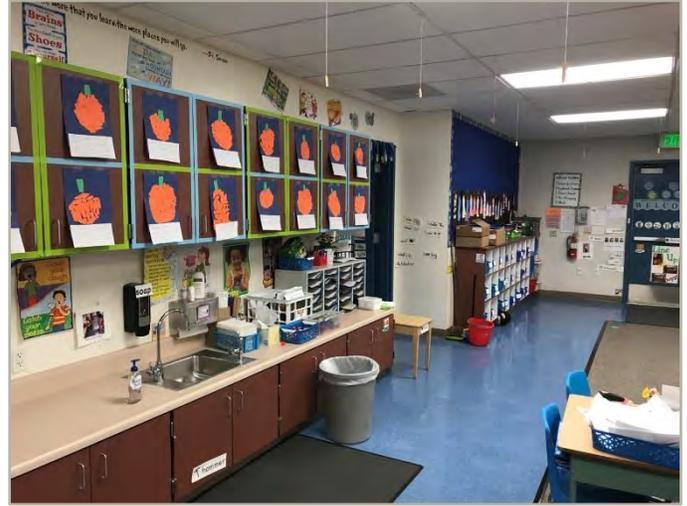
## 4. Child Development Center Building

<b>HVAC</b>	Individual wall mounted heat pump units (large PTAC) Building automation system on all HVAC units	Fair
<b>Fire Suppression</b>	No fire sprinklers	--
<b>Electrical</b>	Source & Distribution: Main service entrance section at transformer. Building panel with copper wiring. Fed from exterior service entrance section at transformer. Interior Lighting: T-12, CFL	Fair
<b>Fire Alarm</b>	Smoke detectors, alarms, strobes, pull stations, back-up emergency lights, and exit signs	--
<b>Equipment/Special</b>	None	--
<b>Accessibility</b>	Presently it does not appear an accessibility study is needed for this property.	
<b>Key Issues and Findings</b>	Damaged flooring at exit.

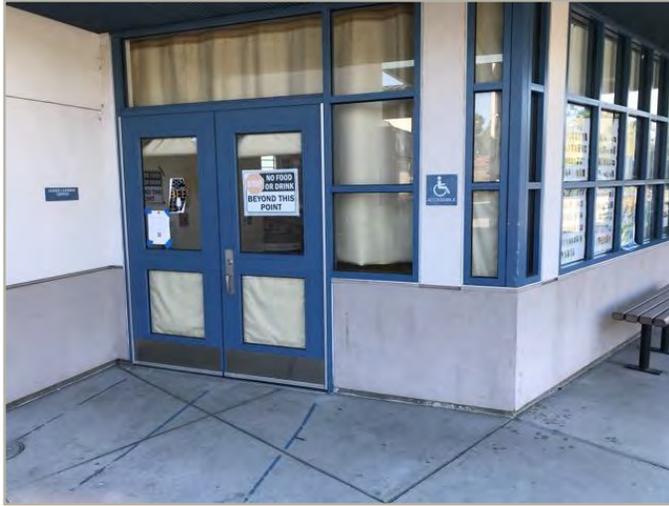
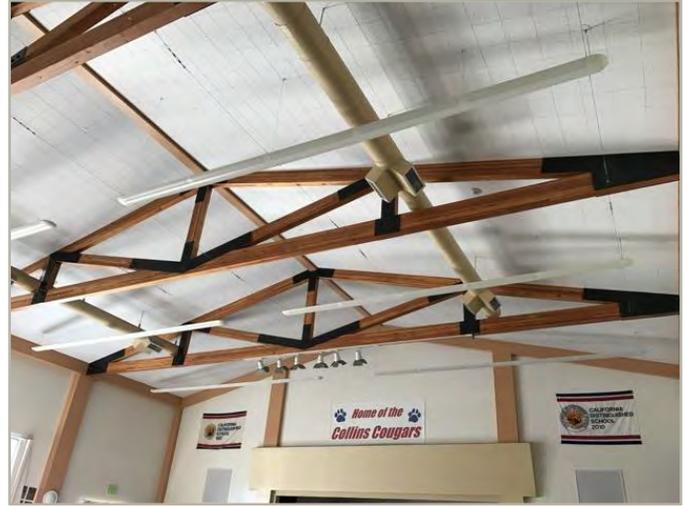
## 5. Guided Learning Center Building

<b>HVAC</b>	Individual wall mounted heat pump units (large PTAC) Package gas-fired units. ductless split-systems Building automation system on all HVAC units	Good
<b>Fire Suppression</b>	Wet-pipe sprinkler system; hydrants, fire extinguishers	Good
<b>Electrical</b>	Source & Distribution: Main service entrance section at transformer. Building panels with copper wiring. Fed from exterior service entrance section at transformer. Interior Lighting: T-12, LED, CFL	Good
<b>Fire Alarm</b>	Alarm panel, smoke detectors, alarms, strobes, pull stations, back-up emergency lights, and exit signs	Good
<b>Equipment/Special</b>	Partial commercial kitchen. Warming and food storage equipment. No cooking appliances.	Good
<b>Accessibility</b>	Presently it does not appear an accessibility study is needed for this property.	
<b>Key Issues and Findings</b>	Roof hatch not working. Possible galvanized water pipes remain and replacement is recommended.

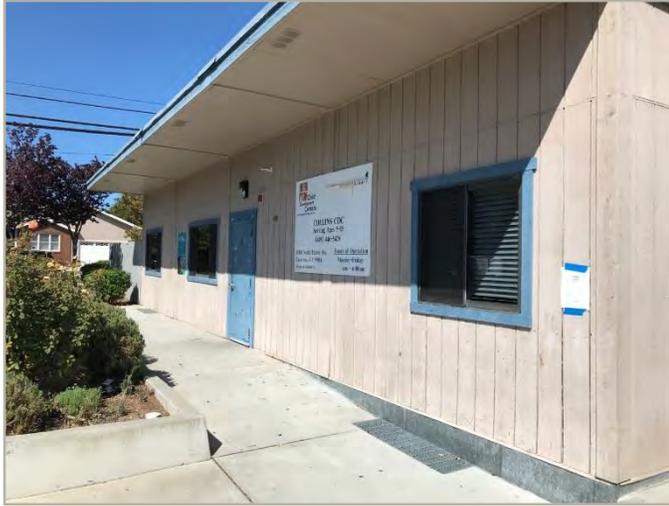
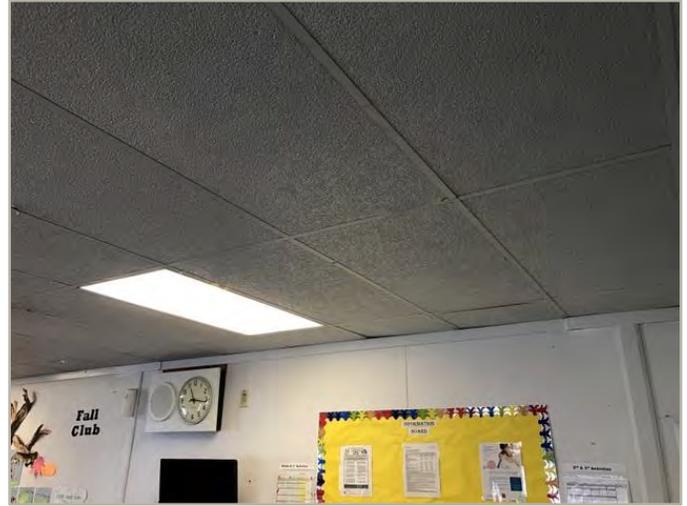
## 6. Modular Classrooms

<b>HVAC</b>	Individual wall mounted heat pump units (large PTAC) Building automation system on all HVAC units	Fair
<b>Fire Suppression</b>	Fire extinguishers	Fair
<b>Electrical</b>	Source & Distribution: Main service entrance section at transformer. Building panel with copper wiring. Fed from exterior service entrance section at transformer. Interior Lighting: T-12, CFL	Fair
<b>Fire Alarm</b>	Smoke detectors, alarms, strobes, pull stations, back-up emergency lights, and exit signs	Fair
<b>Equipment/Special</b>	None	--
<b>Accessibility</b>	Presently it does not appear an accessibility study is needed for this property.	
<b>Key Issues and Findings</b>	Damaged exterior siding
