FACILITY NEEDS ASSESSMENTS

DE VARGAS ELEMENTARY SCHOOL

2020 | FACILITIES MASTER PLAN

FACILITY CONDITION ASSESSMENT

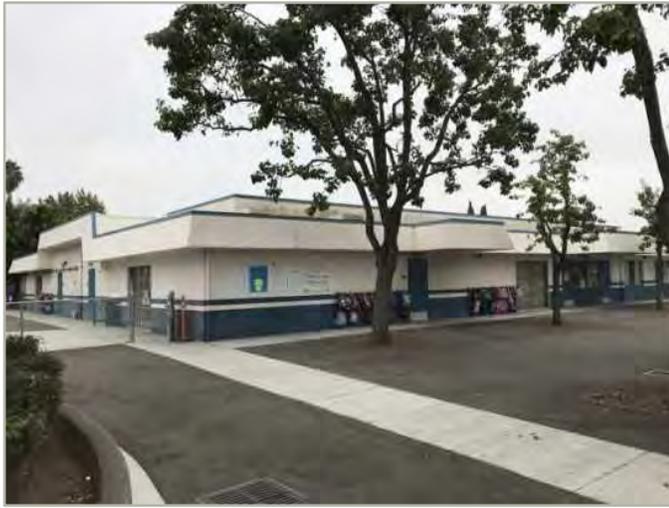
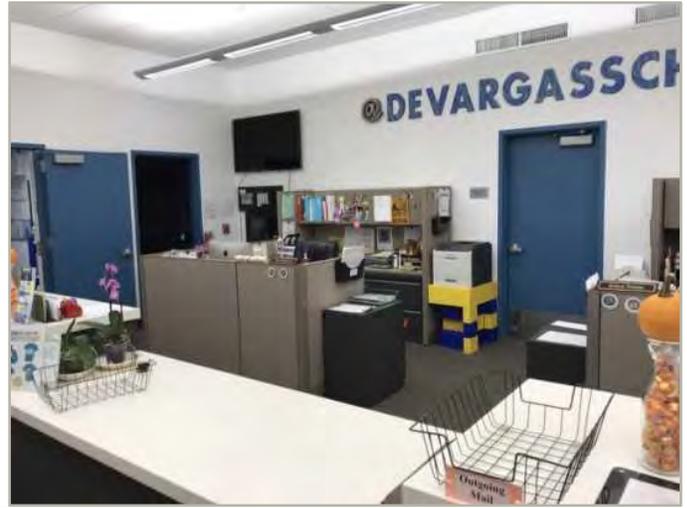
2. Administration

Key Issues and Findings Damaged wood parapet

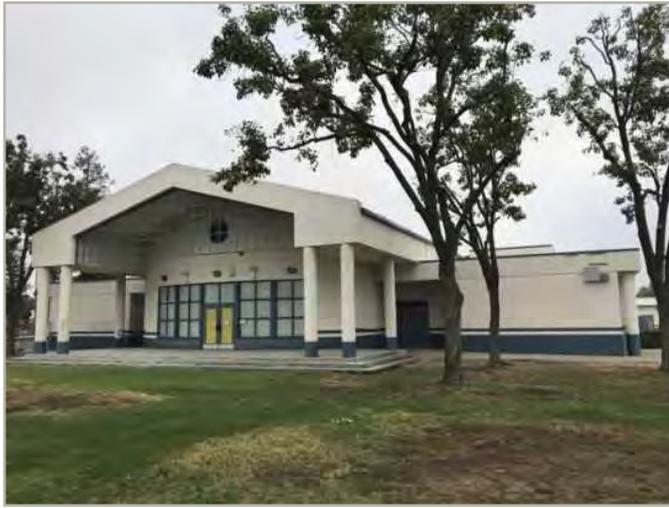
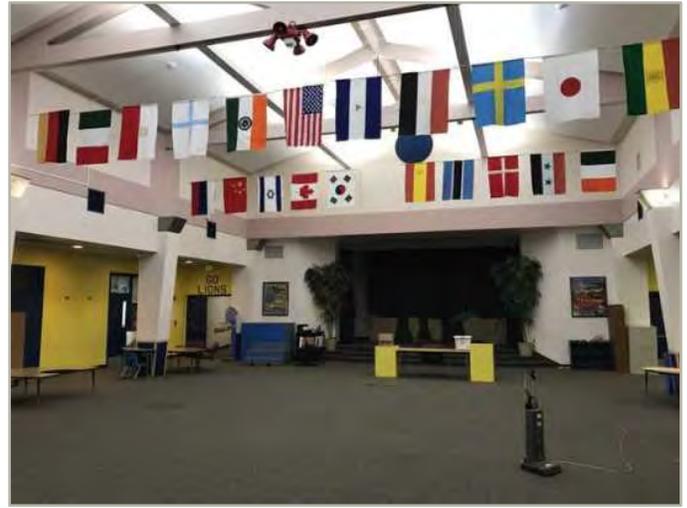
4. Guided Learning Center

Accessibility	Presently it does not appear an accessibility study is needed for this property.
Key Issues and Findings	Roof requires repairs

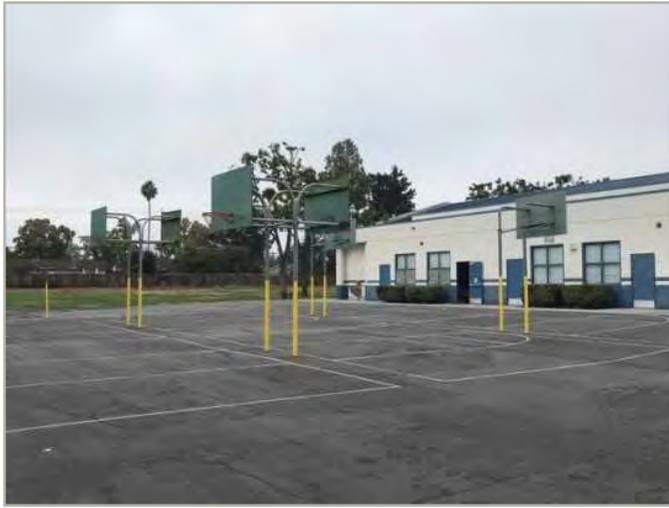
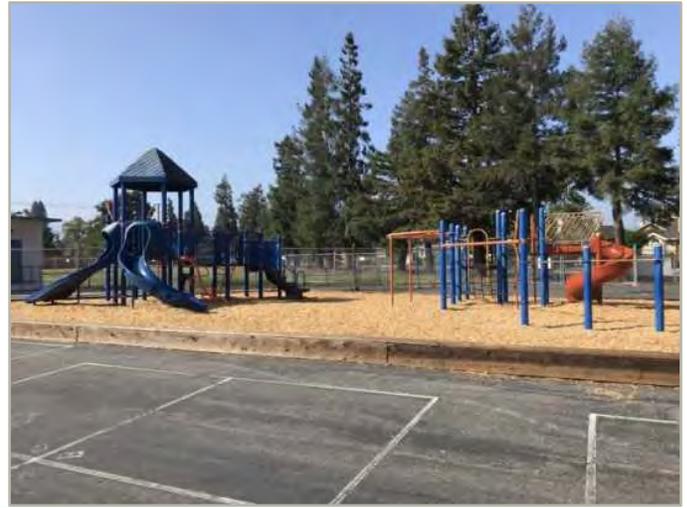
6. Site Summary

Lot Size	8.62 acres (estimated)	
Parking Spaces	72 total spaces all in open lots; three of which are accessible	
<i>System</i>	<i>Description</i>	<i>Condition</i>
Pavement/Flatwork	Asphalt lots with areas of concrete and concrete sidewalks, curbs, ramps, and stairs	Fair
Site Development	Playgrounds and fencing	Fair
Landscaping and Topography	No significant landscaping features Irrigation present Low to moderate site slopes throughout	Fair
Utilities	Municipal water and sewer Local utility-provided electricity and natural gas	Fair
Site Lighting	Building-mounted: LED	Fair
Ancillary Structures	None	--
Accessibility	Presently it does not appear an accessibility study is needed for the exterior site areas. See Section 8.	
Key Issues and Findings	Alligator cracking at parking lot
