# EATON ELEMENTARY SCHOOL

2020 | FACILITIES MASTER PLAN

# FACILITY CONDITION ASSESSMENT

C. B. EATON ELEMENTARY SCHOOL  
20220 Suisun Drive  
Cupertino, California 95014

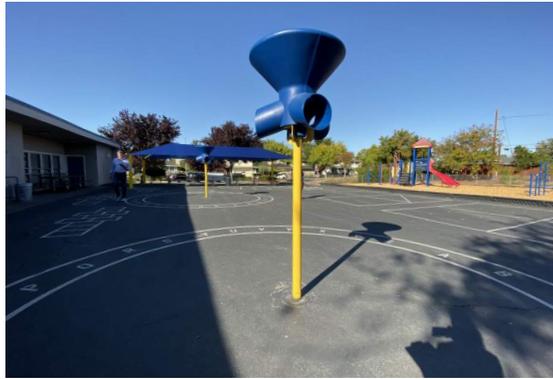
Kindergarten Play Yard

The principal would like the Kindergarten play yard expanded to add grass.

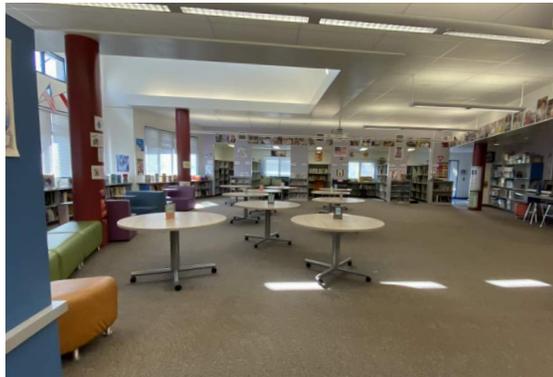
The site has separate facilities for Library and Assembly (which occurs in the Multi-Purpose Room). The Library functions well, despite experiencing some leaks. The MPR functions for assemblies, but does not hold the entire student body.

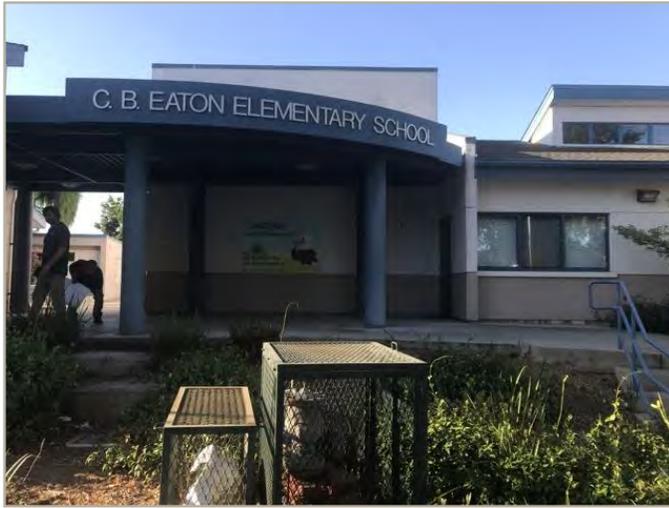
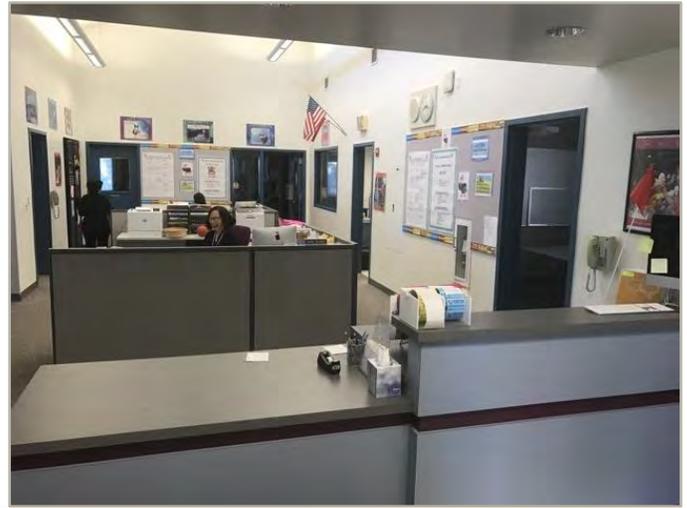
### Building Type 1 - Administration/Library: Systems Summary

<b>Electrical</b>	Source & Distribution: Building panels with copper wiring. Fed from exterior service entrance section at transformer. Interior Lighting: T-12, LED, CFL	Good
<b>Fire Alarm</b>	Fire Alarm panel, smoke detectors, alarms, strobes, pull stations, back-up emergency lights, and exit signs	Good
<b>Equipment/Special</b>	None	--
<b>Accessibility</b>	Presently it does not appear an accessibility study is needed for this property.	
<b>Key Issues and Findings</b>	Comprehensive replacement of building components as they reach the end of their useful service life. Limited wood trim to be replaced at metal roof fascia. Up-grades to fire alarm system and building automation systems for HVAC units.

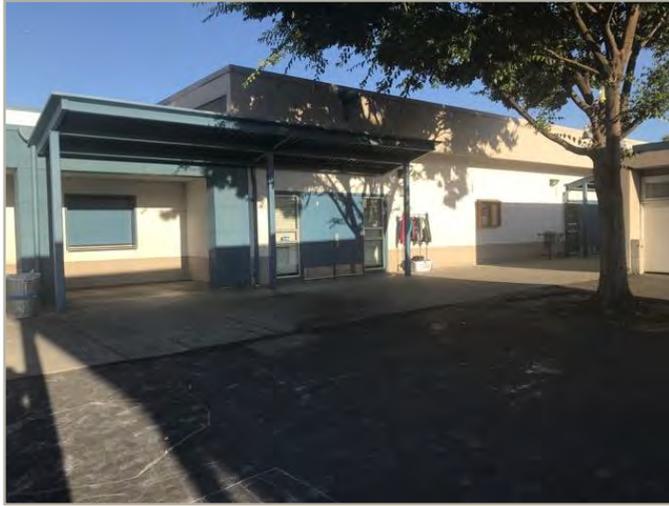
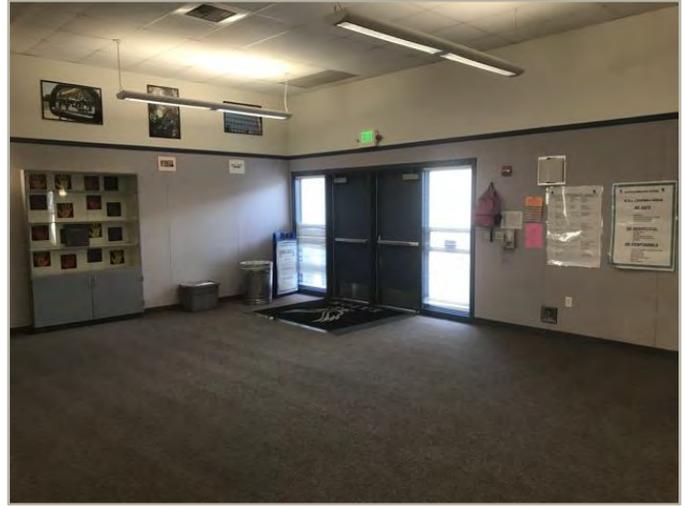
### Building Type 3 - Multi-Use: Systems Summary

<b>Electrical</b>	Source & Distribution: Main service entrance section at transformer. Building panels with copper wiring. Fed from exterior service entrance section at transformer. Interior Lighting: T-12, LED, CFL	Good
<b>Fire Alarm</b>	Alarm panel, smoke detectors, alarms, strobes, pull stations, back-up emergency lights, and exit signs	Good
<b>Equipment/Special</b>	Partial commercial kitchen. Warming and food storage equipment. No cooking appliances.	Good
<b>Accessibility</b>	Presently it does not appear an accessibility study is needed for this property.	
<b>Key Issues and Findings</b>	Comprehensive replacement of building components as they reach the end of their useful service life. Possible galvanized water pipes remain, and replacement is recommended. Up-grades to fire alarm system and building automation systems for HVAC units.

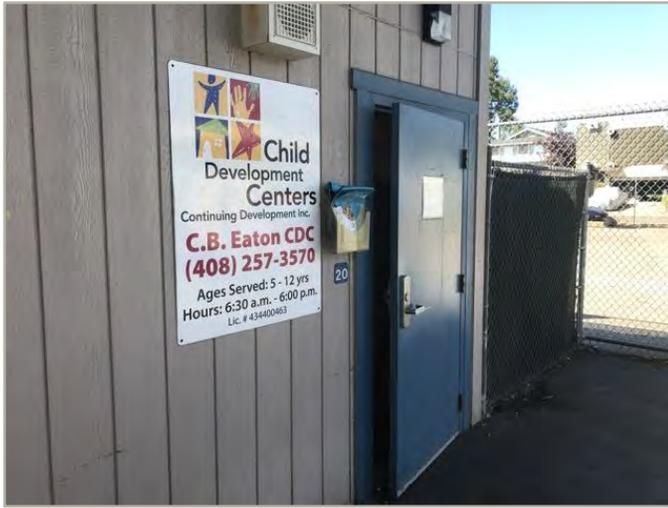
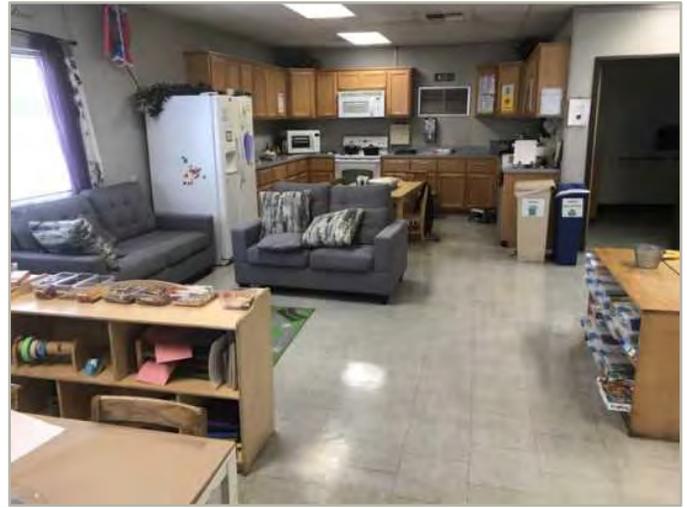
### Building Type 4 - Child Development Center: Systems Summary

<b>Electrical</b>	Source & Distribution: Main service entrance section at transformer. Building panel with copper wiring. Fed from exterior service entrance section at transformer. Interior Lighting: T-12, CFL	Good
<b>Fire Alarm</b>	Smoke detectors, alarms, strobes, pull stations, back-up emergency lights, and exit signs	Good
<b>Equipment/Special</b>	None	--
<b>Accessibility</b>	Presently it does not appear an accessibility study is needed for this property.	
<b>Key Issues and Findings</b>	Comprehensive replacement of building components as they reach the end of their useful service life. Up-grades to fire alarm system and building automation systems for HVAC units.

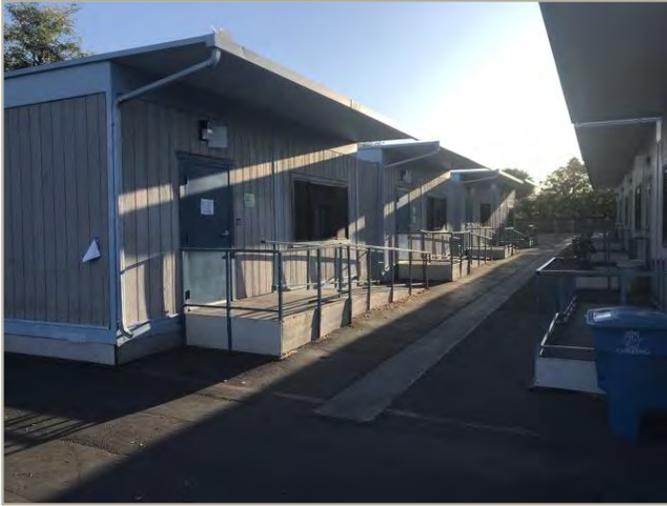
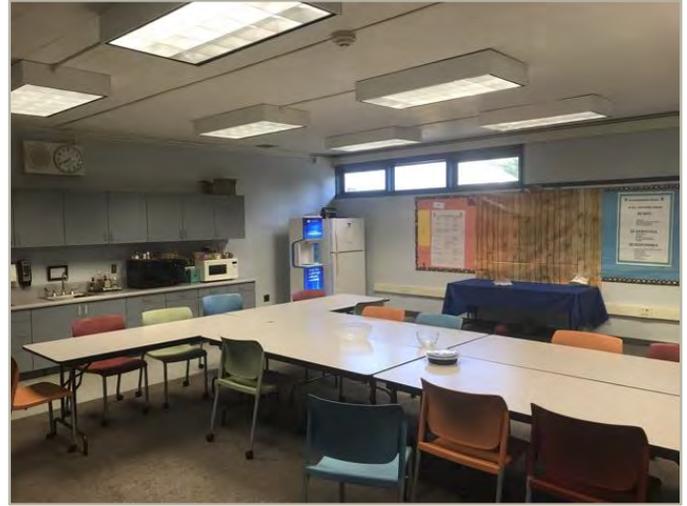
### Building Type 5 - Modular Classrooms: Systems Summary

<b>Electrical</b>	Source & Distribution: Main service entrance section at transformer. Building panel with copper wiring. Fed from exterior service entrance section at transformer. Interior Lighting: T-12, CFL	Good
<b>Fire Alarm</b>	Smoke detectors, alarms, strobes, pull stations, back-up emergency lights, and exit signs	--
<b>Equipment/Special</b>	None	--
<b>Accessibility</b>	Presently it does not appear an accessibility study is needed for this property.	
<b>Key Issues and Findings</b>	Comprehensive replacement of building components as they reach the end of their useful service life. Up-grades to fire alarm system and building automation systems for HVAC units.

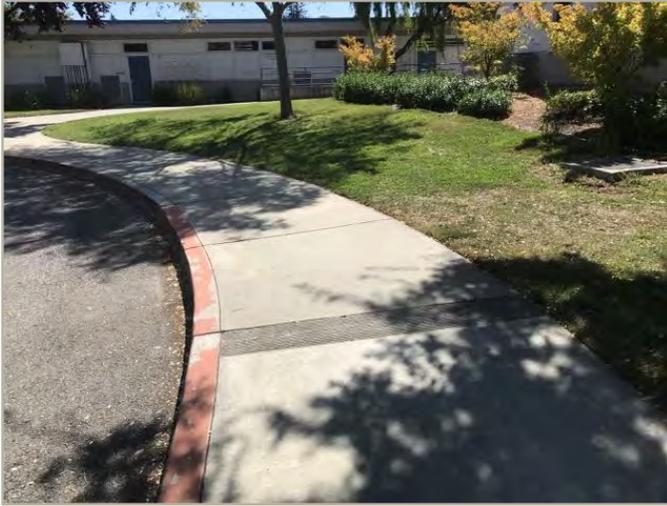
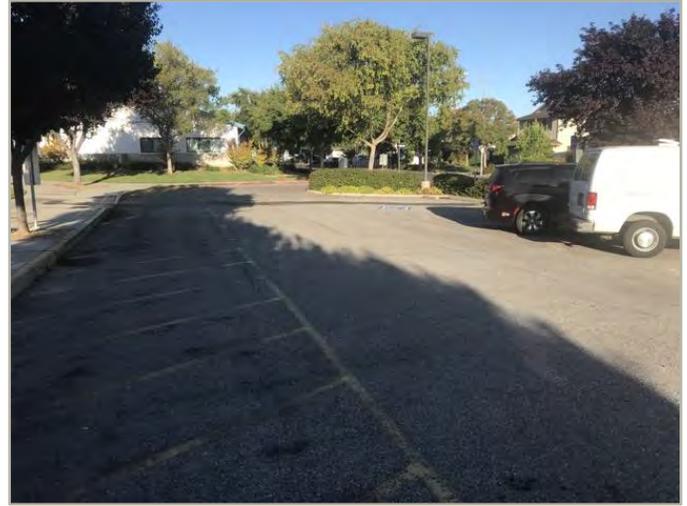
### Site Information

<b>Accessibility</b>	Presently it does not appear an accessibility study is needed for this property. See Section 9.	
<b>Key Issues and Findings</b>	No significant deficiencies observed. Comprehensive replacement of site components as they reach the end of their useful service life
